December 2018  
SF558A

## Subject: Cascadia Front Suspension Crossmember Steel Sleeves

**Models Affected: Specific Freightliner Cascadia vehicles  
manufactured May 3, 2016, through October 13, 2017.**

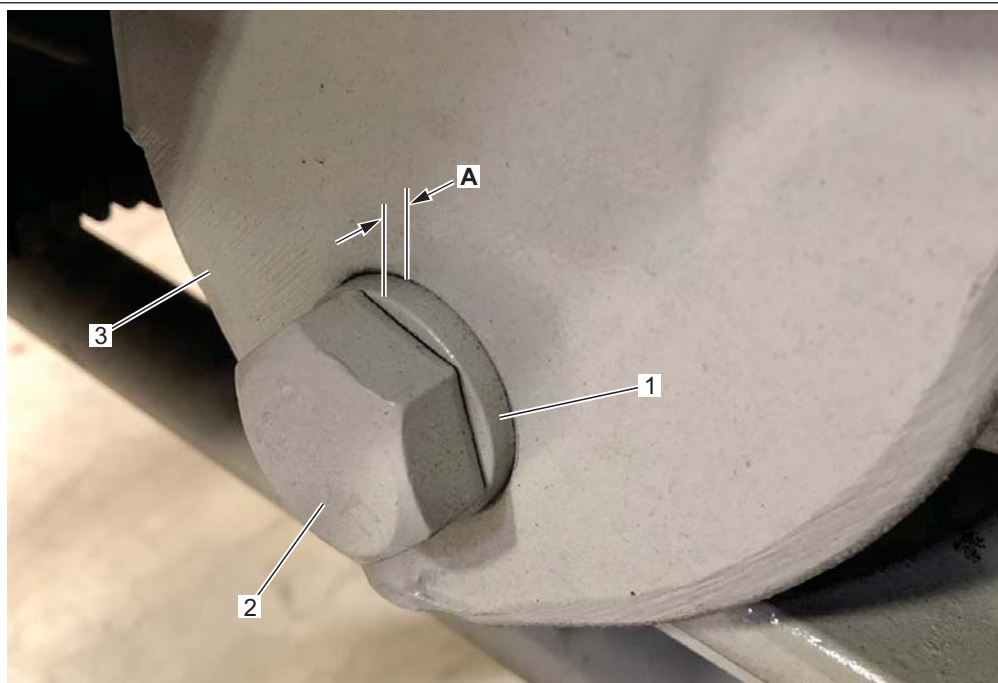
**Fig. 2, Sleeve Protrusion Measurement at the Forward Spring Bolt**

If the steel sleeve protrudes **more** than 1/4 in (6 mm) outboard of the hanger casting, continue with the next step.

A. If 1/4 inch (6 mm) or greater, adjustment required. If less than 1/4 inch (6 mm), no further work is needed.

11. Tighten the bolt 245 lbf·ft (332 N·m). The steel sleeve should be fully seated in the casting. The maximum protrusion past the casting surface is 1/4 in (6 mm).
12. Remove the bolt, nut, wedge, and plate.
13. Install a new bolt and nut. Tighten the bolt 245 lbf·ft (332 N·m).
14. Clean a spot on the base label (Form WAR259). Write the campaign number, SF558, on a blank gray completion sticker (Form WAR261) to indicate the work has been completed and attach it to the base label.
