# Service Bulletin

Bulletin No.: 18-NA-020

**Subject: Malfunction Indicator Lamp Illuminated with DTC P0300 and/or P0299/P2227 Set**

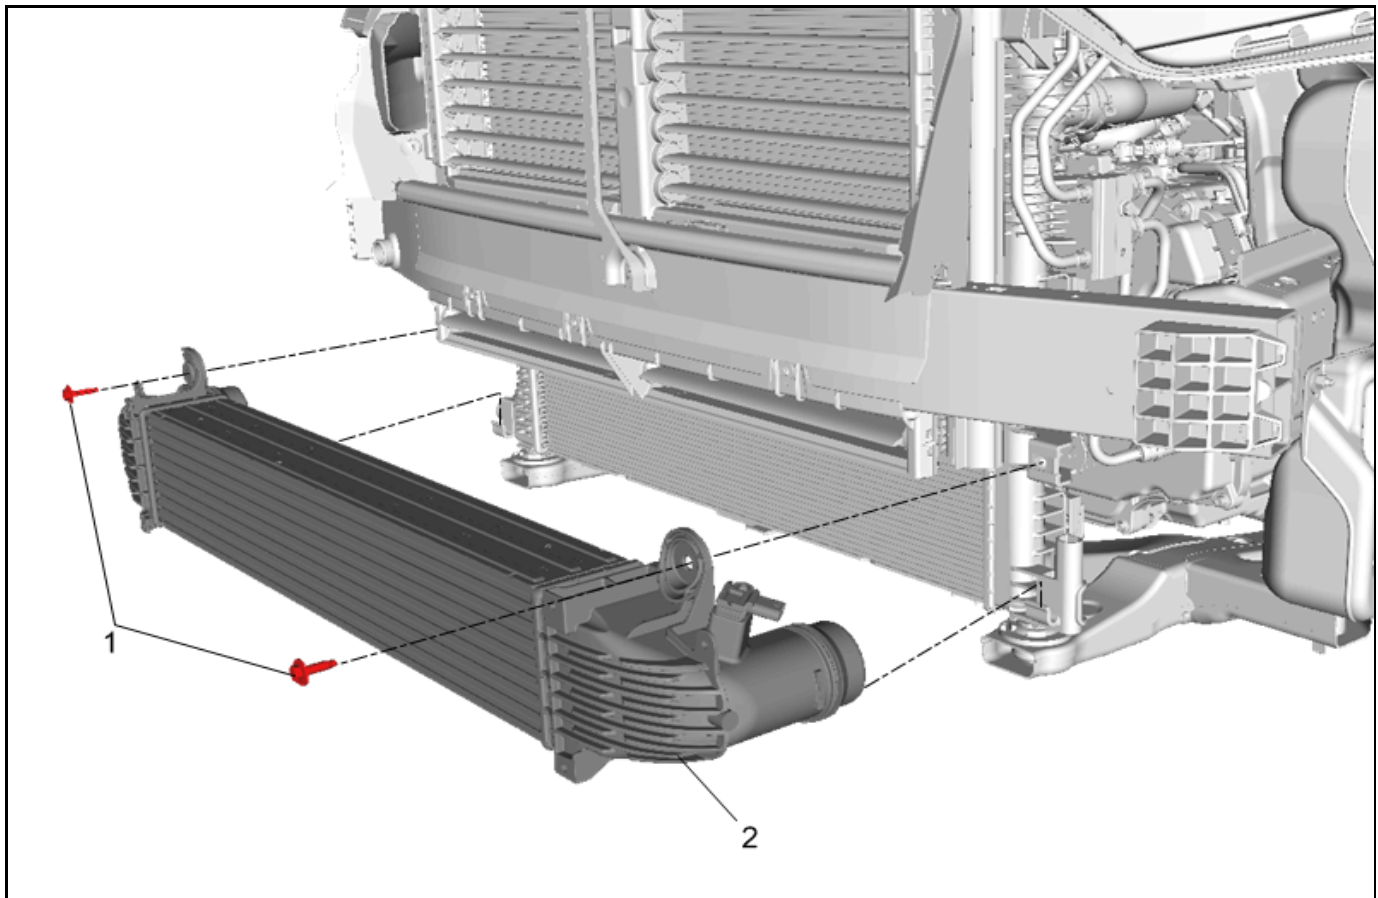
4597334

<b>Involved Region or Country</b>	North America and N.A. Export Regions
VK3	LICENSE PLATE FRONT-FRT MOUNTING PKG
WBL	SALES PACKAGE-SPORT
<b>Additional Options (RPOs)</b>	Equipped with LICENSE PLATE FRONT-FRT MOUNTING PKG, SALES PACKAGE-SPORT (RPOs VK3, WBL)
<b>Condition</b>	Some customers may comment on a malfunction indicator lamp illuminated. During diagnosis, a technician may find DTC P0299, P2227, or P0300 set/stored.
<b>Cause</b>	This may be caused by moisture build up inside the charge air cooler. Long drives through rainy conditions and/or high humidity conditions (heavy fog) can cause moisture to collect in the charge air cooler. A heavy acceleration can draw moisture into the engine causing DTC P0300. In cold temperatures, ambient and PCV moisture can freeze in the charge air cooler, restricting flow, and causing DTC P0299 and/or P2227.
<b>Correction</b>	<p>Perform a smoke leak test of the charge air cooler. If a leak is determined, replace the charge air cooler with the newly designed part. If there is NO leak, but a P0300, P0299 and/or P2227 are present, and the vehicle was built AFTER March 1, 2018, refer to SI for diagnosis. If there is no leak, but a P0300, P0299 and/or P2227 are present, AND the vehicle was built BEFORE March 1, 2018, then replace the charge air cooler with the newly designed part. LTG only remove boost sensor from the intake charge pipe to the throttle body and wipe with a clean rag to remove residual moisture</p> <p>If the charge air cooler is icing in cold weather conditions, a grille cover can be installed to help prevent the icing. Give the installation instructions, included with the covers, to the owner for future installations/removals.</p> <p><b>Important:</b> During temperatures ABOVE 32°F / 0°C, the grille cover <b>MUST</b> be removed to prevent the engine and transmission from overheating.</p> <p><b>Important:</b> The grille cover <b>MUST</b> be removed before towing a trailer of any size. Failure to do will decrease the transmission cooling efficiency and possibly cause damage to the drivetrain.</p>

If you encounter a vehicle with the above concern, replace the charge air cooler. Refer to *Charge Air Cooler Replacement* in SI.
