# Service Bulletin

Bulletin No.: 18-NA-307

**Subject: Lack of Power, Reduce Power Displayed on Drivers Information Center (DIC), Rough Idle, Stabilitrak Light On, Malfunction Indicator Light (MIL) Illuminated - DTC P0014 , P0365, and P0366 Set**

Brand:	Model:	Model Year:		VIN:		Engine:	Transmission:
		from	to	from	to		
Chevrolet	Colorado	2015	2019			LCV	
GMC	Canyon

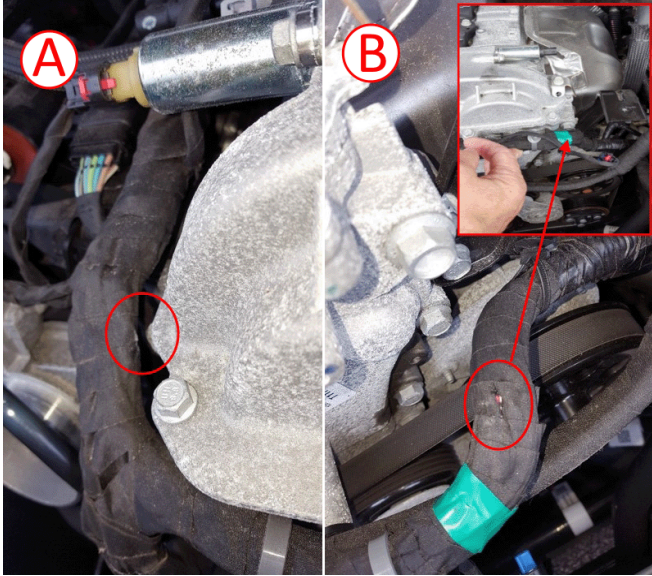
<p style="text-align: right;">5153274</p> <p>This may be caused by the engine wiring harness chaffing on the edge of the camshaft cover (A) and/or the cylinder head (B).</p>
<p><b>Correction</b></p>	<p><b>Note:</b> Possible multiple effects or driver notifications may be experienced by one of the wires in the engine harness being chafed or cut in different circuits. Due to the cause of the condition, and the positions of the wires in the engine harness, it is unlikely that more than one circuit and/or fuse will be affected by the condition.</p> <ol style="list-style-type: none"> <li>1. Inspect the engine wiring harness conduit and wires for chaffing.</li> <li>2. Repair the wires per the <i>Wiring Repairs</i> procedure in SI.</li> <li>3. Using Woven Polyester Electrical Tape (PET), tape all the contact points of the engine harness ensuring that the tape is applied in a double layer extending along the engine harness past the camshaft cover or cylinder head.</li> <li>4. Utilizing tie straps, position the engine wiring harness away from the camshaft cover or cylinder head.</li> </ol>
