Service Bulletin

Bulletin No.: 18-NA-347

Subject: Unable to Adjust Clock Manually

Brand:	Model:	Model Year:		VIN:		Engine:	Transmission:
		from	to	from	to		
Chevrolet	Sonic	2018	2018			All	All
	Trax						
GMC	Terrain	2018	2018

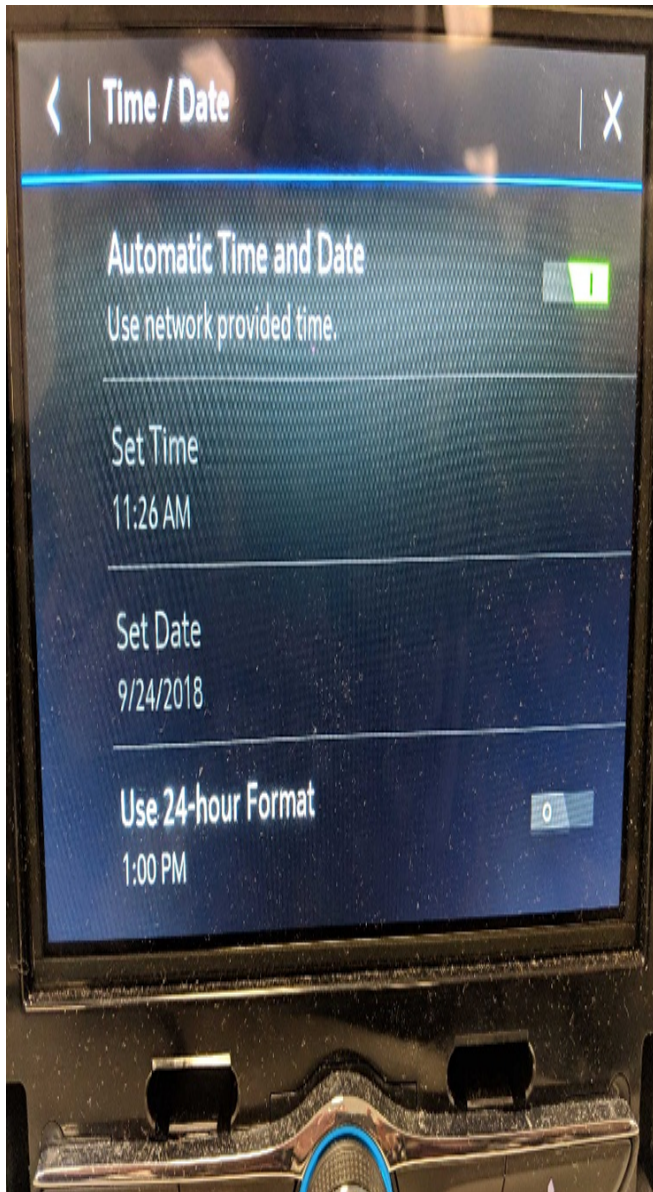
5168244

Menu displayed with OnStar Terms and Conditions accepted:

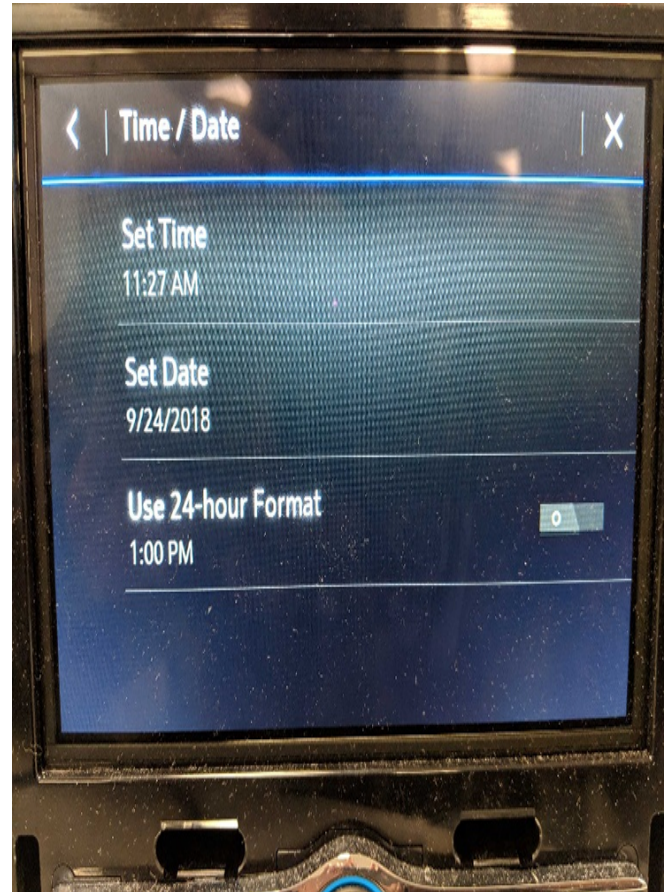
5168251

Note: If OnStar account Terms and Conditions are declined, the Auto Update option is removed from the Time/Date menu. A software anomaly allows the Auto Update option to remain enabled when the option is removed from the menu, preventing manual clock adjustments from occurring.

Menu displayed with OnStar Terms & Conditions declined:
