## **Service Bulletin**

Bulletin No.: 18-NA-361

**Subject:** Diagnostic Tip for Fuel System Contamination

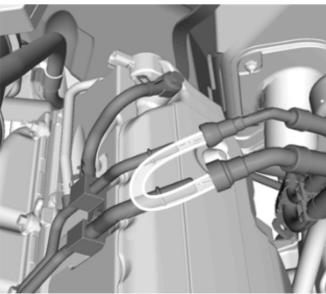
**Note:** The white "Tubing" shown in the graphics below depict the route of the clear line, not the length.

6. Install a clear line between the fuel supply hose and the fuel return hose.

7. Run the fuel pump until the fuel runs clear in the line.
