# Service Bulletin

Bulletin No.: 18-NA-367

**Subject: Diagnostic Tip for Malfunction Indicator Lamp (MIL) Illuminated with DTC P305F, P058B and/or P058D**

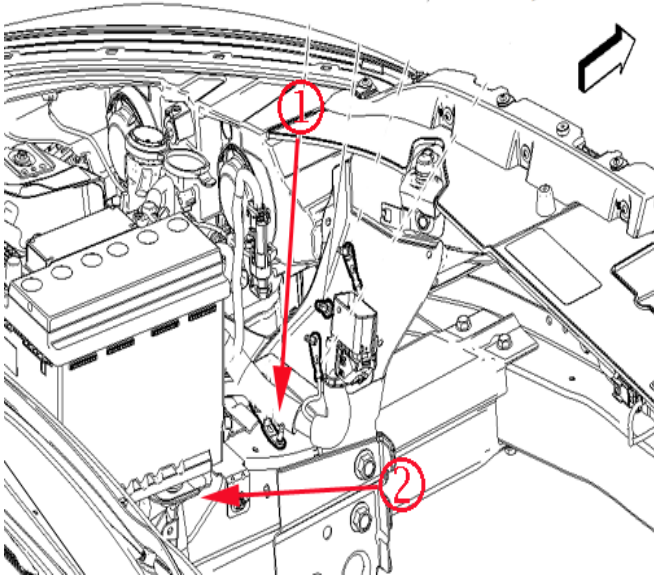
4005667

Inspect the following if DTC P305F has been set:

1. Check state of health of auxiliary battery with the GR8 tester. Not just a state of charge check.
    - If low, replace the battery, clear codes and re-check.
    - If good, proceed to step 2.
  2. Check ground resistance from the Dual Battery Isolation Module (DBIM) to G103. Wiggle the harness (1) and negative battery terminal connections during test to look for varied resistance values.
    - If resistance is greater than 0.5 ohms, or changes more than 1 ohm, then inspect ground connections and/or splice in the harness about 1.5 ft. from the connector end.
- ⇒ Fix poor connections, clear codes and re-check.
- If resistance is less than 0.5 ohms, proceed to step 3.
3. Verify the engine harness is not pinched underneath the main battery tray (2).

**Note:** The DBIM is located on the fuse block assembly. If found the cause of the concern, the Battery Distribution Fuse Block must be replaced.

4. Replace the battery distribution fuse block and wiring harness connector, clear codes and re-check.

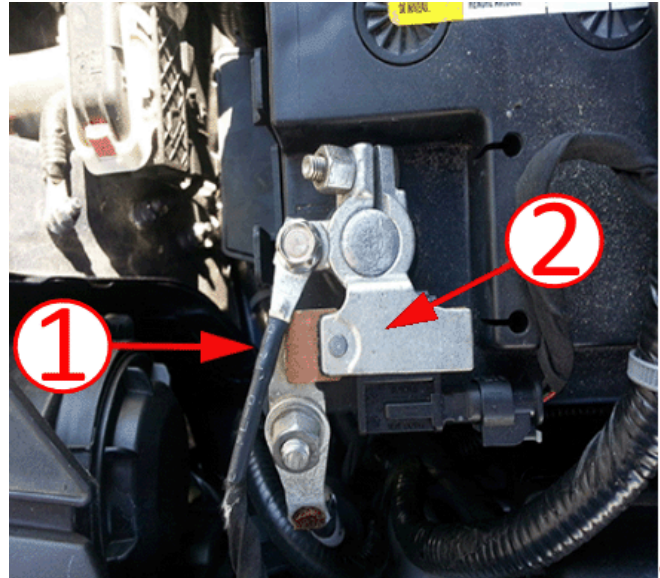
5148609

Inspect the following if DTC P058B and/or P058D is set current or in history:

1. Inspect the orientation of the grounding ring for circuit 150 (1) to the B110 Battery Sensor Module (2).
