# Service Bulletin

Bulletin No.: 18-NA-374

**Subject:** Low Oil Light On

Brand:	Model:	Model Year:		VIN Breakpoint:		Engine:	Transmission:
		from	to	from	to		
Cadillac	CTS	2014	2019	K0121280	EOP	2.0L (RPO LTG)

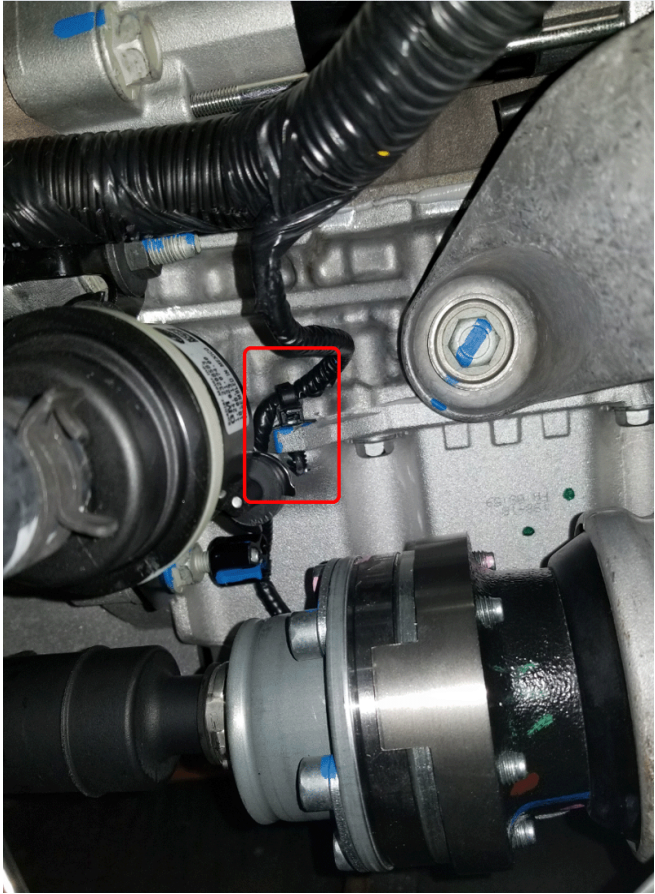
5181559

<b>Involved Region or Country</b>	North America, Europe, Japan, Middle East, Russia, Israel, South Korea, China
<b>Additional Options (RPOs)</b>	AWD (F46)
<b>Condition</b>	Some customers may comment that the Low Oil Light is on.
<b>Cause</b>	This condition may be caused by the oil level sensor wiring harness clip installed incorrectly, causing the harness to become too long and contact the driveshaft.
<b>Correction</b>	<p>If the above condition has been validated, inspection of the wiring harness must be done.</p>

<p><b>Note:</b> Original routing of the harness has the clip being installed from the bottom. Correction is to reverse the direction of that clip.</p> <ol style="list-style-type: none"> <li>1. With a suitable light, inspect the wiring harness point of contact at the driveshaft and positioning of the clip.</li> <li>2. Repair the harness as needed.</li> </ol> <p>⇒ Refer to <i>Wire to Wire Repair</i> in SI.</p> <ol style="list-style-type: none"> <li>3. Using Woven Polyester Electrical Tape (PET), tape all the contact points of the harness ensuring that the tape is applied in a double layer.</li> <li>4. Reposition the harness clip from the top down as shown in the graphic above.</li> </ol> <p>⇒ Verify the harness to driveshaft clearance. Adjust as necessary.</p>
--	--
