# Service Bulletin

Bulletin No.: 18-NA-375

**Subject:** Information on Diagnosis of No Start, Radio Click Noise or Inoperative, Malfunction Indicator Lamp (MIL) Illuminated, and/or Various Electrical Issues

| Brand: | Model: | Model Year: | | VIN: | | Engine: | Transmission: |
|---|---|---|---|---|---|---|---|
| Chevrolet | Camaro | 2016 | 2019 | | | All | All |

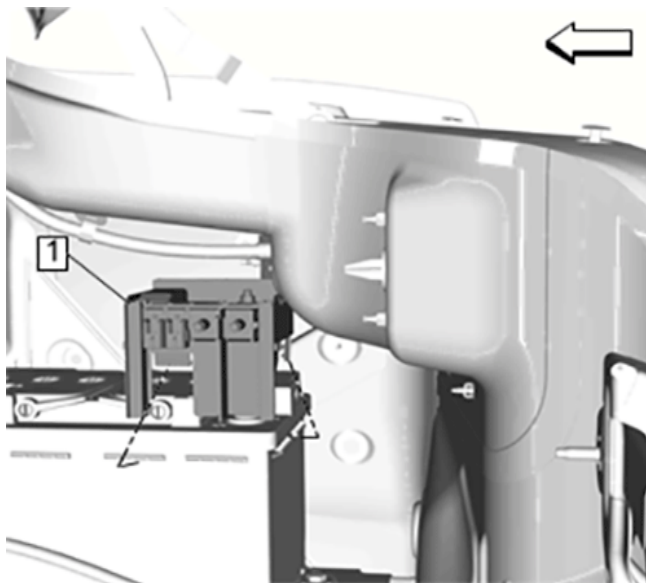
| <b>Cause</b> | <p>The cause of the condition may be water intrusion into the electrical components located in the rear compartment area.</p> <p>5187163</p> <p>Some technicians may find water intrusion related damage at the Rear Body Fuse Block (1).</p> |

| <b>Correction</b> | <p>To determine the source of water intrusion, water test and inspect the following areas:</p> <ul style="list-style-type: none"> <li>• Rear compartment lid weatherstrip area.</li> <li>• Rear body structure stop lamp pockets.</li> <li>• Rear body structure stop lamp foam missing.</li> <li>• Seams around rear window.</li> <li>• Sunroof drain hose disconnected or damaged.</li> <li>• Missing or not fully seated body plugs (2 plugs located below the rear window on convertibles).</li> </ul> |

**If the source of the water leak is determined to be caused by a manufacturing defect,** replace modules and repair wiring as necessary and please submit a field product report with details and photos of concern.
