Service Bulletin

Bulletin No.: 18-NA-376

Subject: Radio Software Version V509 Over-the-Air Update

Brand:	Model:	Model Year:		VIN:		Engine:	Transmission:
		from	to	from	to		
Cadillac	XT4	2019	2019				
Chevrolet	Blazer	2019	2019			All	All
	Camaro						
	Colorado						
	Equinox						
	Malibu						
	Silverado 1500 (New Model)						
	Volt						
GMC	Canyon	2019	2019				
	Sierra 1500 (New Model)						
	Terrain

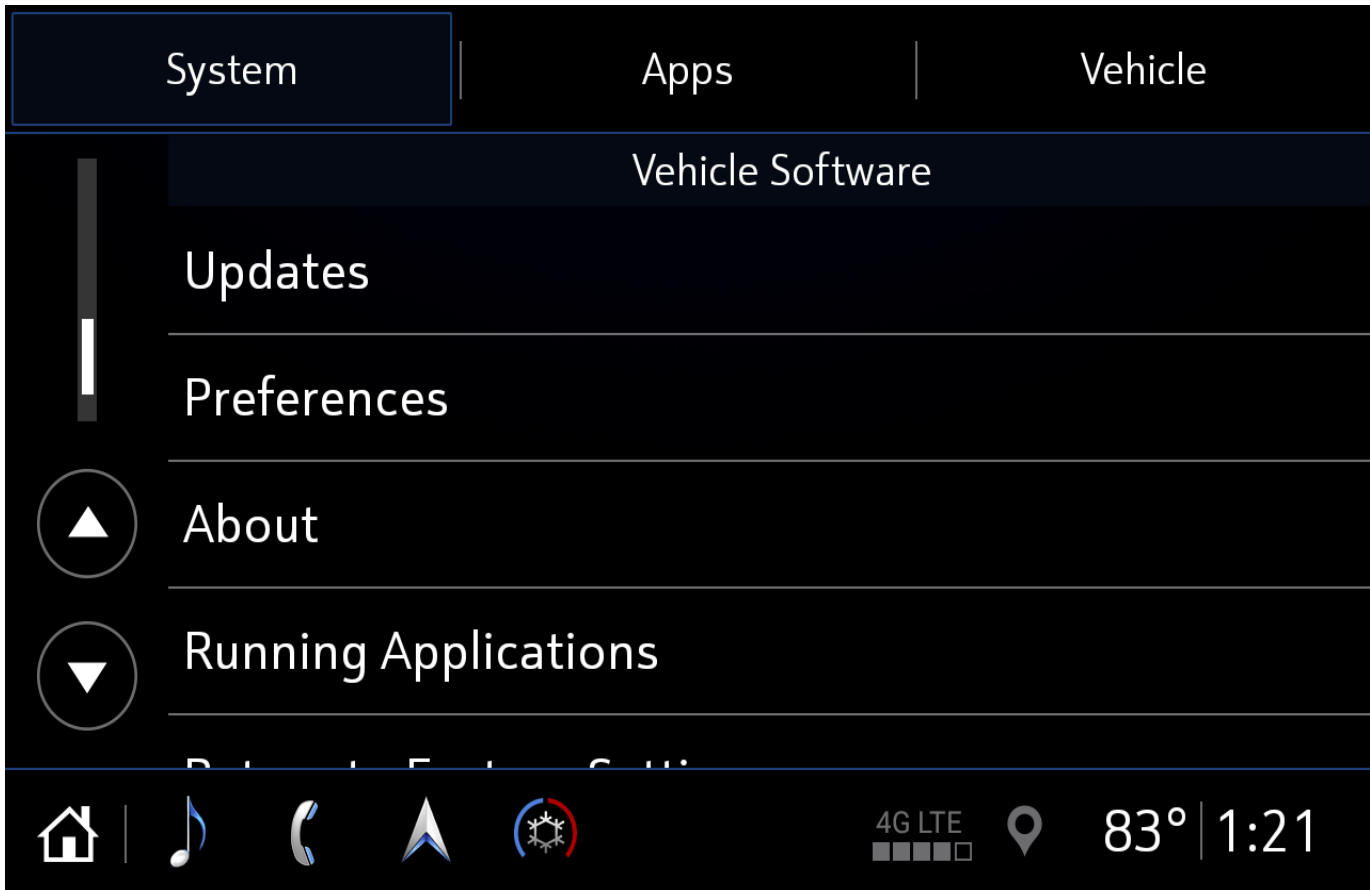
5191512

The process used for this update is dependent on the status of the software on the module and if the module already has a remote install package downloaded. To verify if an update package is already on the vehicle, open “Settings” and then scroll to “Updates” on the radio screen. If an update is shown under the “Updates” screen, proceed to the Update Procedure Using Remote Vehicle Update section of this document.

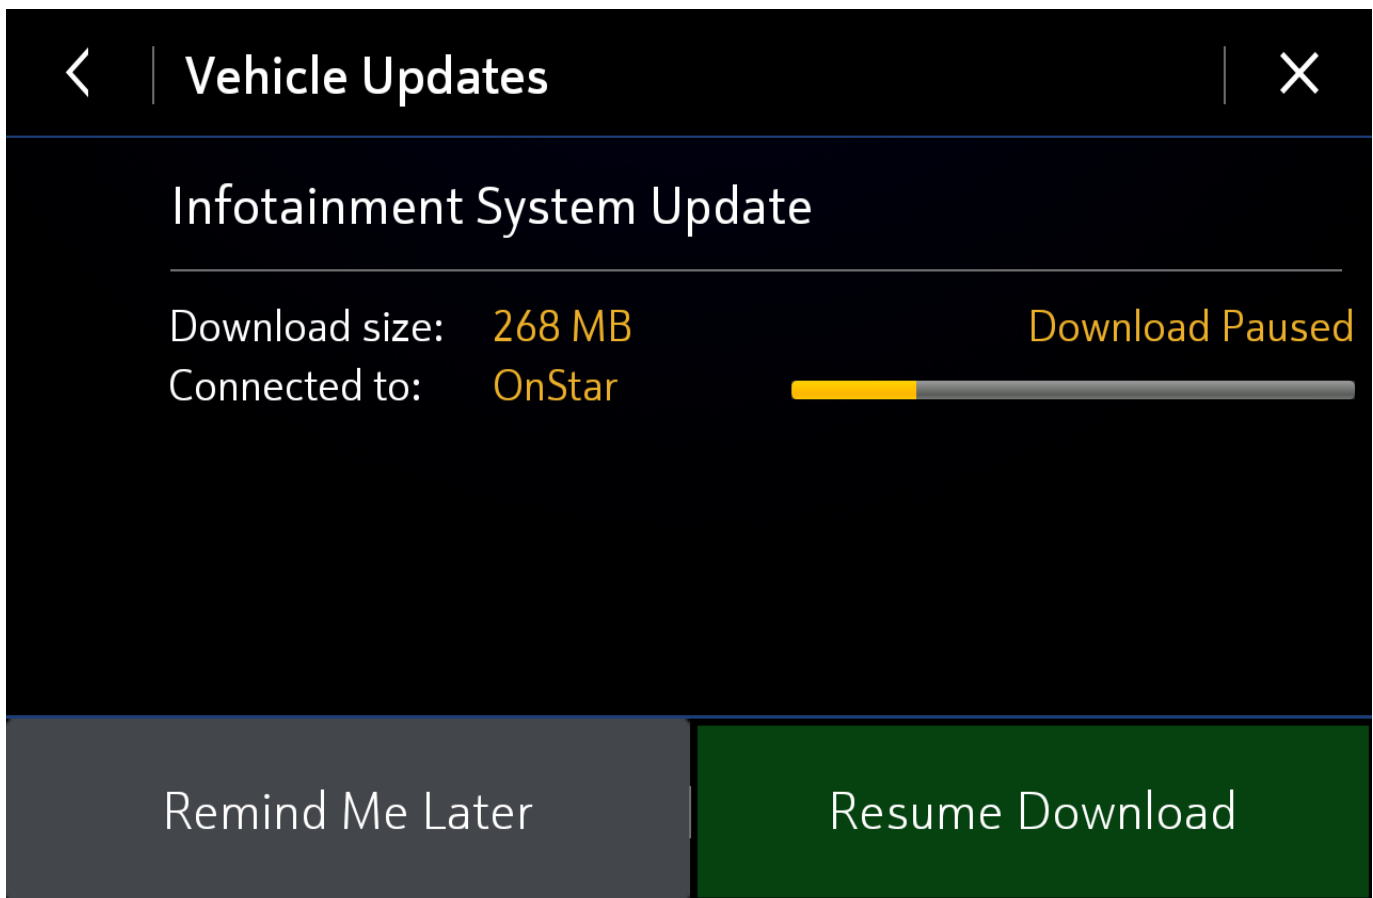
5191499

Caution: If Vehicle Update screen shows “Infotainment System Update” (such as the screen above) do not use TIS2WEB or insert a USB stick. Use of the USB stick when the Remote Update has already been downloaded, installed, or paused during installation could result in program failures or module lockup condition. The update should be completed using the Remote Vehicle Update procedure, following prompts on the infotainment screen. Refer to Update Procedure Using Remote Vehicle Update after reading the remaining information in this section if the Remote Update has already been downloaded to the radio.

- If the remote vehicle update CANNOT be completed, the radio must be updated through SPS via USB. Refer to Update Procedure Using TIS2WEB (USB Download) in this bulletin.

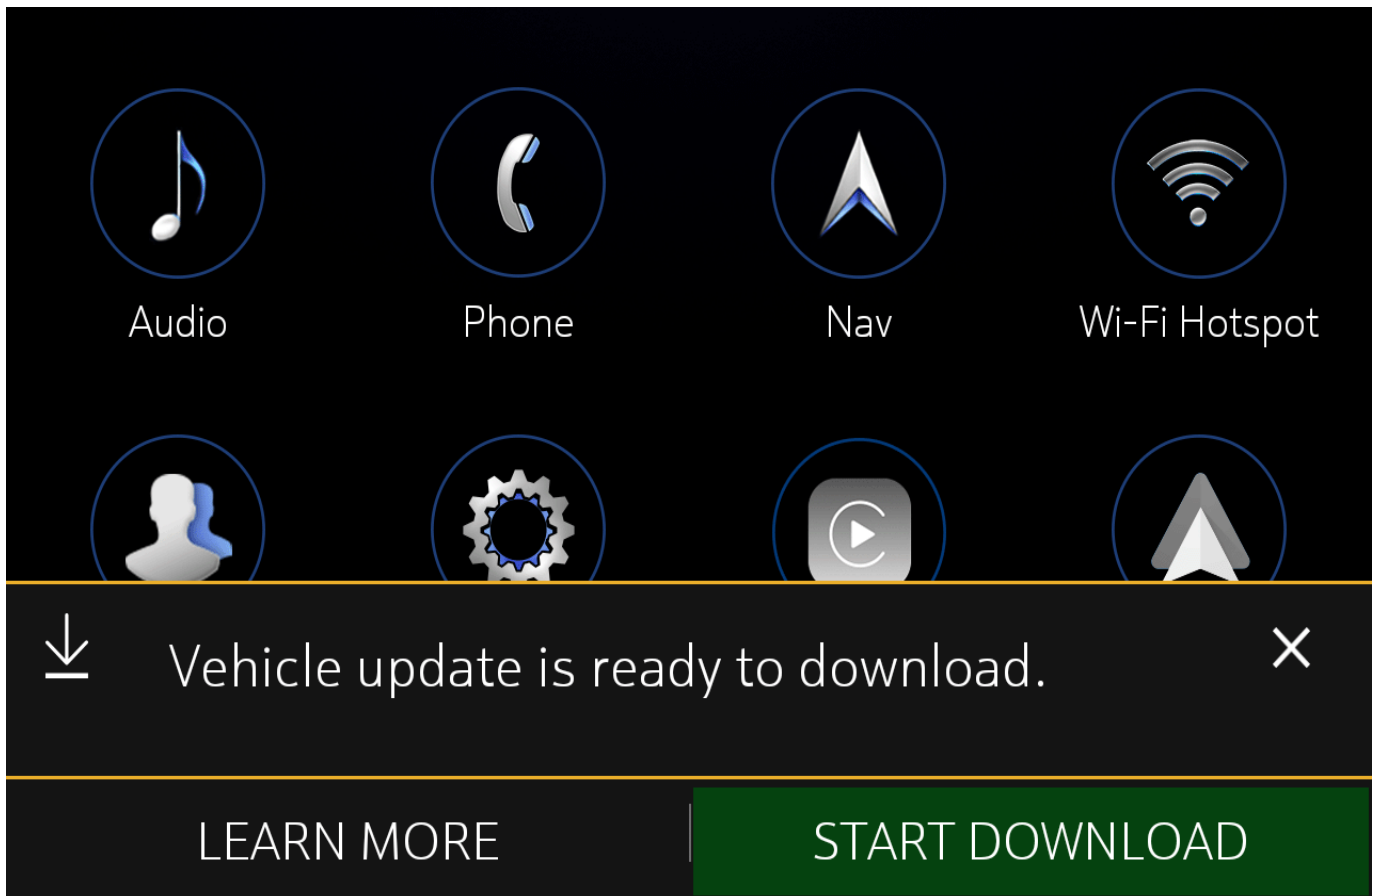
5191504

1. If a remote package is on the system, you may see the below pop up.
 - If the remote vehicle update has not been downloaded, select “Start Download”, wait for the download to complete and then follow the prompts to complete installation.

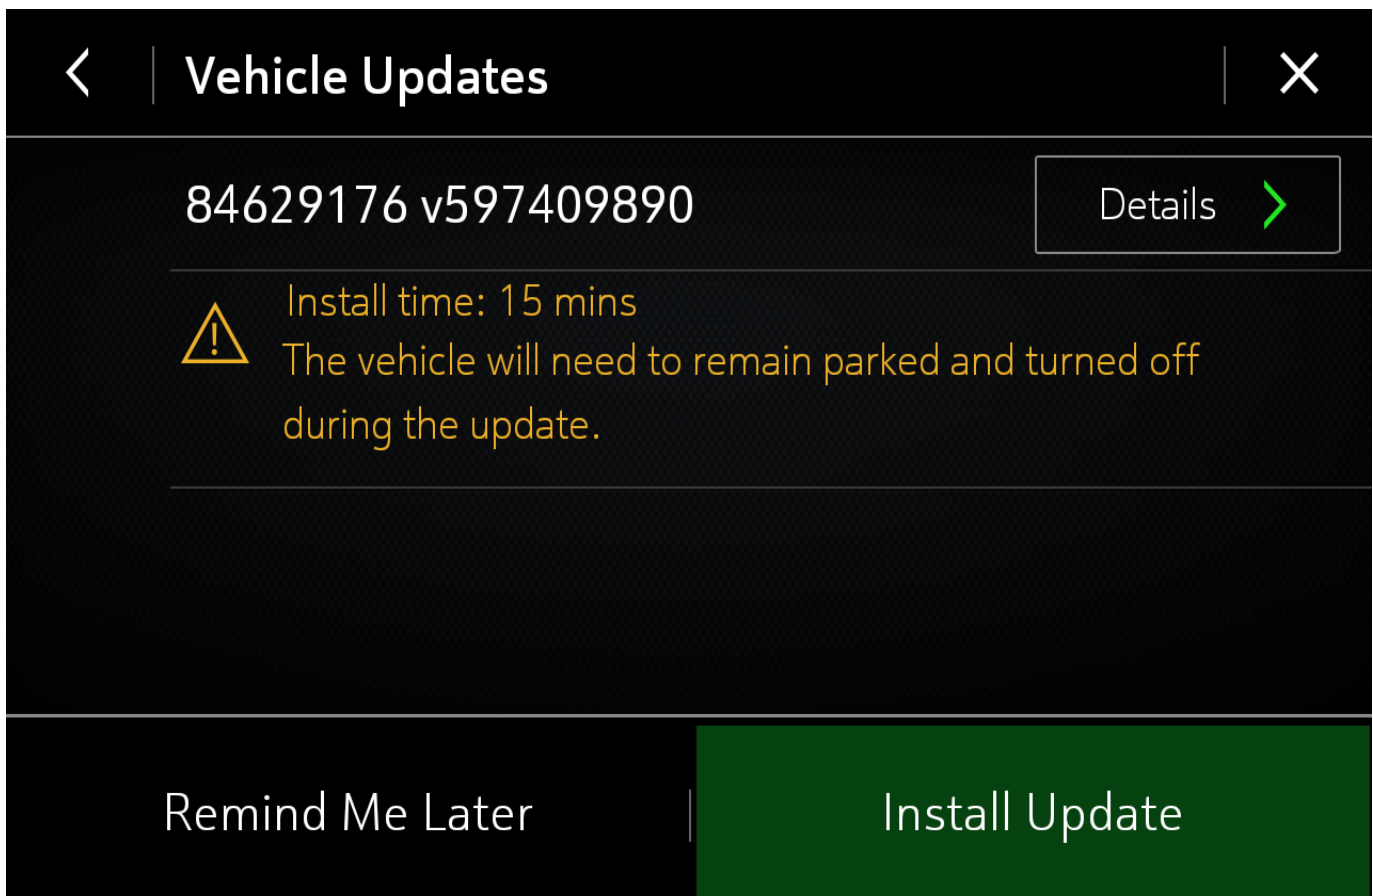
5191507

3. Insert the USB into the vehicle while in Park. On the radio screen, select "Settings, "Updates" or select "Learn More" on pop up after USB insertion.
4. Confirm the part number with image below.
5. Follow on screen prompts to complete the update.

- Clear DTCs after programming is complete.
Clearing powertrain DTCs will set the Inspection/
Maintenance (I/M) system status indicators to NO.

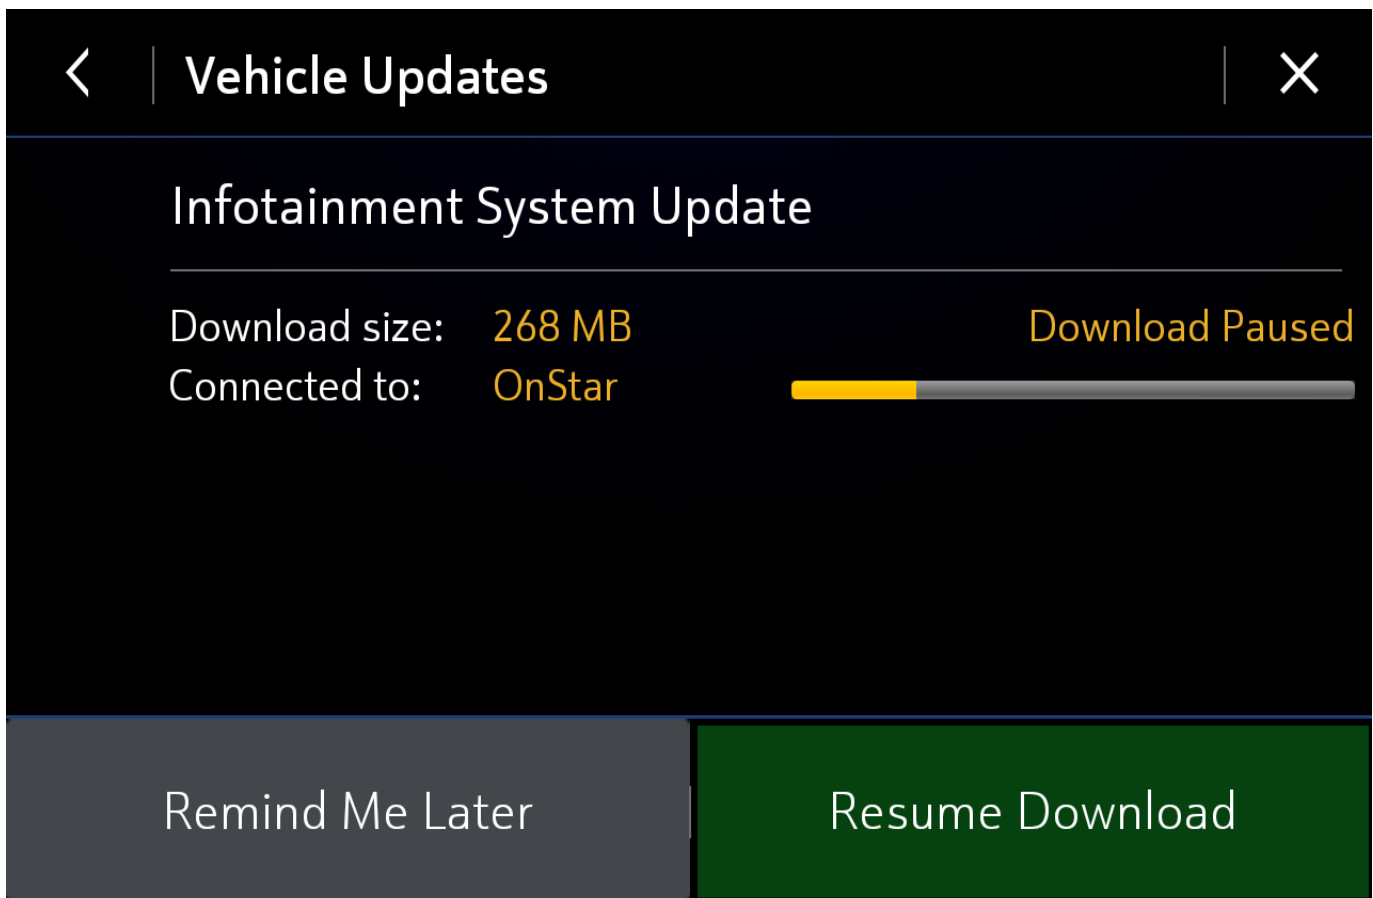
5191499

Scenario 2: Consistently Paused Download

If the above screen is shown and resuming the download repeatedly fails, a USB update will need to be performed. Turn the vehicle on, return to the home screen, and insert USB stick (see previous section). A pop up should be shown to "Install Now." Click "Install Now", verify the part number is correct and follow on screen prompts.

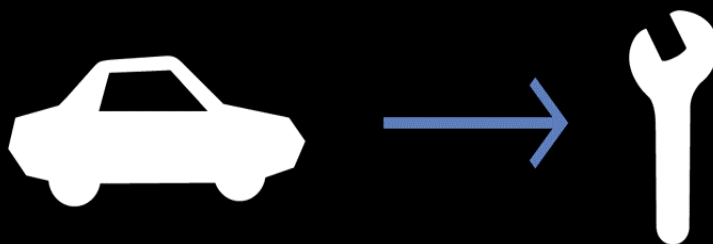
5191519

Scenario 3: Update Failed. Return to dealer screen

If the above screen is shown, download the update through TIS2Web and insert USB stick into the radio **twice** (USB stick is not recognized on first insertion). A blue progress bar should come on the screen and update will proceed. If this screen above is shown when trying to update the radio through USB, reformat to FAT32 on your PC, and then try to download the update through TIS2WEB again.

If the screen above is shown again, contact the Techline Customer Support Center (TCSC) at 1-800-828-6860 (1-800-503-3222 French) for assistance.
