Bulletin No.: PIE0498

Date: December, 2018

Service Bulletin

Subject: Engineering Information – Pictures of Door Weather Strip, Door Body Fit and/or Rear Tail Lamp Moisture Product Issues Covered Under Warranty

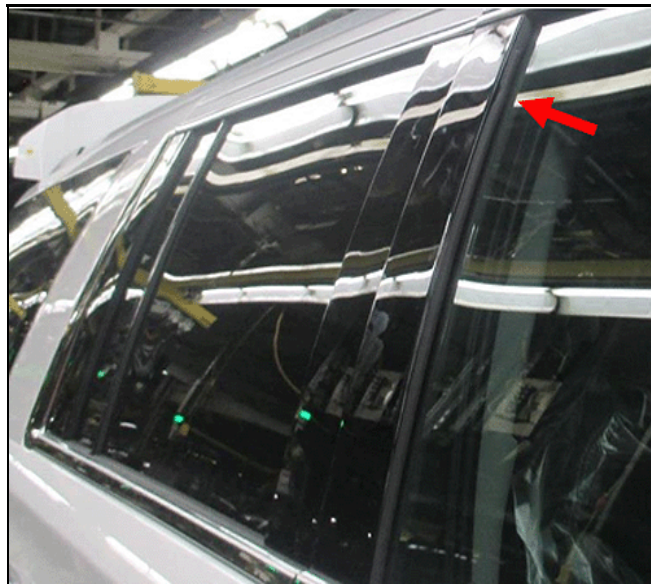
5190061

1. Shown above is a picture of the entire door showing the location of the issue area.

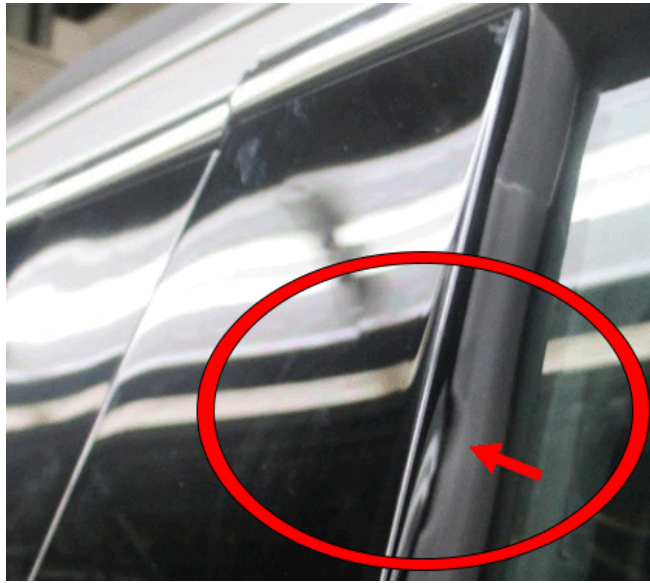
5190070

2. Shown above is a picture close-up to better show the detail of the issue.

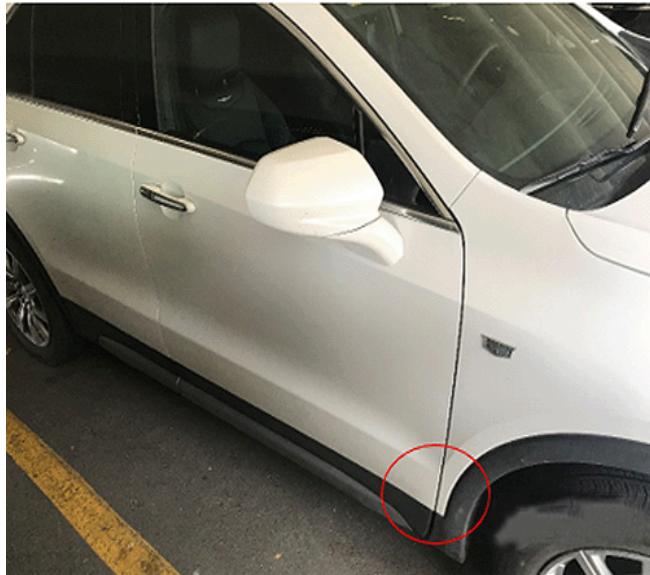
5190079

1. Shown above is a picture of the entire door showing the location of the issue area.

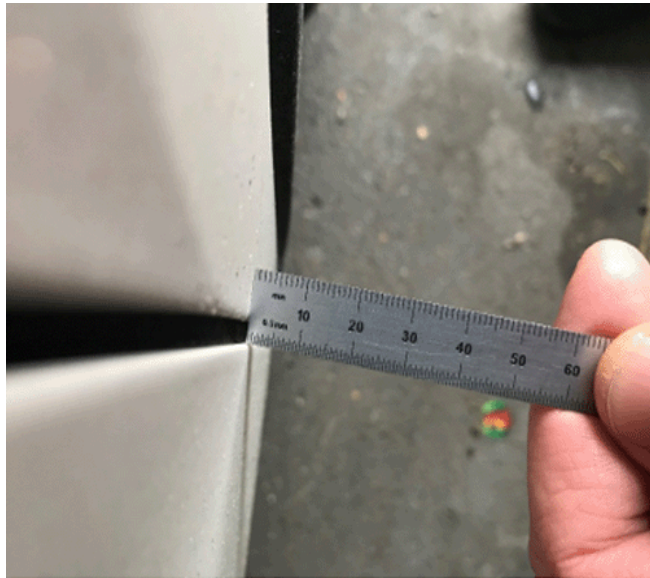
5190109

2. Shown above is a picture with a measurement tool to show magnitude of gap/flush/fit issue.

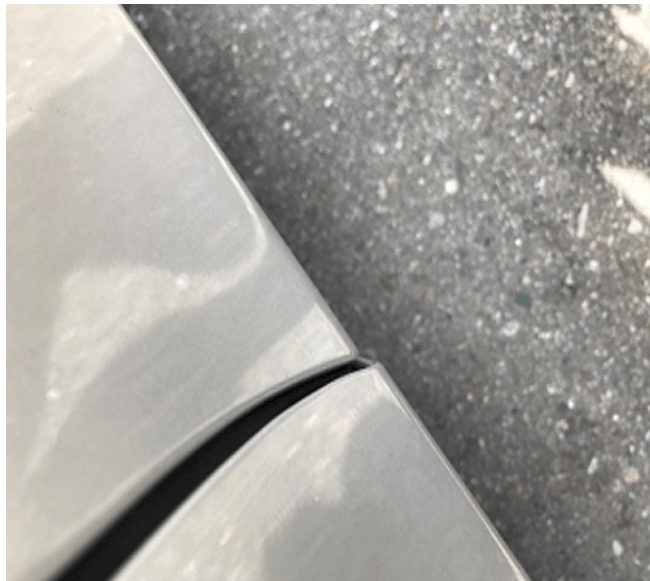
5190125

3. Shown above is a picture without the measurement tool to better show the customers perspective of the fit issue.

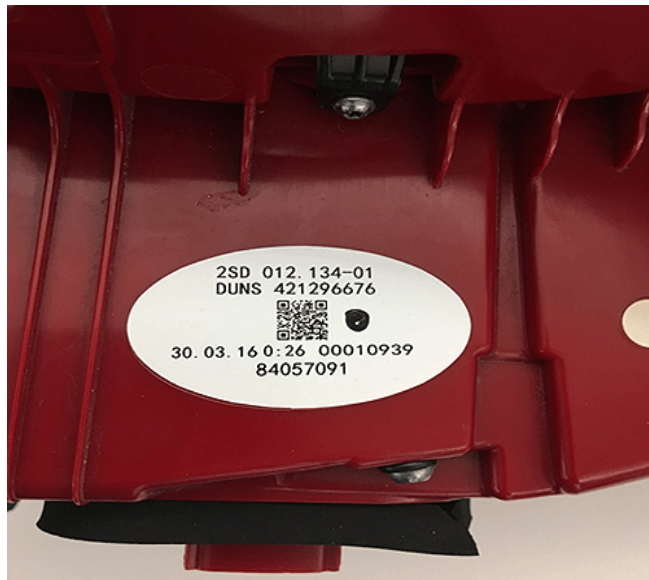
5192025

1. Shown above is a picture of the lamp part number information.

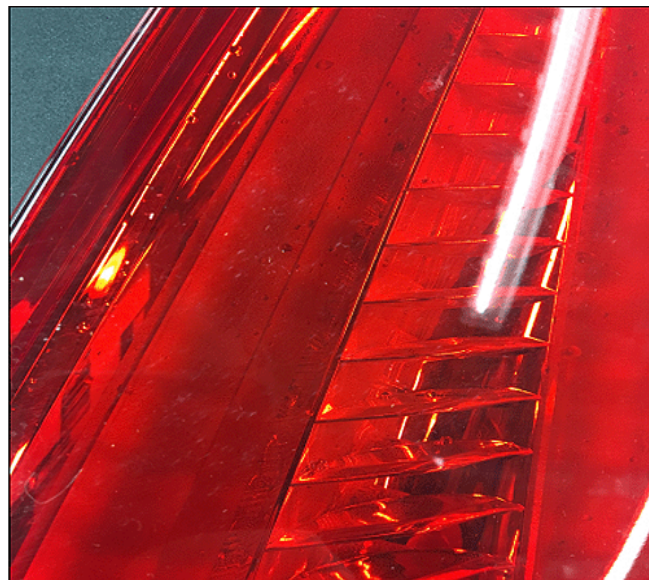
5190212

2. Shown above is a picture close-up to better show the detail of the issue.
