# Service Bulletin

Bulletin No.: PI1178F

**Subject:** Engine Runs Rough with Malfunction Indicator Lamp (MIL) ON, Low Compression on Cylinder with Misfire, DTC P0300 Set

**Models:** 2014-2018 Buick Regal  
2016-2018 Buick Envision  
2013-2018 Cadillac ATS  
2014-2018 Cadillac CTS  
2016-2018 Cadillac CT6  
2013-2018 Chevrolet Malibu  
2016-2018 Chevrolet Camaro  
2018 Chevrolet Equinox, Traverse  
2018 GMC Terrain  
2018 Holden Commodore, Equinox  
Equipped with 2.0L Turbo Engine (RPO LTG)

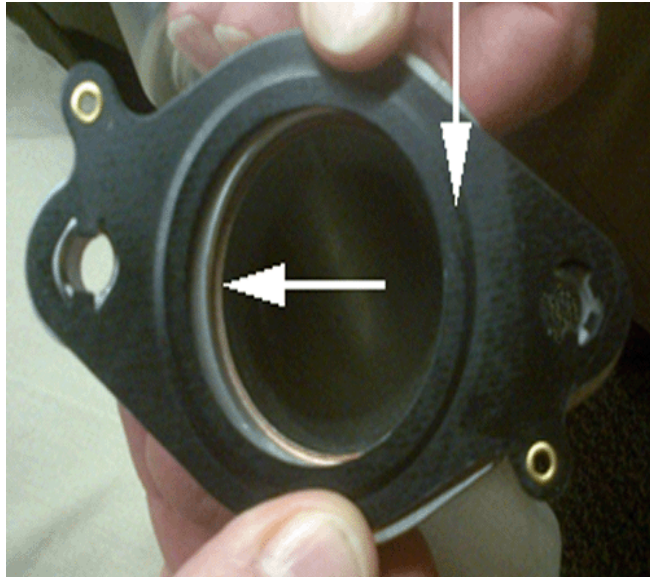
3657523

**Note:** If the gasket is flipped, as shown in the illustration above, it will reduce the outlet flow.
