# Service Bulletin

Bulletin No.: 18-NA-023

**Subject:** Warped Driver Side Floor Liner in Accelerator Pedal Area

| Brand: | Model: | Model Year: | | VIN: | | Engine: | Transmission: |
|---|---|---|---|---|---|---|---|
| Chevrolet | Traverse | 2018 | 2018 | | | All | All |

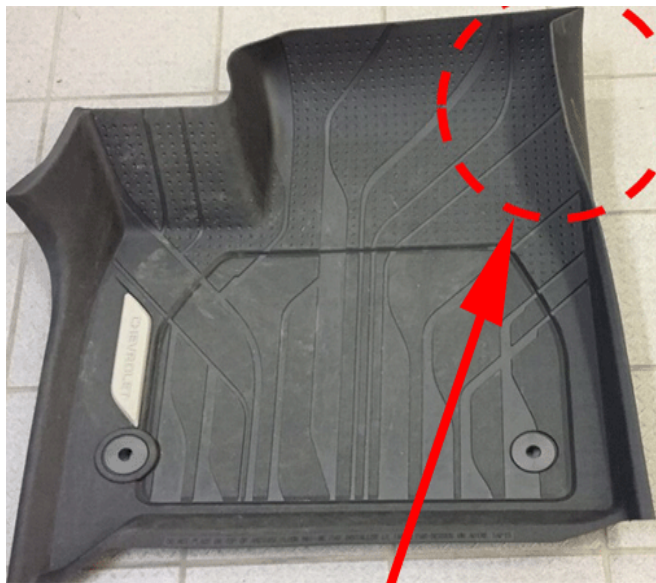
4944586

| Condition | Some technicians may comment on the new floor liners that are attempting to be installed on the vehicle are warped around the accelerator pedal location of the liner. |
| Cause | This may be due to the packaging of the liners may not provide sufficient support during transit. |

### Example of Warped Liner

| Correction | <b>Important:</b> Do not install the warped liners in the vehicle.<br>Return and re-order warped parts to ADI (US) or to the Service Warehouse (Canada) for part replacement through the Part Quality Return process. These returns then go to the CCRC for evaluation and action as required. |

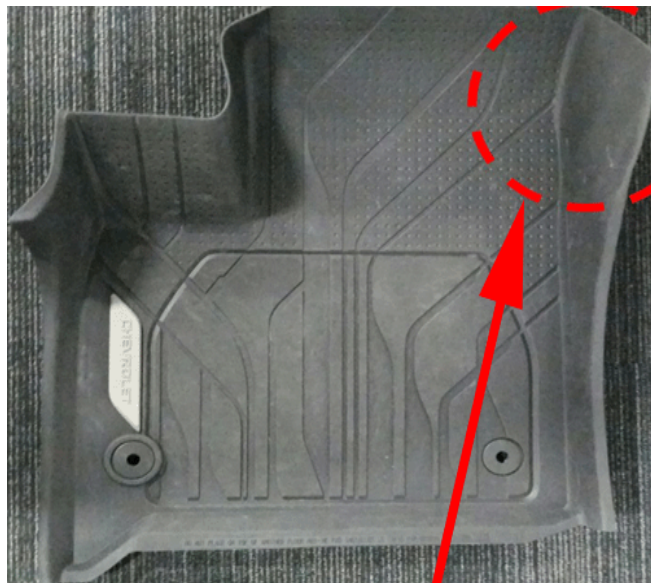
4944588

### Example of Good Liner
