Service Bulletin

Bulletin No.: 18-NA-318

Subject: Body Creak, Rattle and/or Itching Type Noise Heard in the Rear Upper Header Near Liftgate Hinge

Brand:	Model:	Model Year:		Breakpoint:		Engine:	Transmission:
		from	to	from	to		
Cadillac	XT5	2018	2019

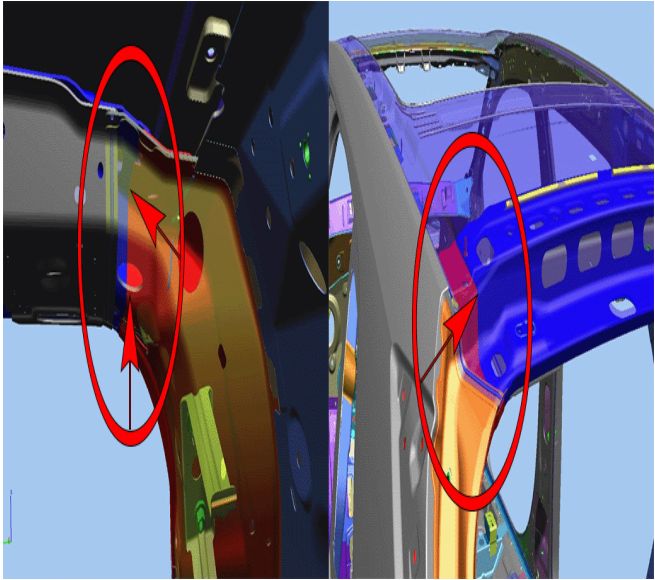
<p style="text-align: right;">5159392</p> <p>This condition may be caused by the two metal structure panels (red and blue) located in the rear header, rubbing together causing noise. Note: This condition may be more often found on the left side, but can be right side as well.</p>
Correction	Pry the two metal structure panels away from each other following the procedure listed below.

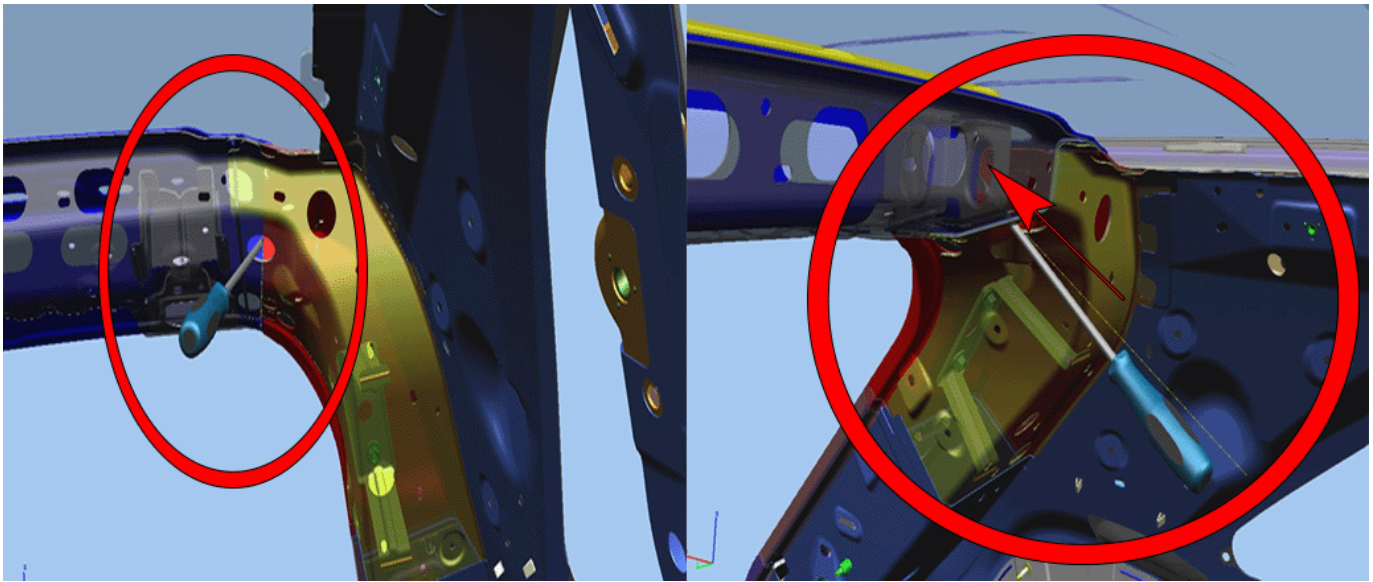
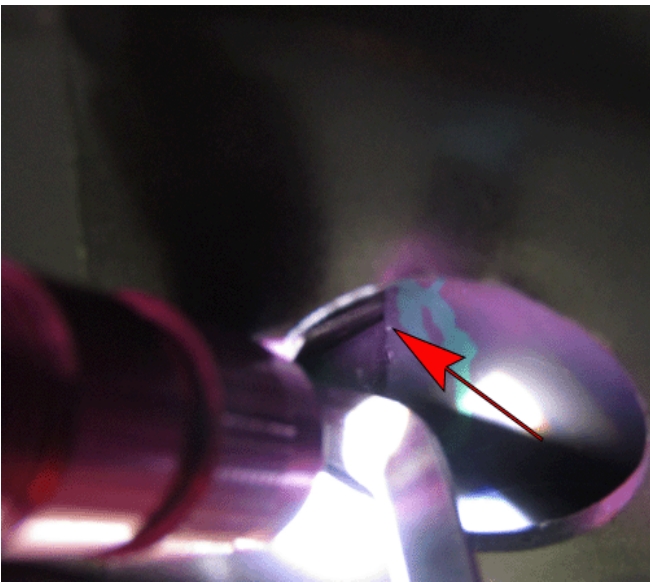
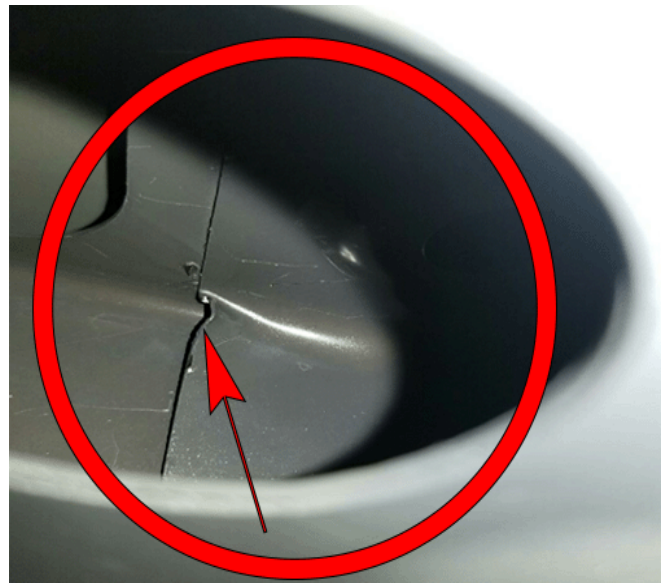
Note: The access panel seam is located towards the liftgate opening on a 90° angle, **NOT** directly above the access hole.
