Service Bulletin

Bulletin No.: 18-NA-338

Subject: Rear Infotainment Audio Output Choppy/Intermittent When Headphones are Connected VIA Audio Jack or Bluetooth

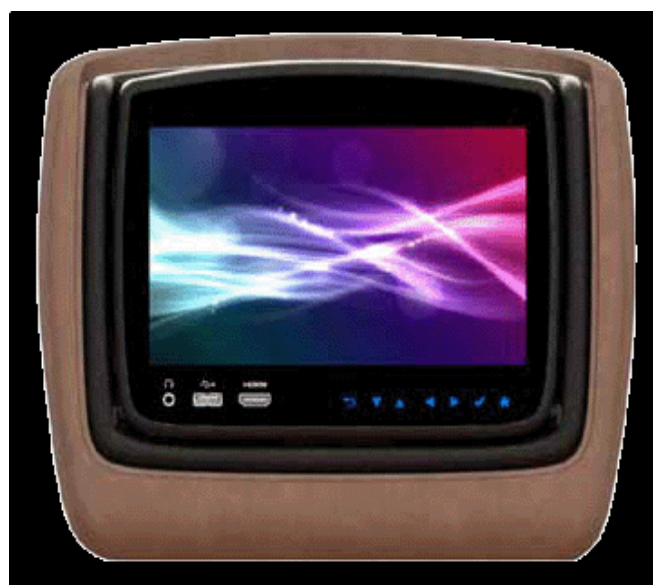
5163549

- The software update only supports one type of Rear Seat Entertainment accessory system as shown above.

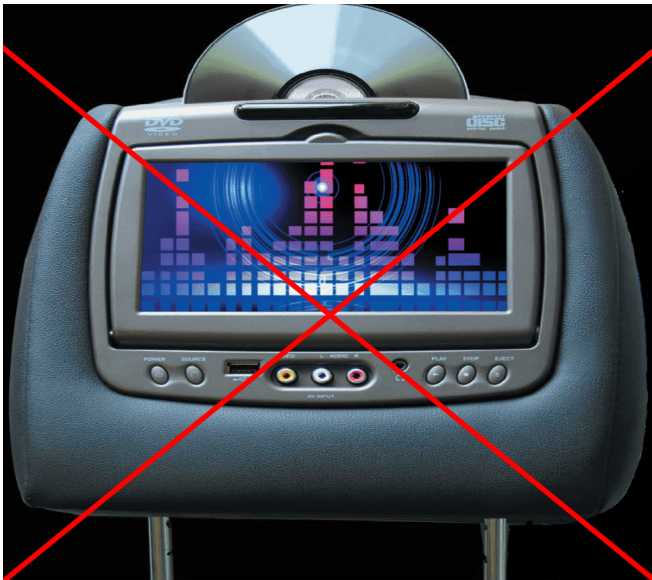
5163552

- The Rear Seat Entertainment system shown above, cannot be updated with the software version indicated in this bulletin.
