# Service Bulletin

Bulletin No.: 18-NA-340

**Subject: Front Row Seat Belt Extraction Difficult, Retraction Rate Slow and/or Incomplete**

Brand:	Model:	Model Year:		VIN:		Engine:	Transmission:
		from	to	from	to		
Cadillac	CTS Sedan (VIN A)	2014	2015			All	All
Cadillac	CTS	2016	2018

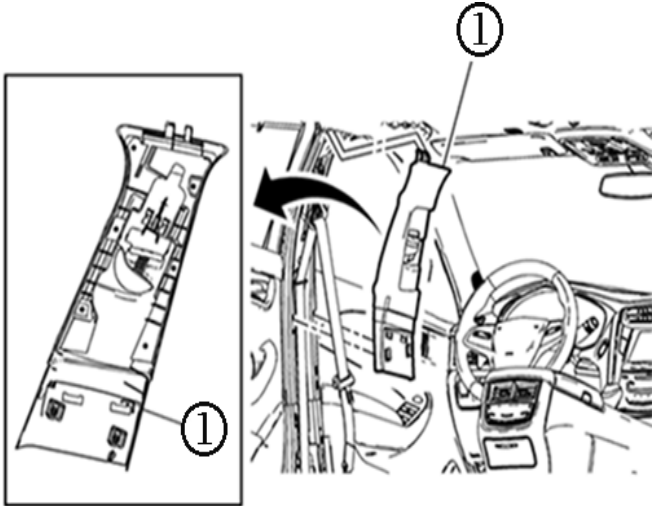
<b>Involved Region or Country</b>	North America, N.A. Export Regions
<b>Additional Options (RPOs)</b>	
<b>Condition</b>	<p>Customer may comment on any of the following, pertaining to the front row seat belt:</p> <ul style="list-style-type: none"> <li>• The belt may be difficult to extract from the center pillar.</li> <li>• The belt may not fully retract, and the occupant's belt can become caught in the door.</li> <li>• The belt may be slow to retract back to the center pillar.</li> </ul>
<b>Cause</b>	<p>The cause of the condition may be one, or both, of the following causes:</p> <ul style="list-style-type: none"> <li>• Lack of adjustable guide loop engagement to the center pillar upper trim attachment hooks, due to the hooks taking a permanent set over time, causing a disconnection between the two components.</li> <li>• Limited D-ring rotation on the belt, due to warping of the center pillar trim.</li> </ul>

</div> <p style="text-align: right;">5163622</p> <p><b>Important:</b> DO NOT replace the seat belt retractor for any of the Conditions noted above.</p> <p>Replace the center pillar upper trim panel (1) on the affected side. Refer to <i>Center Pillar Upper Trim Panel Replacement</i>, in SI.</p>
