Service Bulletin

Bulletin No.: 18-NA-343

Subject: Lateral Seat Movement and/or Squeak Type Noise Heard in the Driver Seat Cushion Area

Brand:	Model:	Model Year:		Breakpoint:		Engine:	Transmission:
		from	to	from	to		
Cadillac	CT6	2018	2018

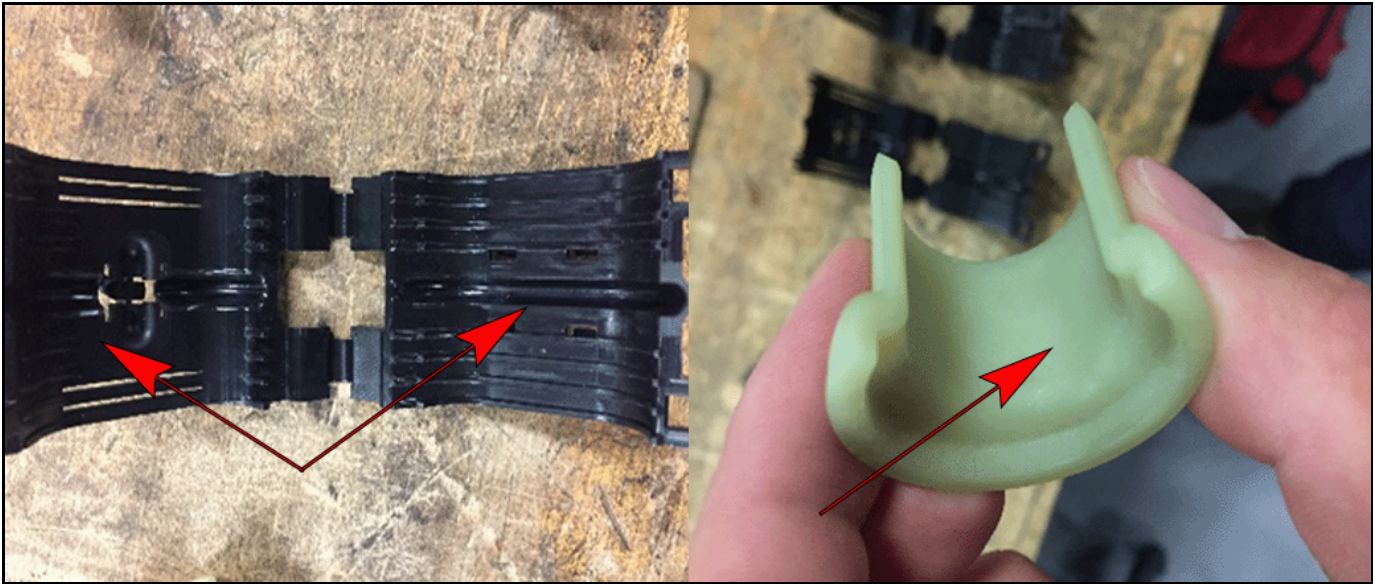
5156030

Involved Region or Country	North America and NA Export vehicles
Condition	Some customers may comment on lateral seat movement and/or squeak type noise heard in the driver seat cushion area.
Cause	This condition may be caused by grease incorrectly applied in the seat frame area.
Correction	Remove the grease and clean the area indicated following the procedure listed below.

- 5. Using Kent Acrysol P20005 or equivalent, clean the inside of the spacer and handcuff bracket.

Important: Make sure the cleaner does **NOT** erode the plastic.
