# Service Bulletin

Bulletin No.: 18-NA-347

**Subject: Unable to Adjust Clock Manually**

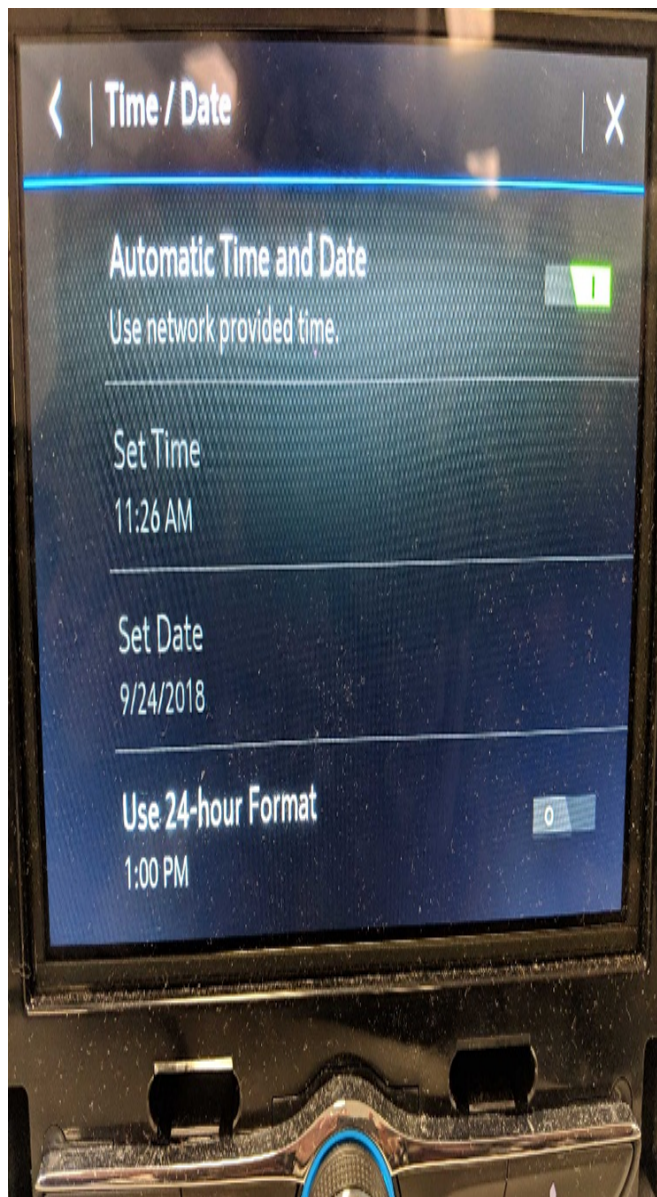
5168244

Menu displayed with OnStar Terms and Conditions accepted:

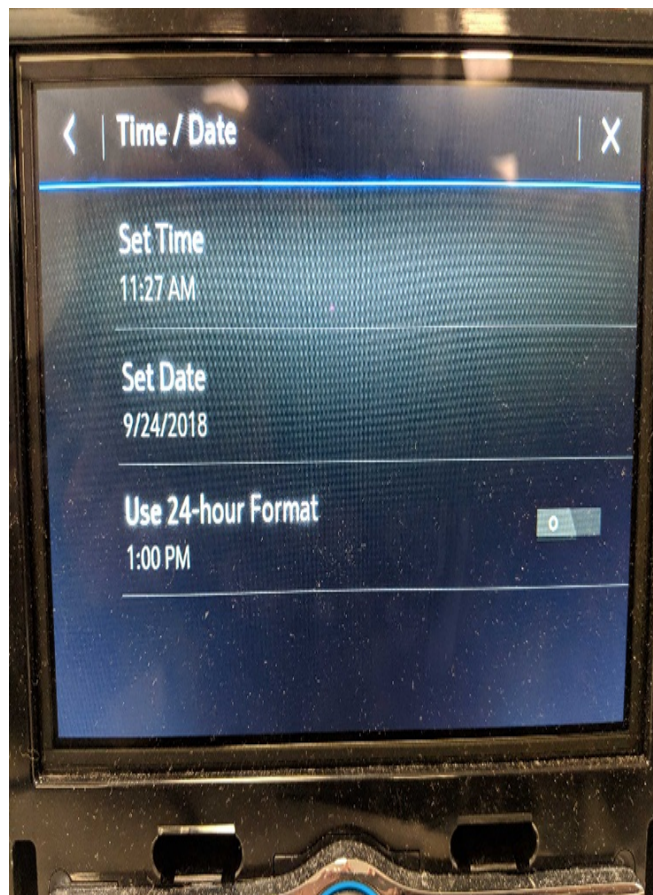
5168251

**Note:** If OnStar account Terms and Conditions are declined, the Auto Update option is removed from the Time/Date menu. A software anomaly allows the Auto Update option to remain enabled when the option is removed from the menu, preventing manual clock adjustments from occurring.

Menu displayed with OnStar Terms & Conditions declined:
