# **Technical Journal**

# IHU sound settings will be set to default after software upgrade

REF NO: TJ 34141.1.0	ISSUING DEPARTMENT: Technical Service	CAR MARKET: United States and Canada		
3 US 7	PARTNER: '510 Volvo Car USA	ISSUE DATE: 2018-10-24	STATUS DATE: 2018-11-05	
FUNC GROUP: 3930	FUNC DESC: Equipment for entertainment (radio/TV/VC	Page	1 of 3

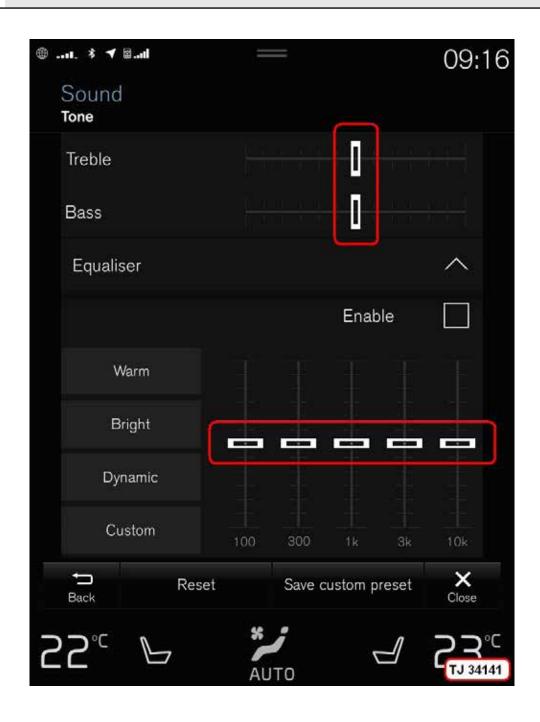
File Name	File Size
Sound.jpg	0.1798 MB

Performing a Total Upgrade, Service 2.0 or PDS Upgrade after the 2018 week 40 software release, will reset the sound settings back to default settings on the MY 2016 - 2018 vehicles listed above.

The new software packages contain updated IHU software that will reset all customer sound settings such as treble, bass, balance and equalizer settings which will go back to default settings after the upgrade.

For reference, please see attached example picture "Sound.jpg".

The customer should be advised that the sound settings will be reset. If possible, record or photograph the settings before performing the software upgrade so they can be re-adjusted afterward.
