Technical Journal

Damaged throttle body due to showroom device

REF NO: TJ 34206.1.0	ISSUING DEPARTMENT: Technical Service	CAR MARKET: United States and Canada	
PARTNER: 3 US 7510 Volvo Car USA		ISSUE DATE: 2018-11-14	STATUS DATE: 2018-11-29
FUNC GROUP: 2510	FUNC DESC: Inlet and exhaust manifolds	Page 1 of 3

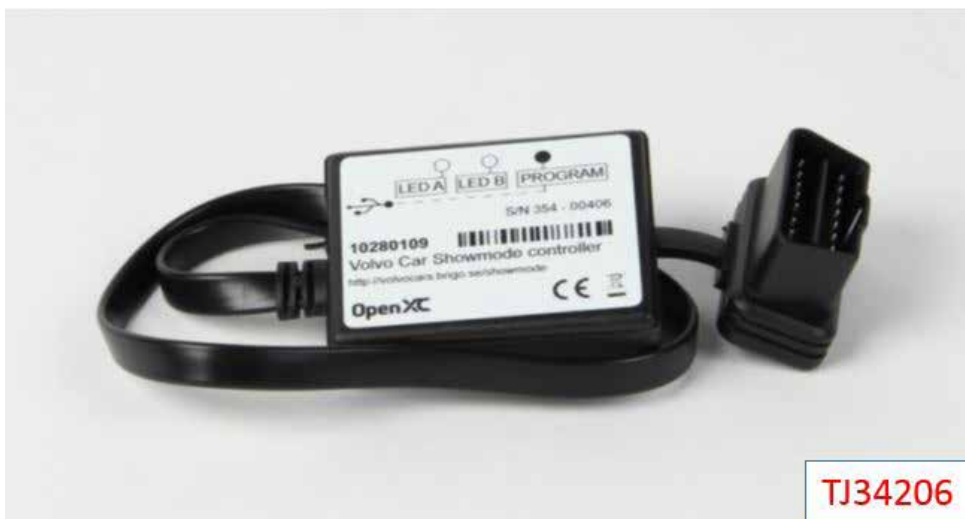
The throttle body may be damaged when using the showroom mode with the BRIGO tool (see picture 34206_2.jpg) due to constant activation.

A new software for the BRIGO device is under development to avoid this damage. Make sure that the BRIGO device always updated with the latest software.
