| <b>Countries:</b> | CANADA, UNITED STATES, MEXICO | <b>Document ID:</b> | IK0800567 |

**Title:** LT Starter power connection cleaning**Applies To:** LT

Red paint, electrical sealant (dielectric coating) found on Starter power cable eyelet removal.

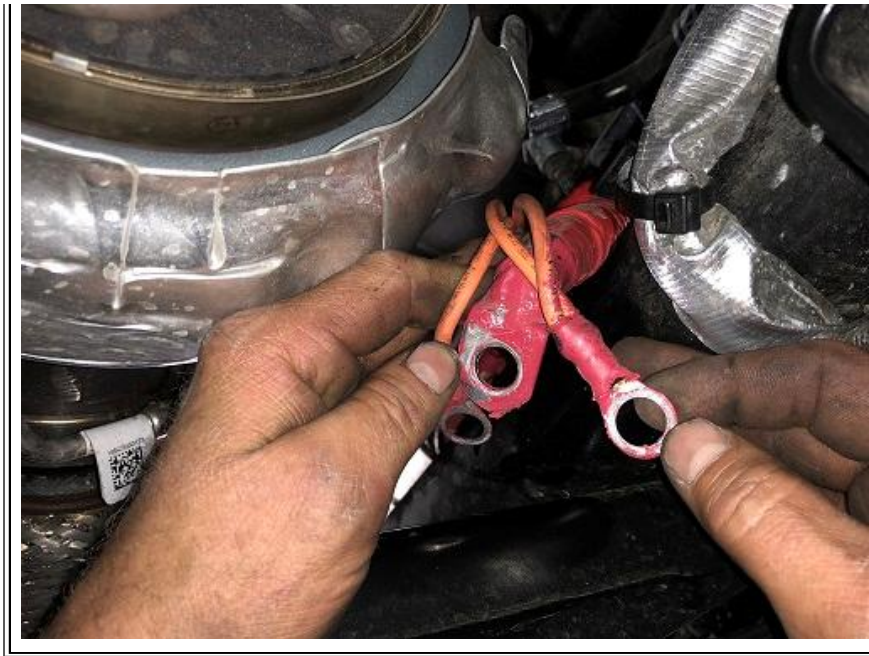
| Figure 1 - Excessive Corrosion Protection |

| Step | Action | Decision |
|---|---|---|
| # | <b>DIAGNOSTIC:</b><br><br>During complaints for no crank, or during starter removal, inspect the eyelets on the starter for excessive dielectric coating.<br><br><b>Is the dielectric coating excessive as shown in Figure 1?</b> | <b>Yes:</b> Proceed to repair steps |

1. The condition shown in Figure 1 can cause a poor connection at the starter.
2. Remove power cable from the positive stud on the starter, using wire brush (tool example) clean all eyelets that show RED dielectric coating covering the connection area of the eyelet.
3. Reassemble the cables on the starter and then apply corrosion protection. (Grafo 112x or Tribo Tuff®)

This iKNow is primarily a reminder to ensure removal of all RED dielectric coating found on any Starter eyelet when replacing a starter on an LT vehicle.
