November 2018
FL791A
NHTSA #18V-646
Transport Canada #18-518

Subject: Freightliner Steering Shafts

Models Affected: Specific Freightliner 108SD, 114SD, and Business Class M2 vehicles manufactured December 1, 2017, through May 30, 2018, and built at the Mt. Holly, North Carolina, and Santiago, Mexico, manufacturing plants.

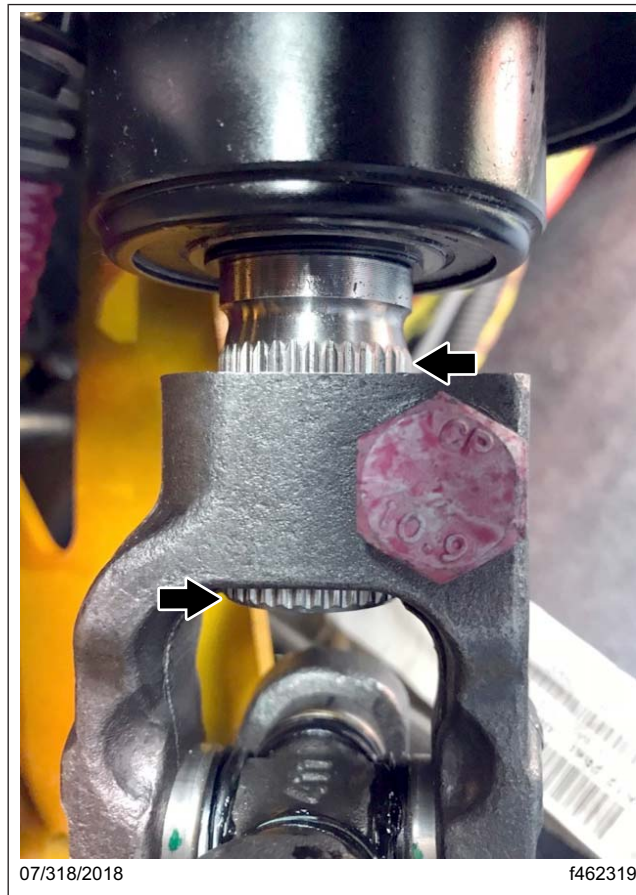
Fig. 1, Steering Shaft Splines

1. Check the base label (Form WAR259) for a completion sticker for FL791 (Form WAR260) indicating this work has been completed. The base label is usually located on the passenger-side door, about 12 inches (30 cm) below the door latch. If a completion sticker is present, no work is needed. If a completion sticker is not present, proceed to the next step.
2. Park the vehicle, shut down the engine, and apply the parking brakes. Chock the tires.
3. Locate the steering shaft inside the cab.
4. Inspect the splines on the bolted steering shaft connection shown in [Fig. 1](#).

If splines are exposed on both sides of the connection, go to step 6. **NO replacement parts** are required.

If splines are not exposed on both sides of the connection, remove the nut and bolt and discard. Continue with step 5.

5. Position the shaft to align the hole with the groove in the shaft, and install a new bolt and nut.
6. Use a calibrated torque wrench and a backing wrench on the bolt head. Set the torque wrench to 33 lbf-ft (45 N·m) and tighten from the nut side.
7. Apply torque seal to the nut.
8. Clean a spot on the base label (Form WAR259), write the recall number, FL791, on a blank red completion sticker (Form WAR260), and attach it to the base label to show this work has been completed.
