November 2018  
FL796A-F  
NHTSA #18V-699  
Transport Canada #2018-551

## Subject: Steering Wheel Fasteners

**Models Affected: Specific Freightliner Cascadia vehicles, and Western Star 5700 vehicles, manufactured July 31, 2018, through August 2, 2018.**

### Subject: Steering Wheel Fasteners

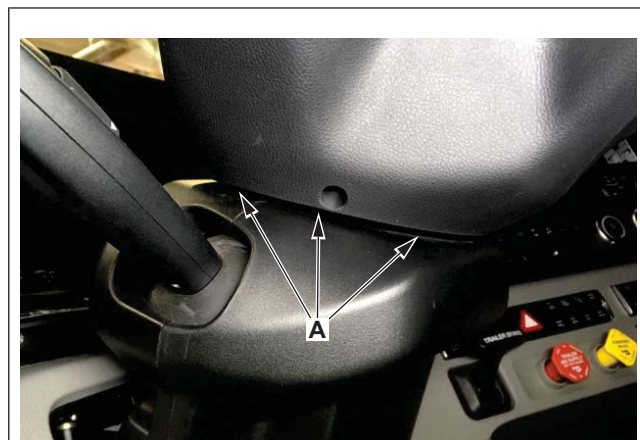
**Fig. 1, Fully Seated Steering Wheel**

A. On a fully seated steering wheel, the lower steering wheel overlaps the column cover.

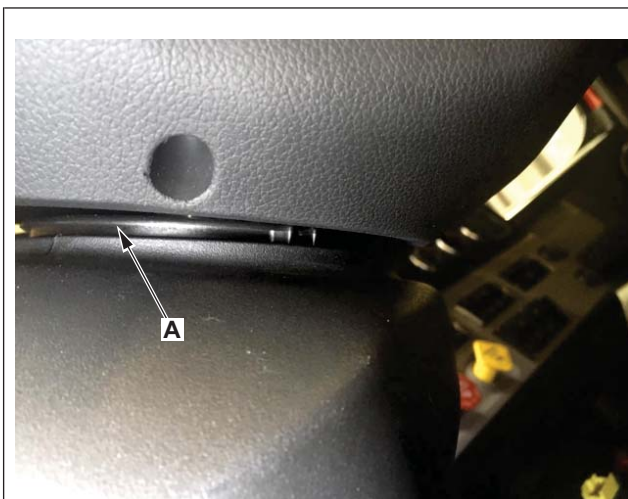
**Fig. 2, Steering Wheel that is Not Fully Seated**

On certain vehicles, steering wheel splines may not be correctly aligned, preventing full depth installation on the steering column and cross threading of the screw. This could cause the steering wheel to separate from the steering column, resulting in a loss of steering control, which could increase the risk of a crash.

A. When the steering wheel is not fully seated, there is a gap between the lower steering wheel and the column cover.

5. Verify that the fastener torque is  $60 \text{ lbf}\cdot\text{ft} \pm 7$  ( $80 \text{ N}\cdot\text{m} \pm 10$ ). If the torque is correct and there is no gap between the lower steering wheel and the column cover, no further action is necessary. Continue to step 33.  
If the steering wheel is not fully seated (excessive gap), and/or if the steering wheel fastener cannot be properly torqued, continue to step 6.
6. Disconnect the batteries.
7. Unclip the clockspring harnesses from the steering wheel.
8. Remove the steering wheel screw, then remove the steering wheel.

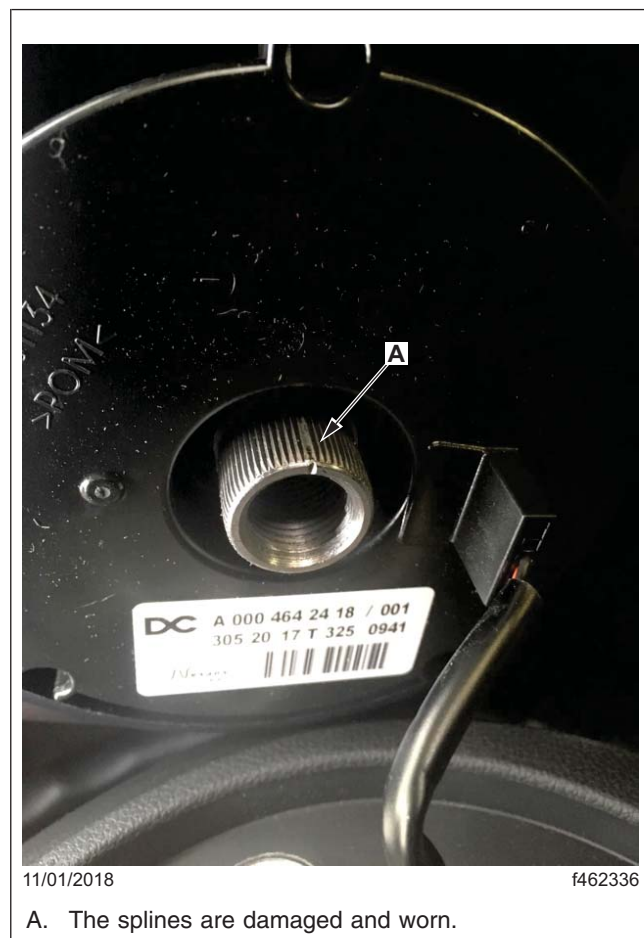
**Fig. 4, Damaged Steering Column Splines**

9. Inspect the steering column splines. There should be no wear or damage on the splines. See [Fig. 4](#) and [Fig. 5](#).
