Daimler Trucks

North America LLC **Customer Advisory Letter**

Subject : M2 Leaner

Models Affected: Air suspension only

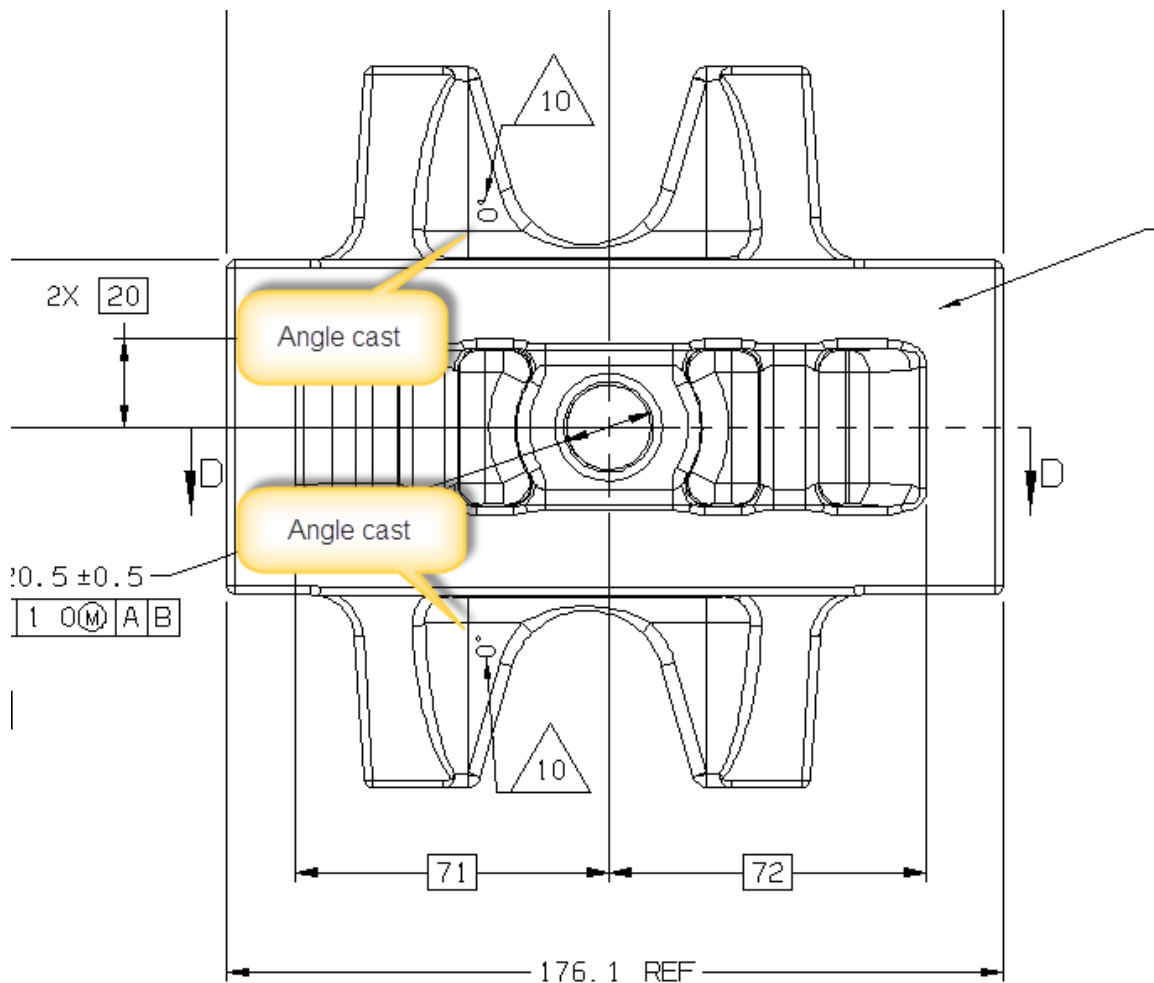
3. If the measurements are down on opposite corners, stop, frame is twisted and this will not apply, check the body for cause.
4. Once 2 is verified, check the saddles for the cast angle number being on the saddle wing (See drawing below), 2 degree will have a 2 on the wing etc, make sure the same number is the same direction on the left and right saddle.

6. Normal for a truck leaning 3/8 inch at the frame will be approx 1.0 degree difference left and right.
7. Left side of the truck lower, left side down 1.3 degrees, change the left side saddle where the angle will increase the spring angle, if no saddle is available, go to the right side and reduce the spring angle by 2 degrees.

8. Look in Parts Pro for the saddle part number your truck should have, the angle of the saddle will be in the description. I have seen wrong saddles installed left and right and reverse causing leans, see number 4.
