Technical Journal

Wind noise, front and/or rear door areaREF NO:
TJ 34262.1.0ISSUING DEPARTMENT:
Technical ServiceCAR MARKET:
United States and CanadaPARTNER:
3 US 7510 Volvo Car USAISSUE DATE:
2018-12-10STATUS DATE:
2018-12-18FUNC GROUP:
8450FUNC DESC:
**Sealing and protect. moulding
for door**

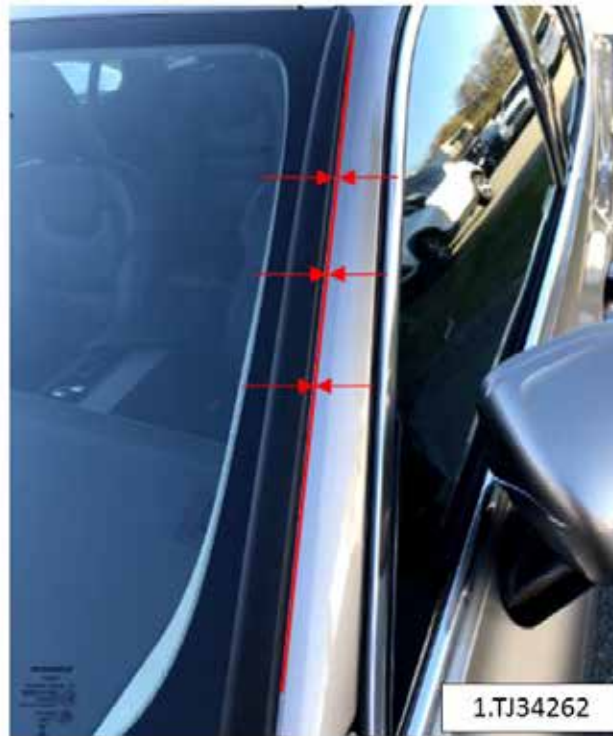
- 1. A-pillar, see attachment 1 TJ34262.pdf (not valid for vehicle type 256).**
Check if the A-pillar moulding clips are properly mounted and no visible gap between the moulding and A-pillar.
If not OK, replace the clips and/or A-pillar moulding according to VIDA.
(If needed, tape between the A-pillar and A-pillar moulding to confirm the wind noise).

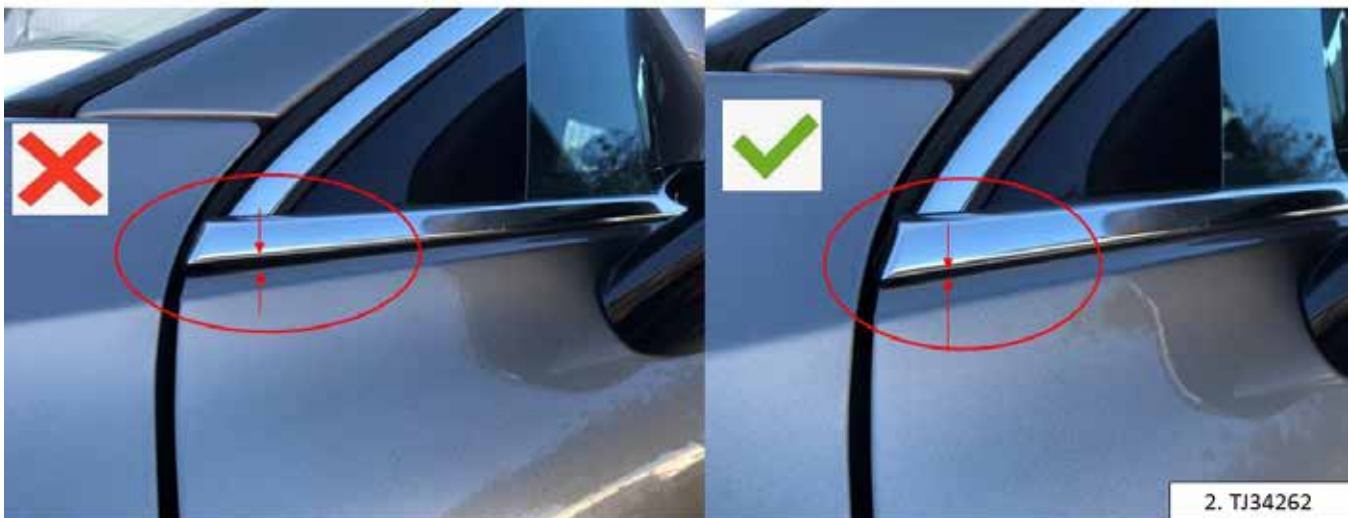
- 2. Front Door trim moulding, see attachment 2 TJ34262.pfd.**
Check if the trim moulding is assembled correctly. If not, re-assemble or replace part according to VIDA.

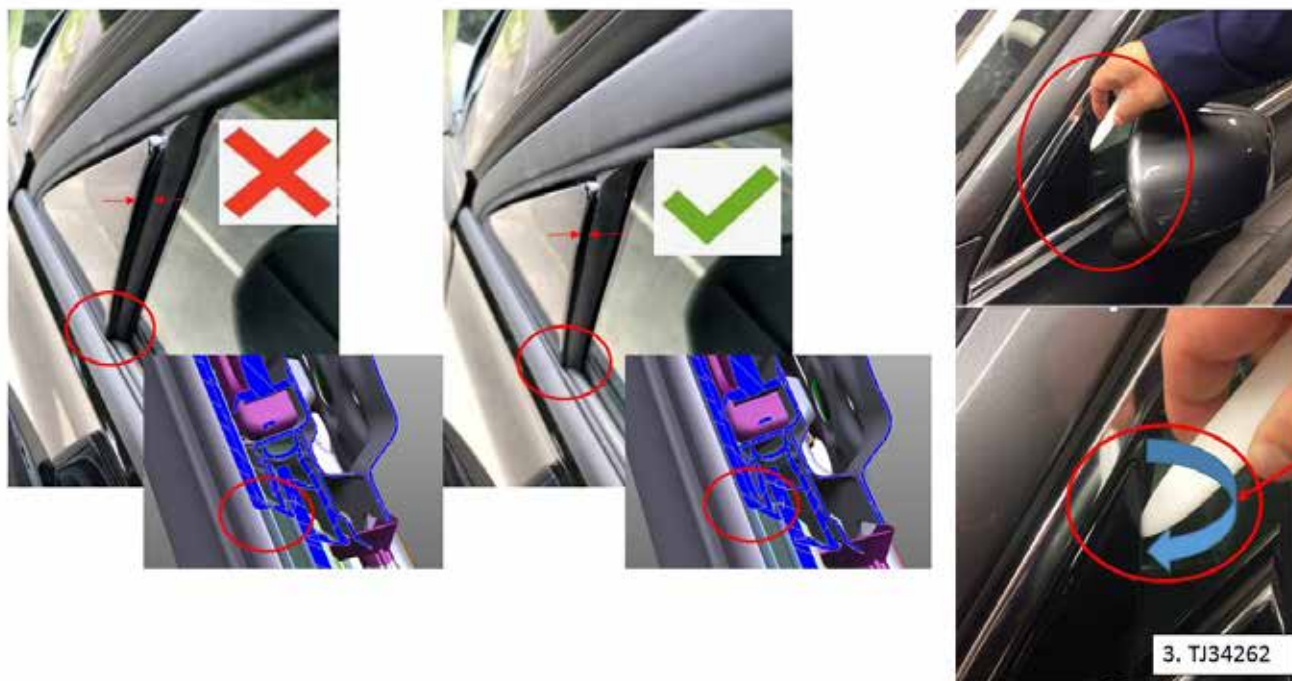
- 3. Front door panel, see attachment 3 TJ34262.pdf (valid for vehicle type 224 and 225).**
Check if the front door guide window moulding is installed correctly.
If not, use a “Bone tool” to adjust the guide moulding towards the panel. Start at the top of the panel and follow the sealing down to the trim moulding. Be careful to not damage the sealing.

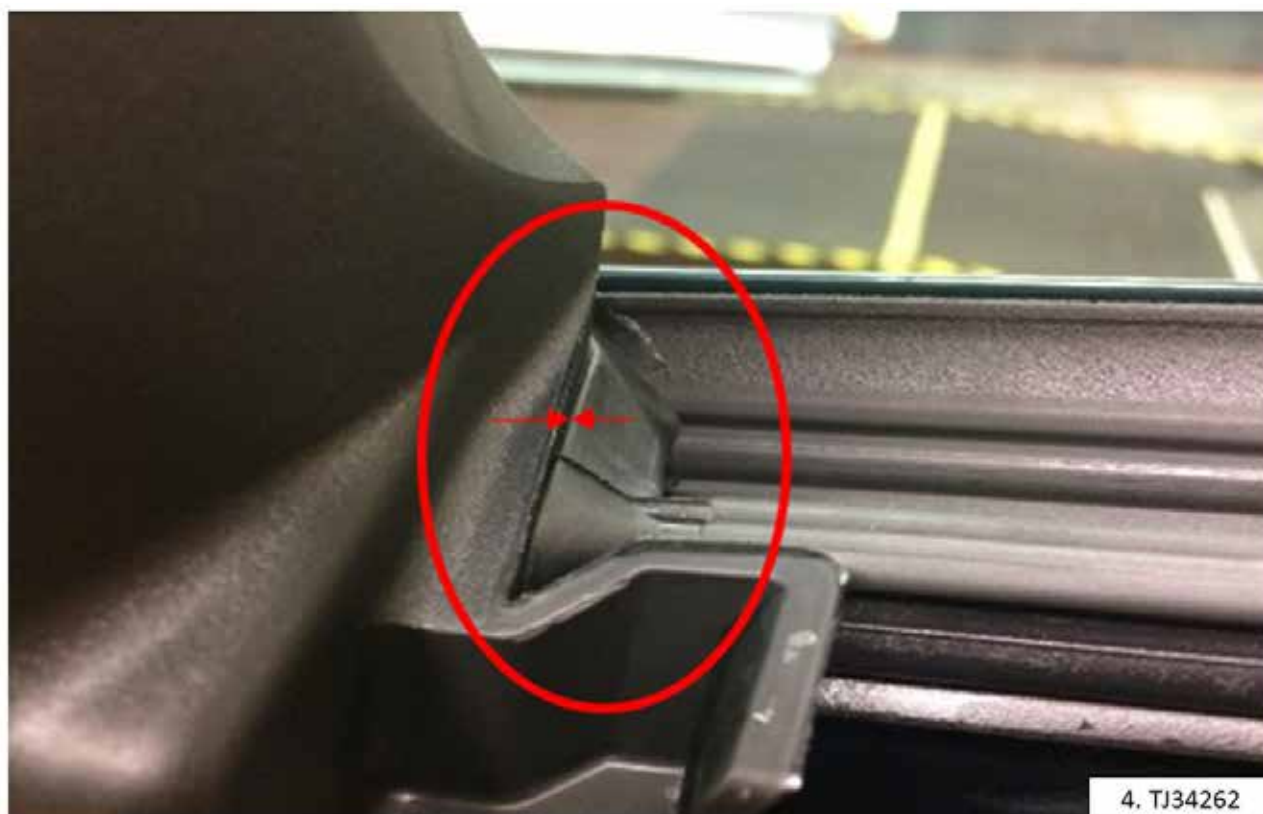
- 4. Front and rear door inner weather strip (without divider bar), see attachment 4 TJ34262.pdf.**
Check if the weather strip ends are sealing against the door. If not, re-assemble or replace part according to VIDA.

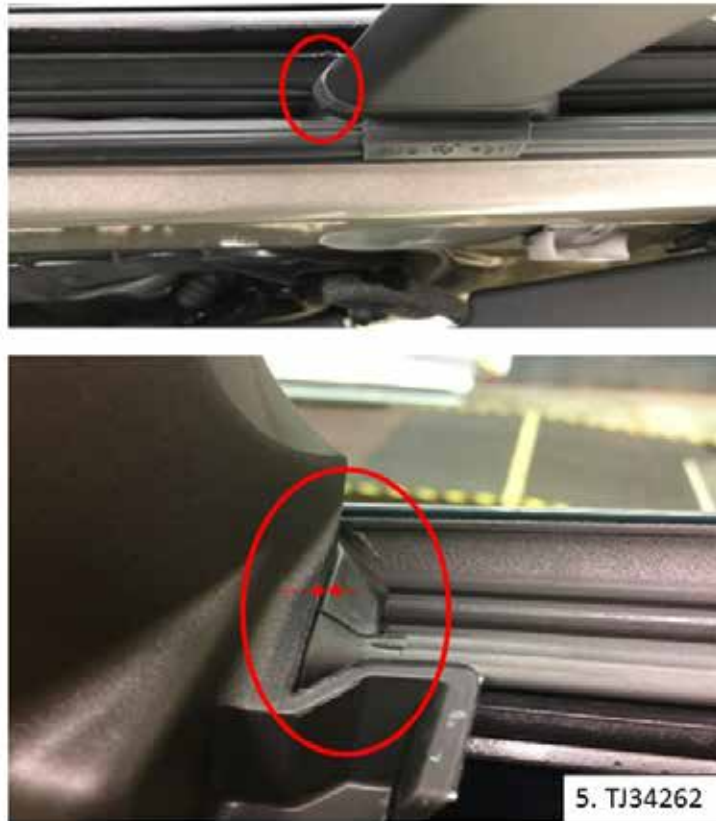
- 5. Rear Door weather strip with divider bar, see attachment 5 TJ34262.pdf (valid for vehicle type 224, 225, 256).**
Check if the weather strip ends are sealing against the door arch panel (see attached) and divider bar.
If not, re-assemble or replace part according to VIDA.
