Technical Journal

TITLE:
SPA Brake noise

REF NO: TJ 34246.1.0	ISSUING DEPARTMENT: Technical Service	CAR MARKET: United States and Canada	
PARTNER: 3 US 7510 Volvo Car USA		ISSUE DATE: 2018-12-14	STATUS DATE: 2018-12-19
FUNC GROUP: 5100	FUNC DESC: Wheel brake	Page 1 of 19

Brake NVH issues in SPA platform

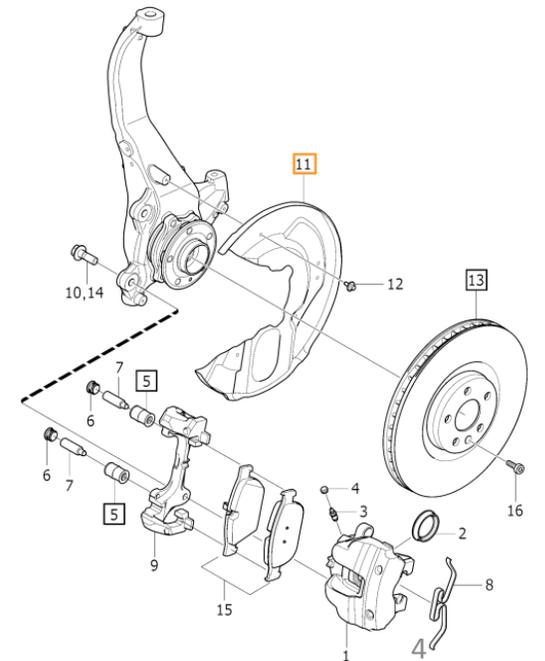
Rattle / Clapper noise

Rattle/clapper noise: Low frequency vibration noise over bumpy road (ex: gravel road)

- Change to damped dust shield (Protecting plate) according to VIDA (all service part dust shields (Protecting plates) are damped)

Note : 16" rear brake -> service part dust shield is not damped

- Issue solved

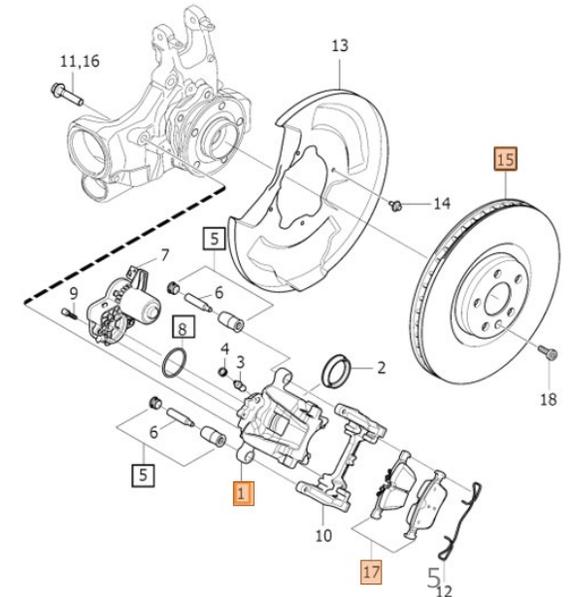
Chirp noise

Chirp noise: Unbraked noise while driving (off-braking, intermittent noise)

- Change rear calipers to latest part number + change rear discs + change rear pads according to VIDA

(latest part number of rear calipers has increased rollback)

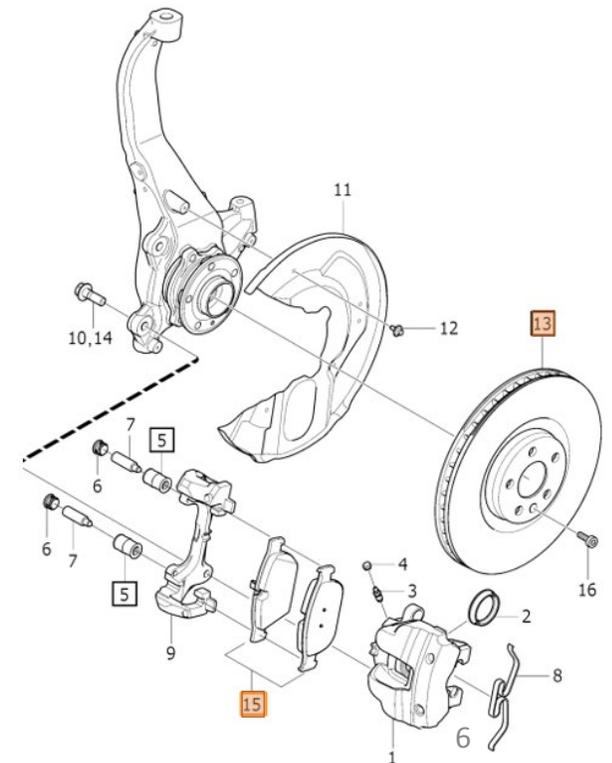
Judder

Judder: Vibration in the steering wheel / brake pedal / car body / seats

- Change front and rear discs + front and rear pads according to VIDA

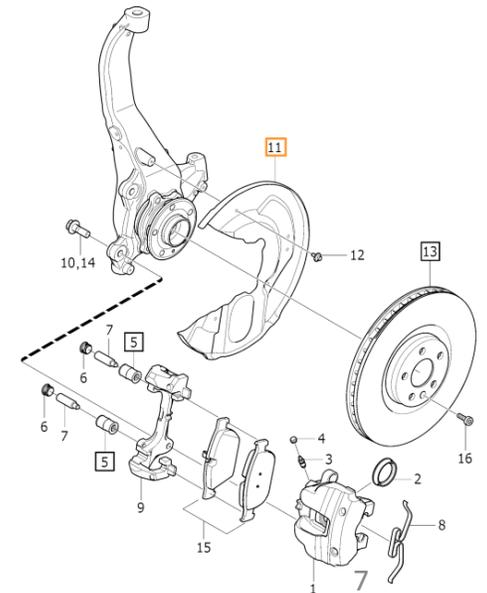
End-of-stop metallic noise

End-of-stop metallic noise: Metallic noise at end-of-stop

- Change to damped dust shield (Protecting plate) in the front and rear according to VIDA (all service part dust shields (Protecting plates) are damped)

Note : 16" rear brake -> service part dust shield is not damped

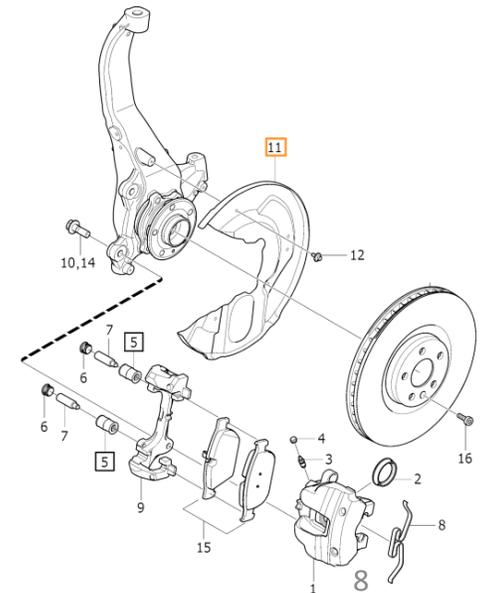
Trumpet noise

Trumpet noise: Noise that occurs when rolling slowly in Drive or Reverse (automatic gearbox) while braking

- Change to damped dust shield (Protecting plate) in the front brakes according to VIDA (all service part dust shields (Protecting plates) are damped)

Note : 16" rear brake -> service part dust shield is not damped

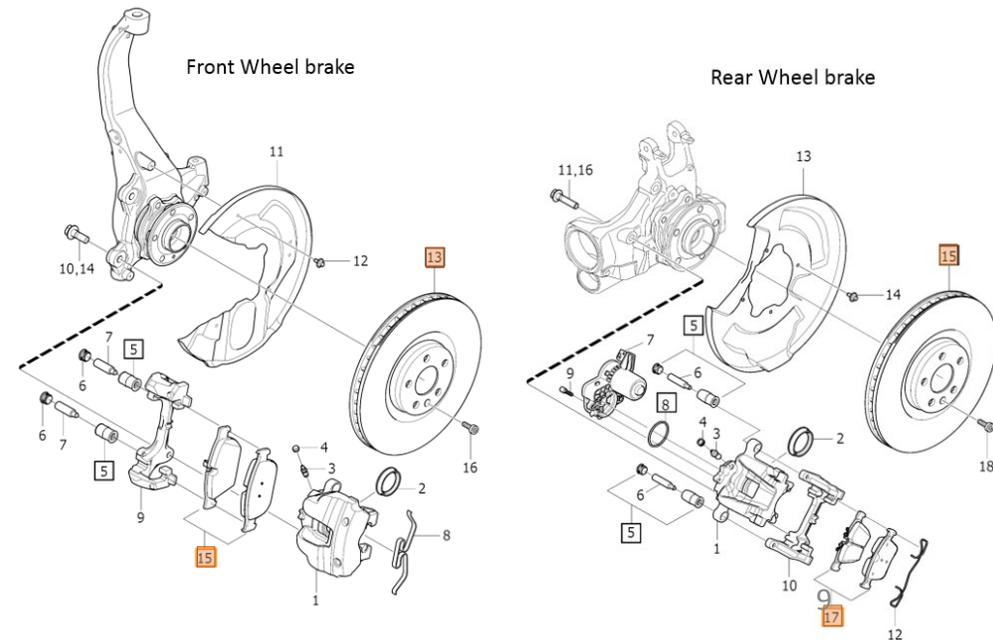
Creep groan

Creep groan: Noise/vibration that occurs when releasing brake pedal from standstill in Drive or Reverse (automatic gearbox)

- Change front/rear discs + front/rear pads according to VIDA

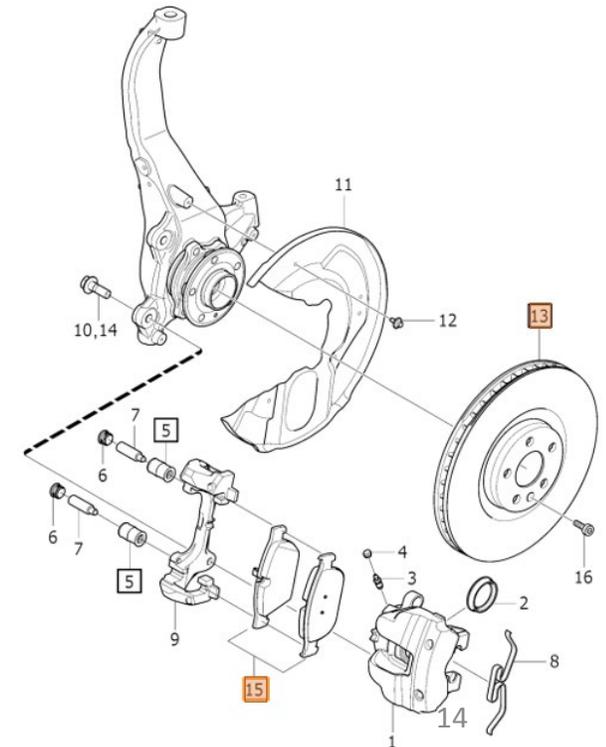
Brake squeal: 16" front

- Main squeal issue: 4.1 kHz cold noise

- Change front discs + front pads according to VIDA

- 4.1 kHz cold noise squeal Issue solved
