TITLE:
C70 headliner hanging down, repair clip

REF NO: TJ 29245.2.2	ISSUING DEPARTMENT: Technical Service	CAR MARKET: United States and Canada	
PARTNER: 3 US 7510 Volvo Car USA		ISSUE DATE: 2018-08-24	STATUS DATE: 2018-08-29
FUNC GROUP: 8389	FUNC DESC: Miscellaneous	Page 1 of 9

TJ 29245

Title	Convertible Top Center Headliner	Page	1 (6)
Action	Product fix	Operation number:	98537-2

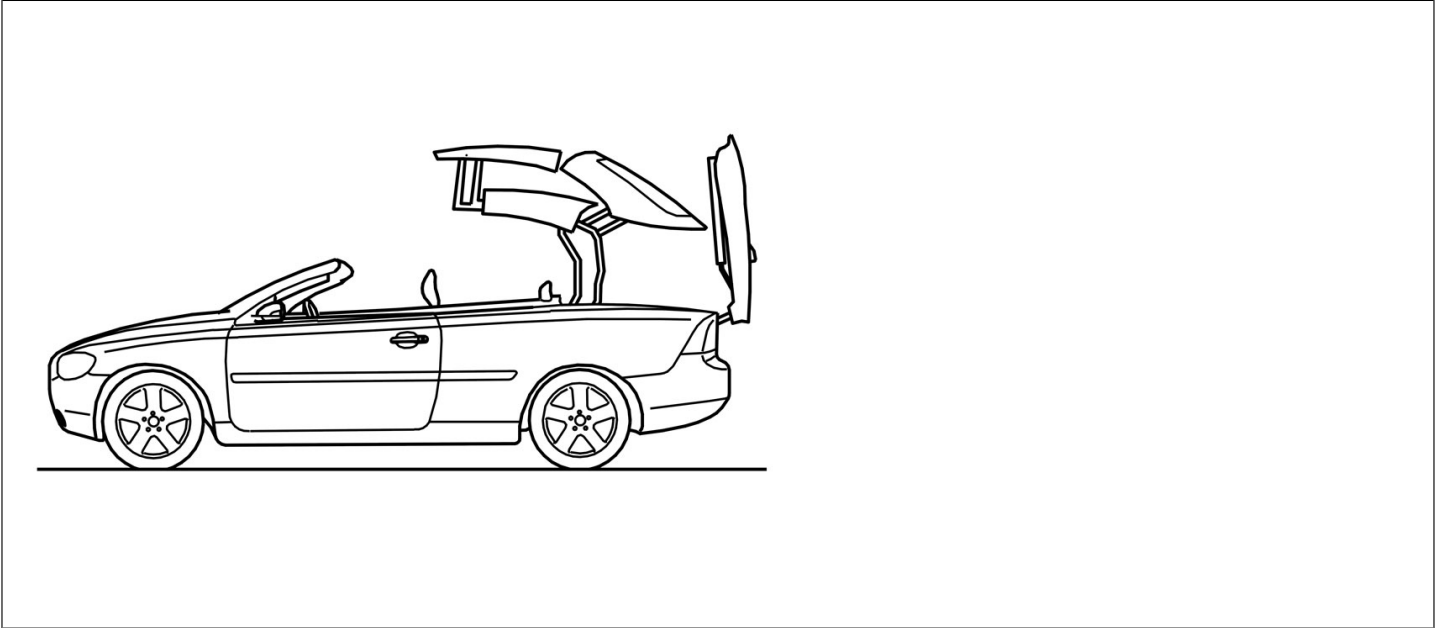
Loosen the clips.

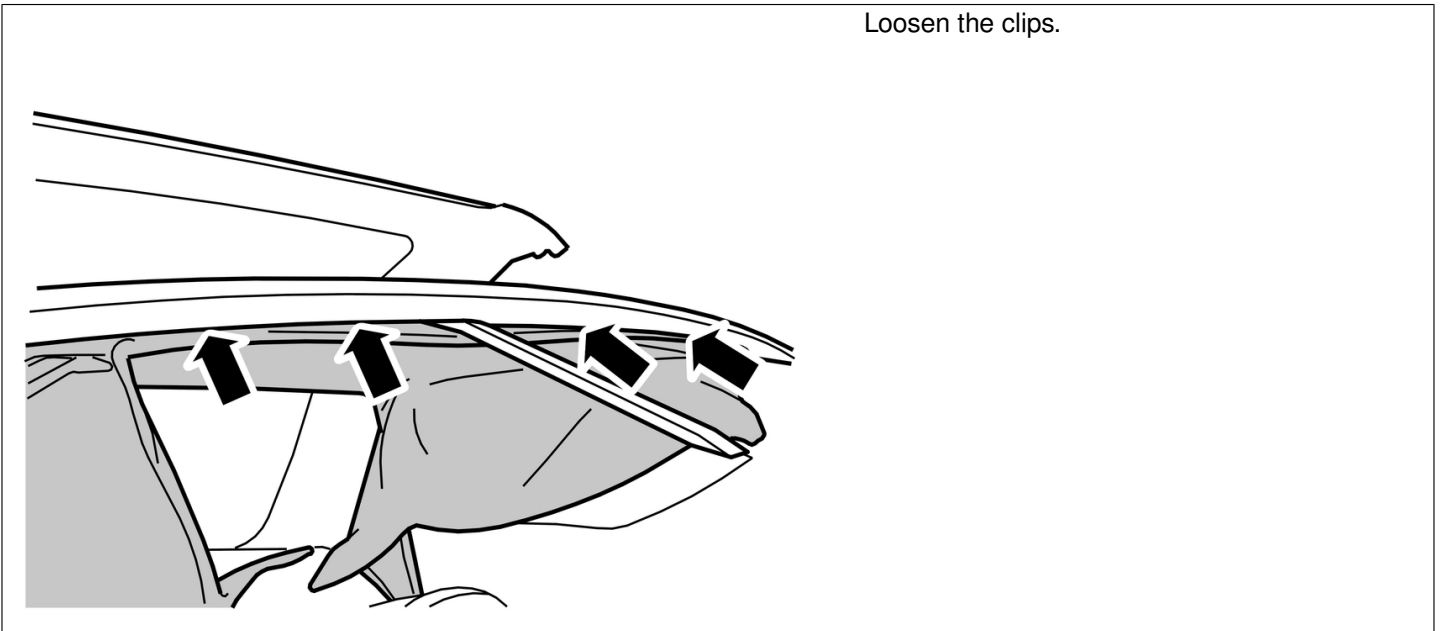
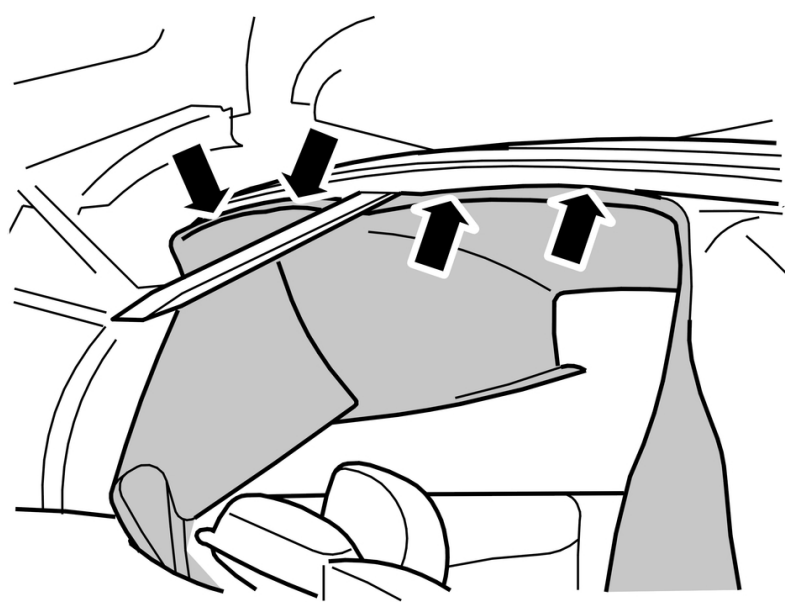
Loosen the clips.

Note! Remove all the loose clips and clean the old glue.
