**Title:** Cummins ECM Programming Procedure for LT, HV, MV, LoneStar

**Applies To:** EPA 2017 Cummins X15 equipped LT, HV, MV, LoneStar built prior to June 4, 2018

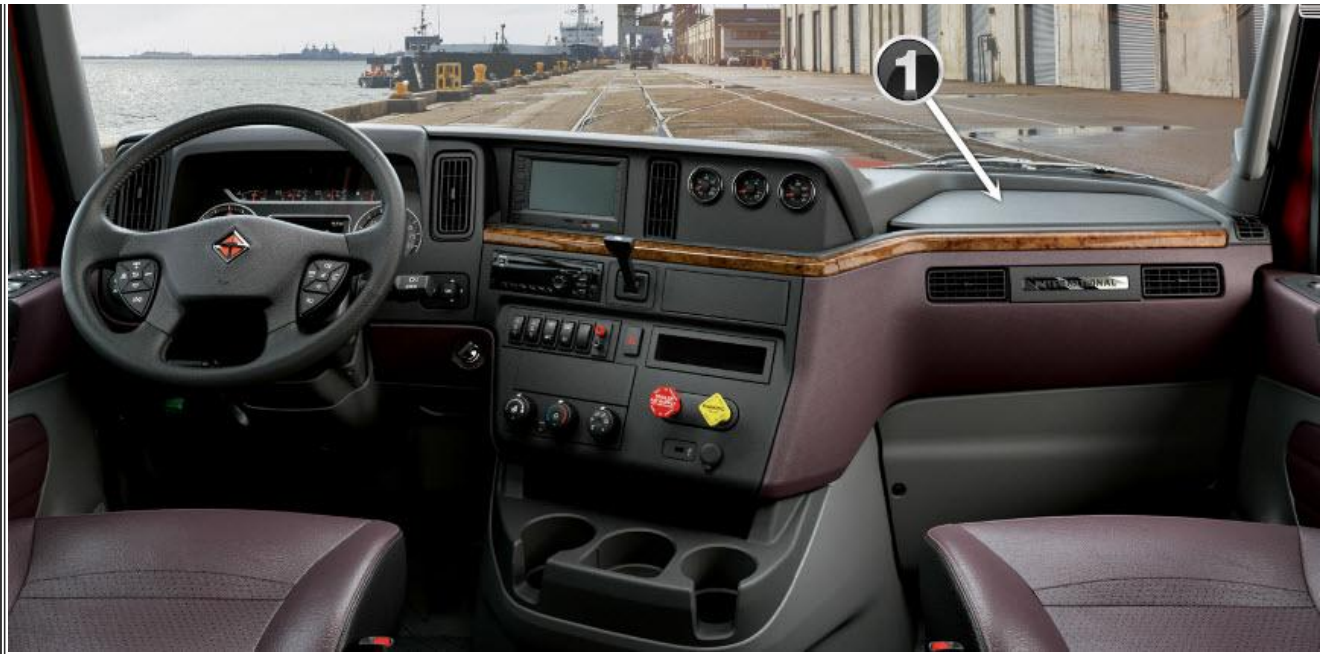
**Figure 1 - Fuse Panel Location**

1. Fuse Panel Cover

- A. Use the 3 pin connector in the engine compartment
- B. Remove the fuses for the door pods (no longer recommended):
  1. Remove the fuse panel cover located at the top of the dash on the passenger side of the vehicle.
  2. Reference the fuse panel graphic and locate the fuse locations for **Driver Side Window/Door/Mirror** and **Passenger Side Window/Door**
  3. Remove both fuses
  4. Connect to the ECM using the vehicle 9-pin diagnostic connector
  5. Update the ECM calibration with INSITE
  6. Once all programming is complete disconnect the service tool from the vehicle 9-pin diagnostic connector
  7. Re-install fuses for Driver Side Window/Door/Mirror and Passenger Side Window/Door
