December 2018  
FL766A-C  
NHTSA #18V-191  
Transport Canada #18-190  
SECOND REVISED NOTICE

## **Subject: Western Star Power Cable Studs**

**Models Affected: Specific Western Star 4700, 4900, 5700, and 6900 model vehicles manufactured September 12, 2016, through February 6, 2018.**

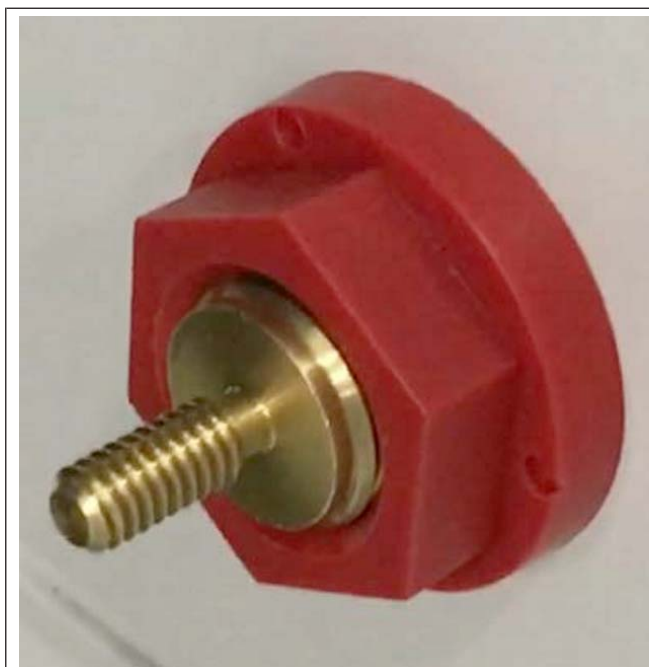
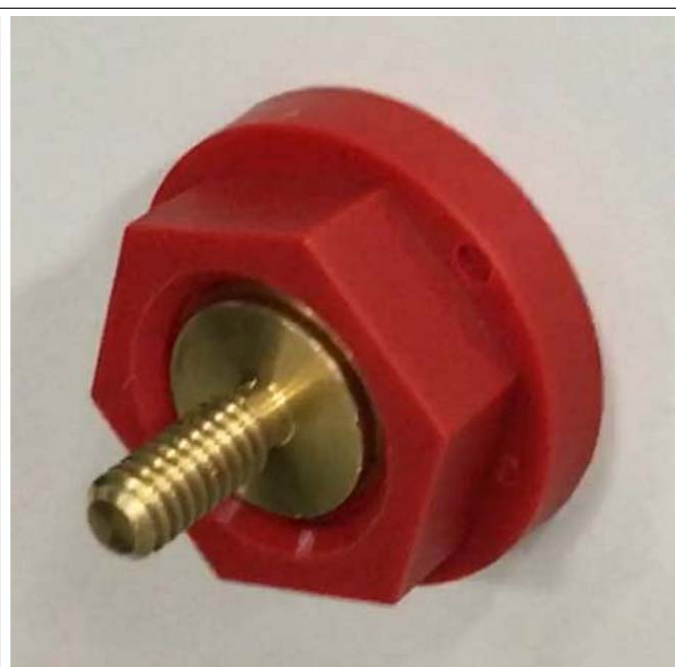
**Fig. 3, Installation Inspection**

If at least one thread does **NOT** protrude past the plastic nut, the installation is **INCORRECT**. Proceed to "Power Cable Stud Replacement."

If at least one thread protrudes past the plastic nut, the installation is **CORRECT** and the recall is complete. Continue with the next step.

**A. Correct Installation**

**B. Incorrect Installation**

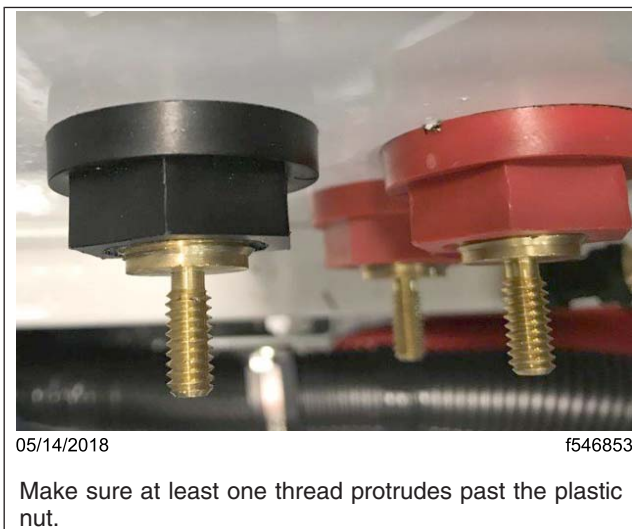
**Fig. 4, Correctly Installed Pass-Through**

1. Open the hood and locate the three or four power cable stud connectors on the front wall. See [Fig. 1](#).
2. Pull back the covers on the power cable stud connectors. See [Fig. 2](#). Inspect each cable stud to make sure at least one thread protrudes past the plastic nut. See [Fig. 3](#) and [Fig. 4](#).
