## Stryker 3313 - Plumbing Vent thru Roof

### Description

There is a possibility that the vent was not completed inside the wall to extend through the roof.

Stryker 3313 manufactured between August 8, 2018 and August 20, 2018 the VIN range is 5RXGG4126K2402434 - 5RXGG4125K2403039

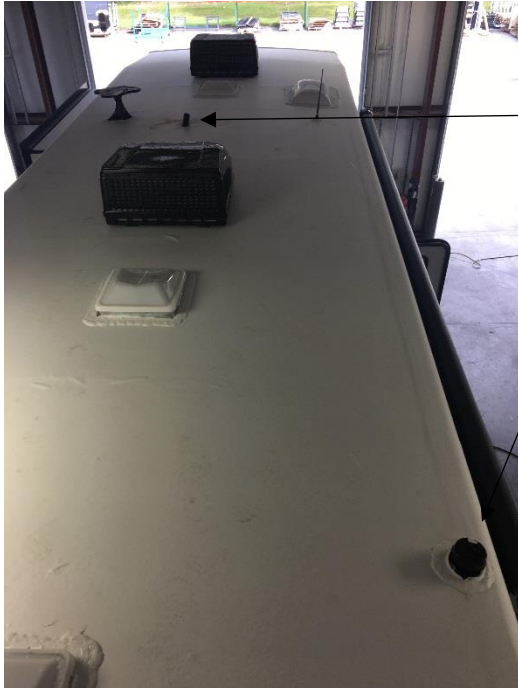
Location of the 2 Vent pipes.

**\*If only 1 plumbing vent is coming up through the roof than this bulletin applies to this RV.**
