## Power windows and/or seat adjustment inoperative

| Topic number | LI72.10-P-069052 |
| Function group | 72.10 Front door |
| Validity | Model 463 in VIN end number range X204078 to X293519 |

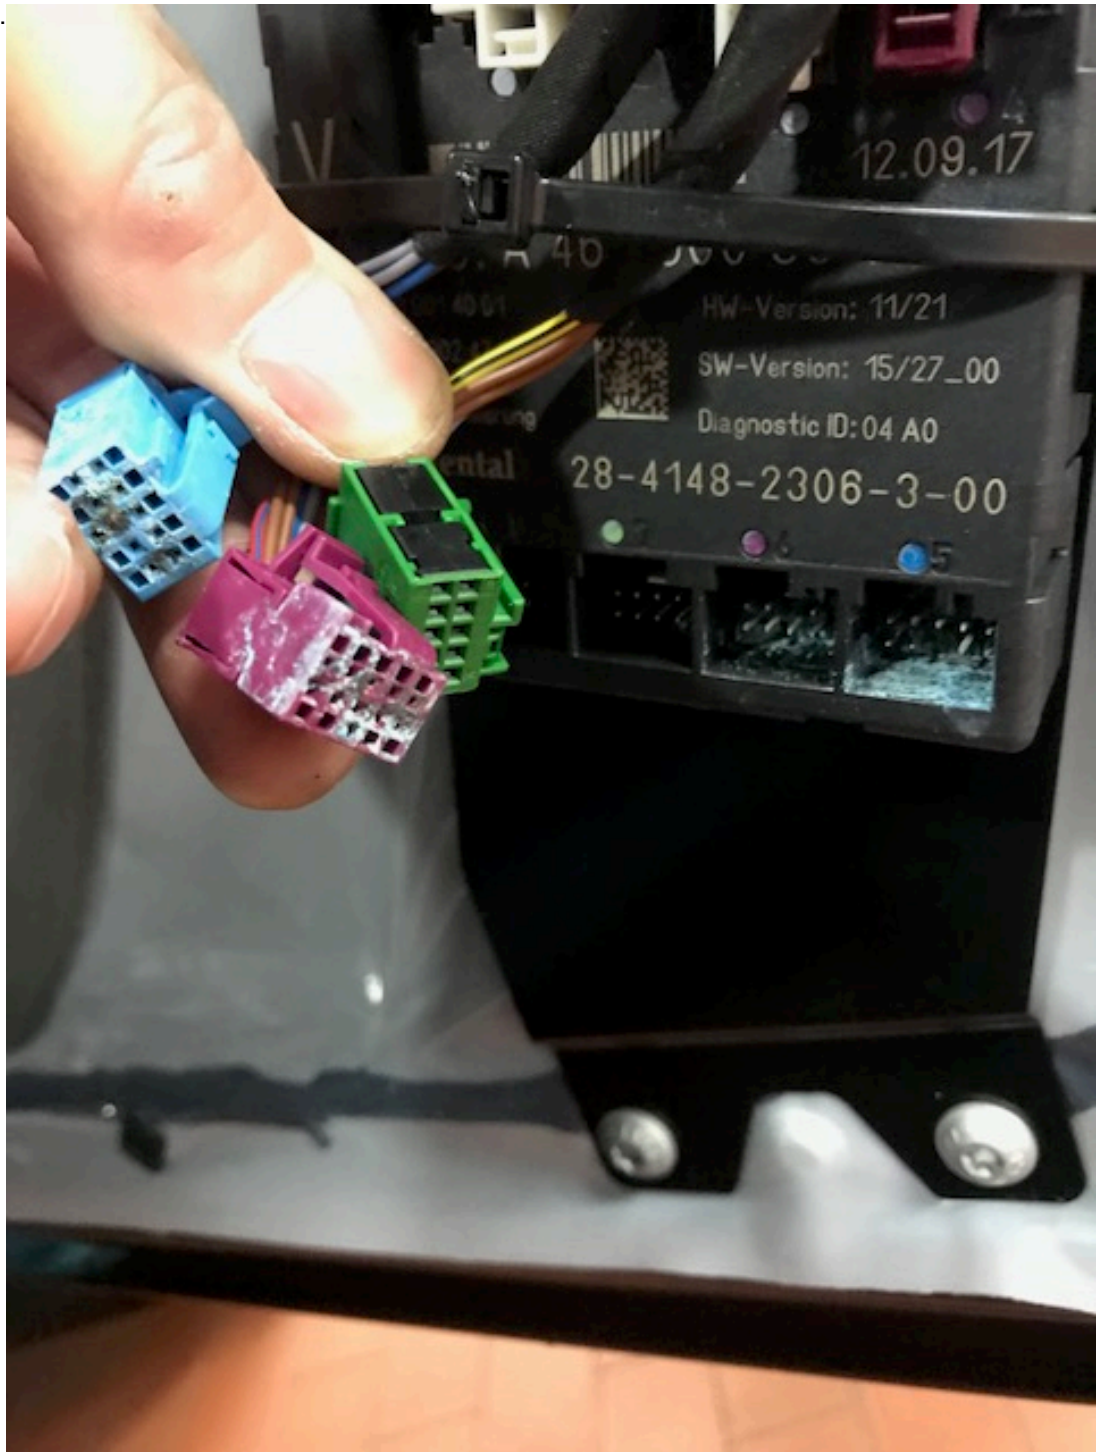
Oxidation Türsteuergerät.  
jpg:

Possible moisture damage to the door control unit.

| Attachments | |
|---|---|
| Oxidation Türsteuergerät.jpg | Oxidation of door control unit. |

Check connections and wiring harness for moisture and oxidation damage.

Repair door wiring harness or replace if necessary.

Replace door control unit if necessary.

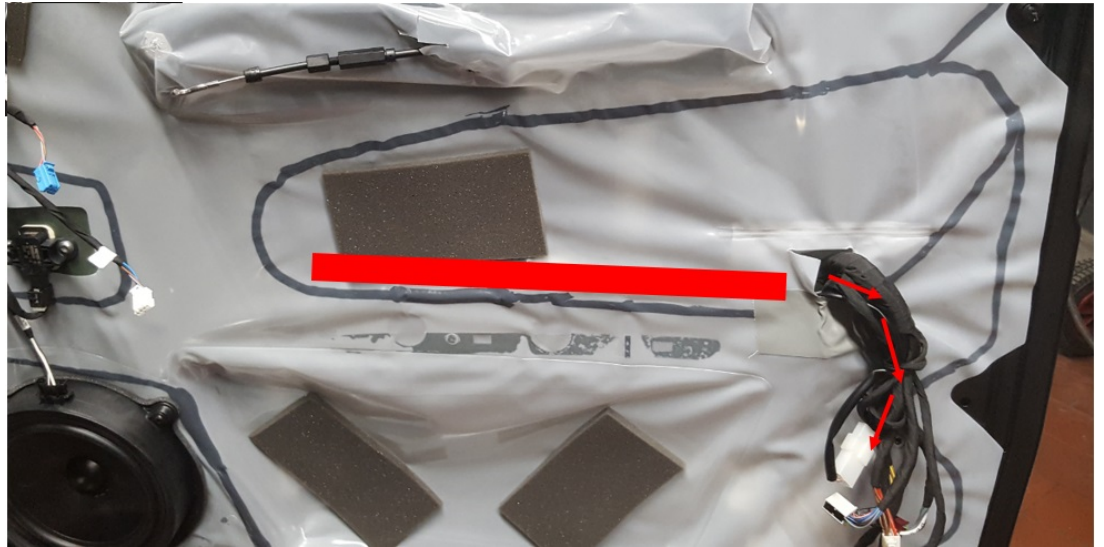
Abdichtung alt.jpg:

| Attachments | |
|---|---|
| Abdichtung alt.jpg | Picture 1: Old sealing |

Adjust adhesive bead of door liner as shown in picture 2 "New sealing". (Prevention of water pocket formation)

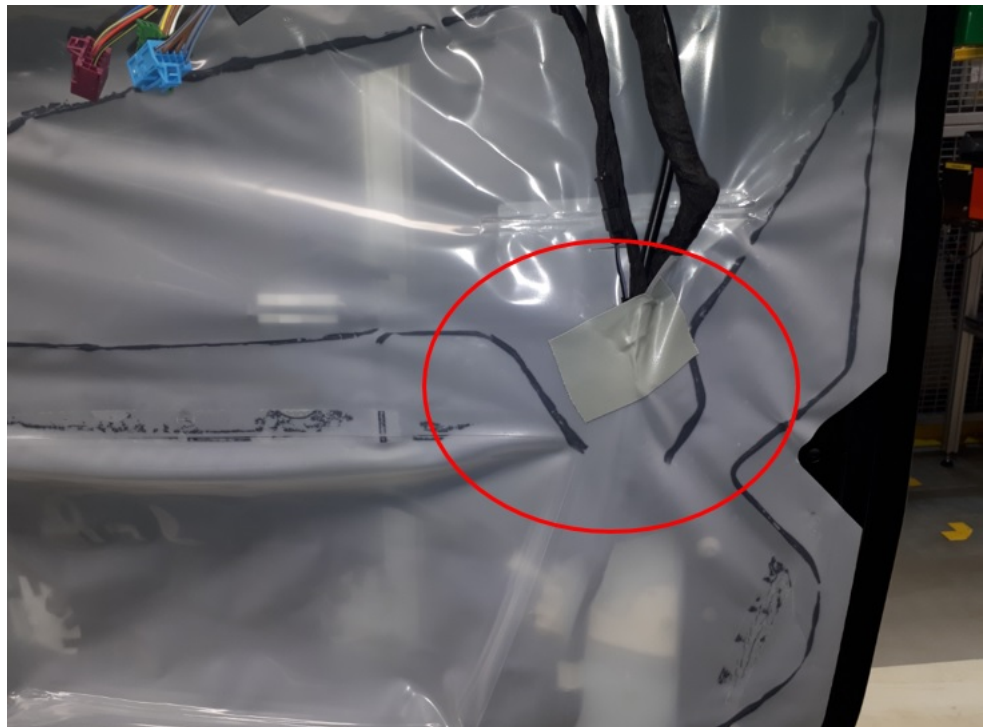
Abdichtung neu.jpg:

| Attachments | |
|---|---|
| Abdichtung neu.jpg | Picture 2: New sealing |
