# Authorized Field Change

**AFC 18904**

**Subject File:** REAR AXLE

**Subject:** International® Ride Optimized Suspension (IROS) Height Control Valve Lower Bracket

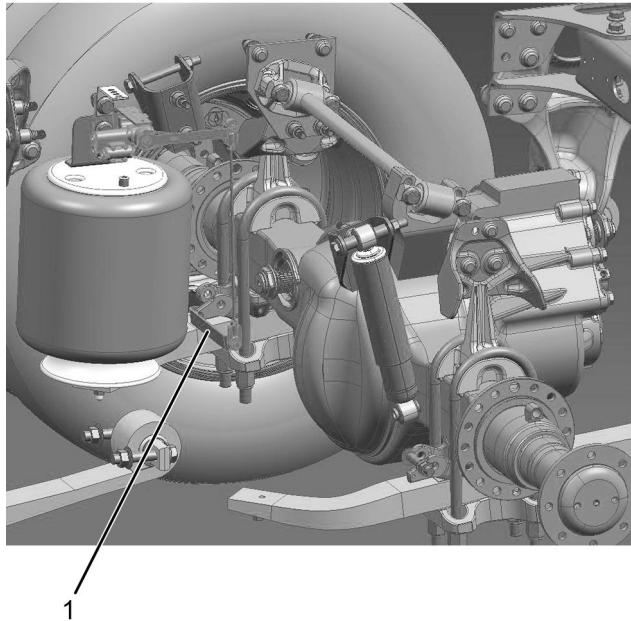
**Figure 1. Ride Height Control Valve**

The Height Control Valve (HCV) lower bracket may fail due to fatigue and result in incorrect ride height and possible driveline vibration.

1. HCV lower bracket

4. Locate and remove HCV lower bracket (Figure 1, Item 1) located on axle seat of left-side forward drive axle.

**NOTE: Install HCV lower bracket so that it wraps around the end of the axle seat and mates to the outboard face of the boss surrounding the bolt hole in order to prevent rotation of the HVC bracket.**

5. Install new bracket.

6. Using a torque wrench, tighten fastener securing bracket to axle to 13 lb-ft (18 N•m).

7. Using a torque wrench, tighten fastener securing rod to bracket to 13 lb-ft (18 N•m).

8. Check and adjust suspension ride height as necessary.
