FIELD SERVICE CAMPAIGN – 18109

02 October 2018

Body Control Module (BCM) Software Update

International® LT® Series and ProStar® trucks

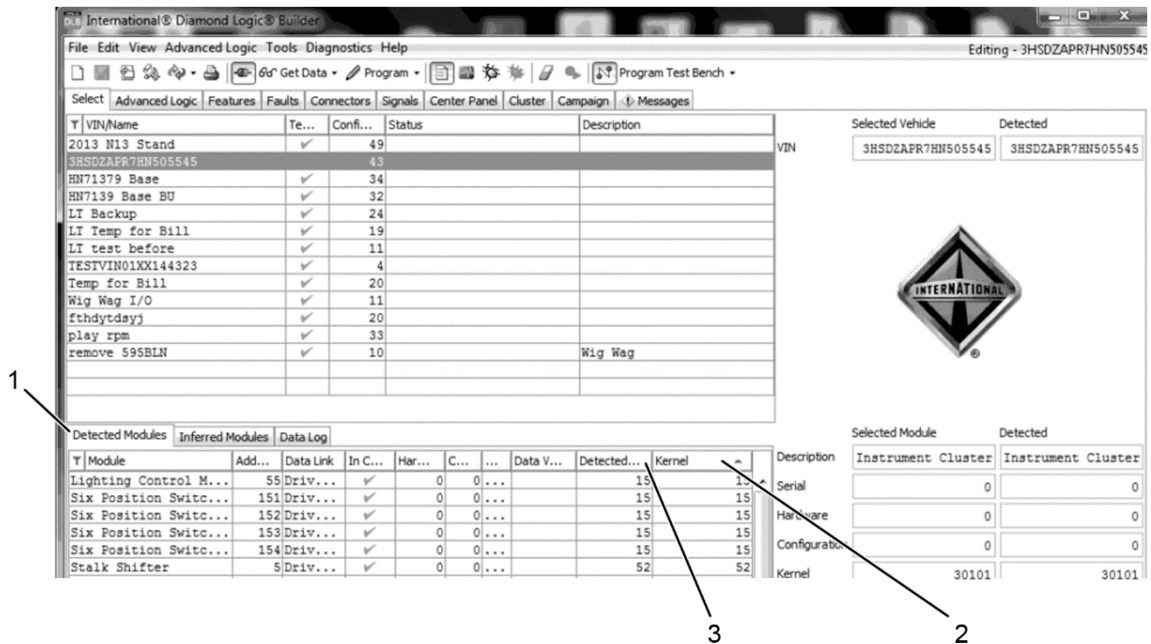
Figure 1. Detected Modules: Before Update

1. Detected Modules tab
2. Column headings
3. Detected and Kernel columns

7. Select Detected Modules tab (Figure 1, Item 1) to see kernel information for this vehicle.
8. If Detected Kernel and Kernel columns (Figure 1, Item 3) are not displayed, enable their display by right-clicking on any column heading (Figure 1, Item 2) and then selecting columns in right-click menu.

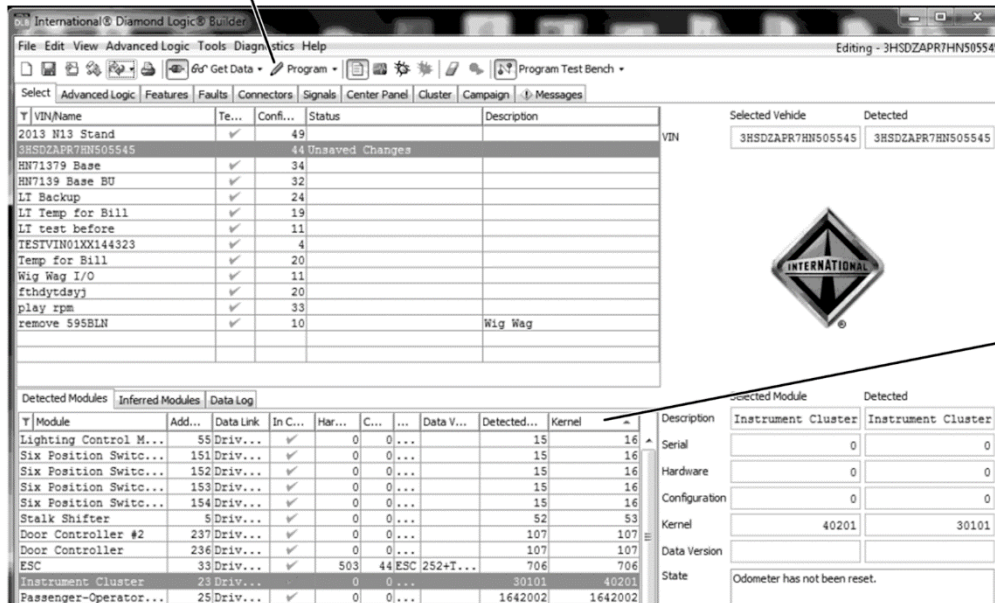
Figure 3. Detected Modules: After Update

1. Program icon
2. Kernel column

10. After versions in Kernel column (Figure 3, Item 2) have been updated, click Program icon (Figure 3, Item 1) in toolbar.

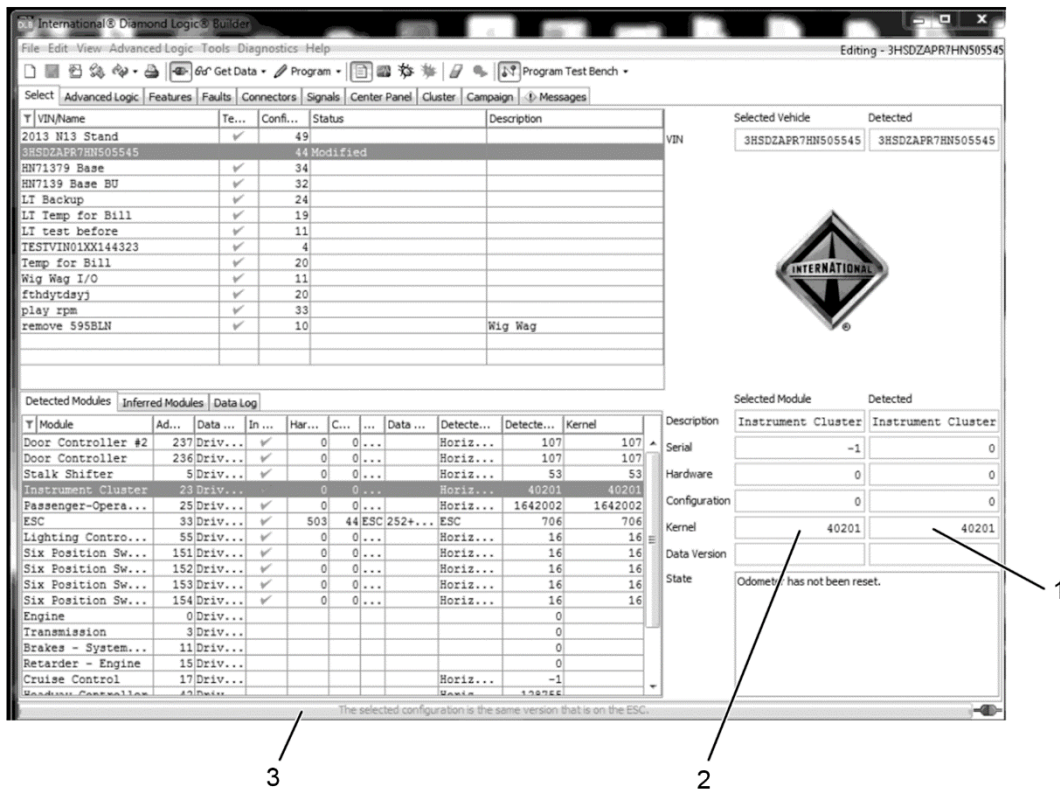
Figure 4. Programming Complete

1. Detected kernel version
2. Selected Module kernel version
3. Status bar

11. Once programming begins, DLB will indicate programming status in status bar (Figure 4, Item 3) located at bottom of window. Programming may take up to 60 minutes, depending on how many modules are being updated.
