**Title:** 2015+ N13 Cylinder Pack - Update for Excessive Lubrication Oil Consumption

**Applies To:** 2015+ N13 ESN: 4400000-4401769

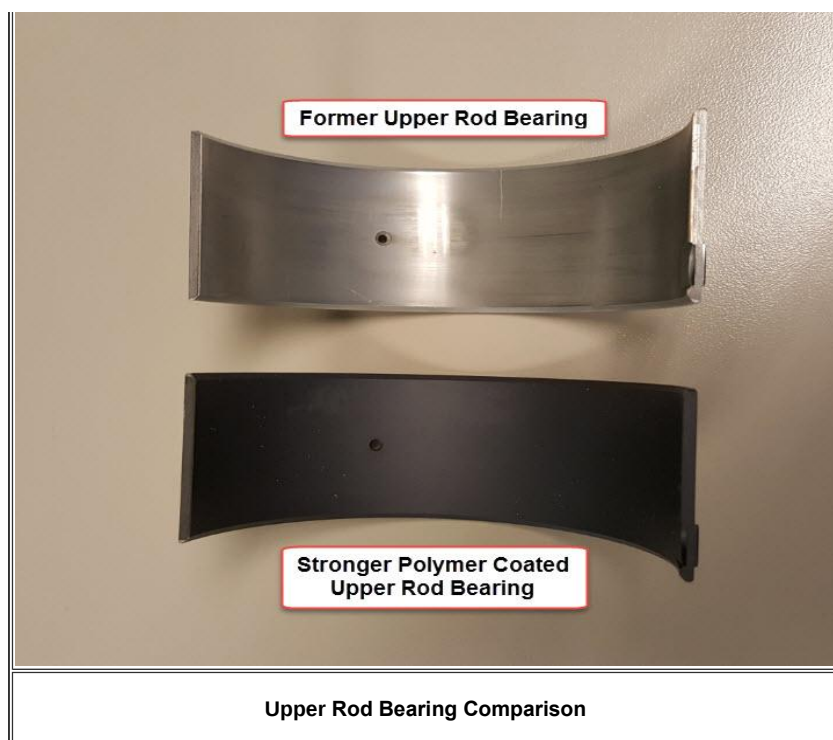
## **CONNECTING ROD BEARING SERVICE INFORMATION**

The 2513433C91 rod bearing set contains a stronger polymer coated upper bearing which is darker in color. This bearing replaces the former 3004714C91 and has been in service since 2015. The coating was added due to increased cylinder pressures found in the 2015 N13. There are no dimensional changes in the bearing, and it is backward compatible to all MaxxForce and N13 engines.
