Countries: CANADA, UNITED STATES **Document ID:** IK1900253
Availability: ISIS, FleetSIS, IsSIR **Revision:** 3
Major System: ACCESSORIES **Created:** 11/10/2017
Current Language: English **Last Modified:** 10/11/2018
Other Languages: NONE **Author:** Charles Schroeder
Viewed: 931

Title: A/C Condensers for LT and RH Part Number Update

Applies To: LT and RH

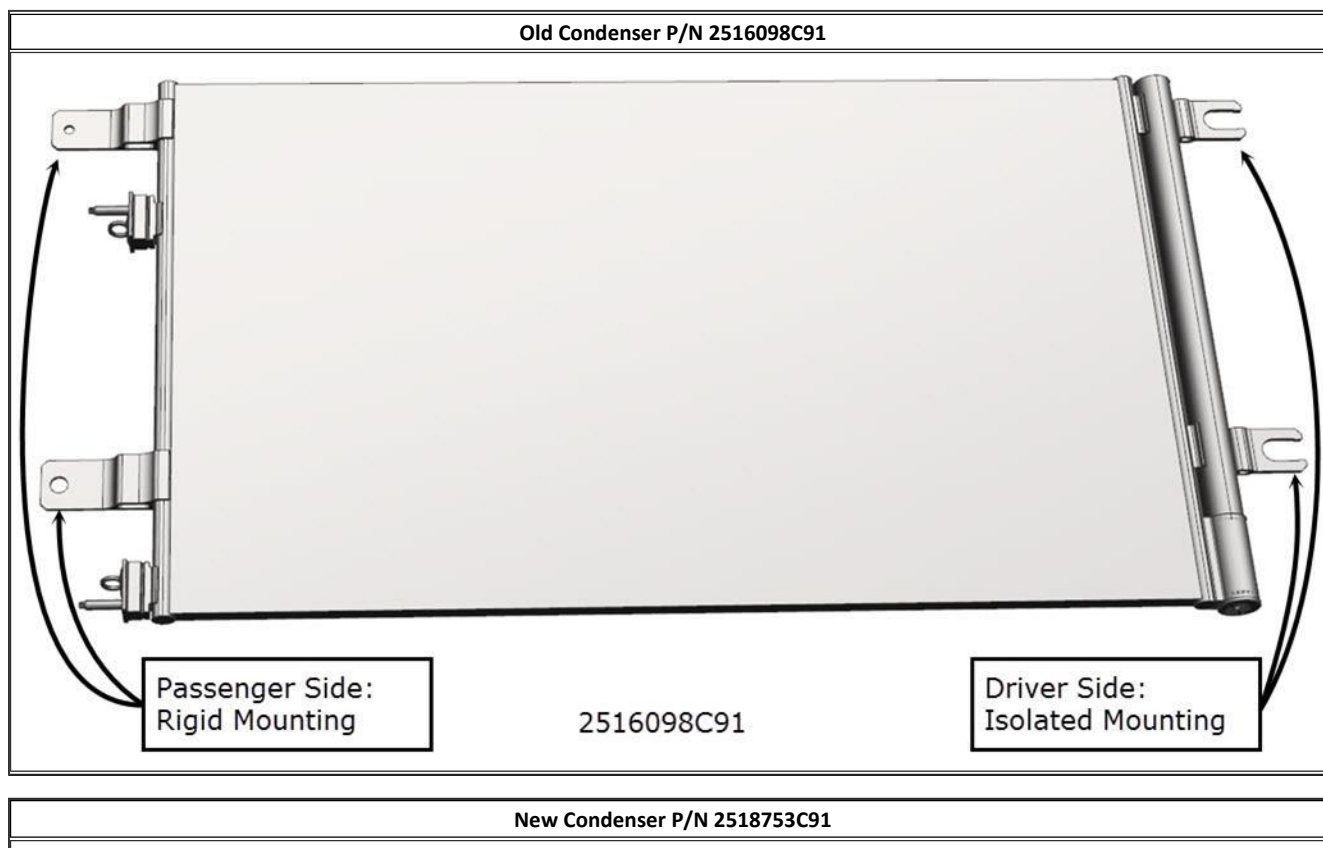
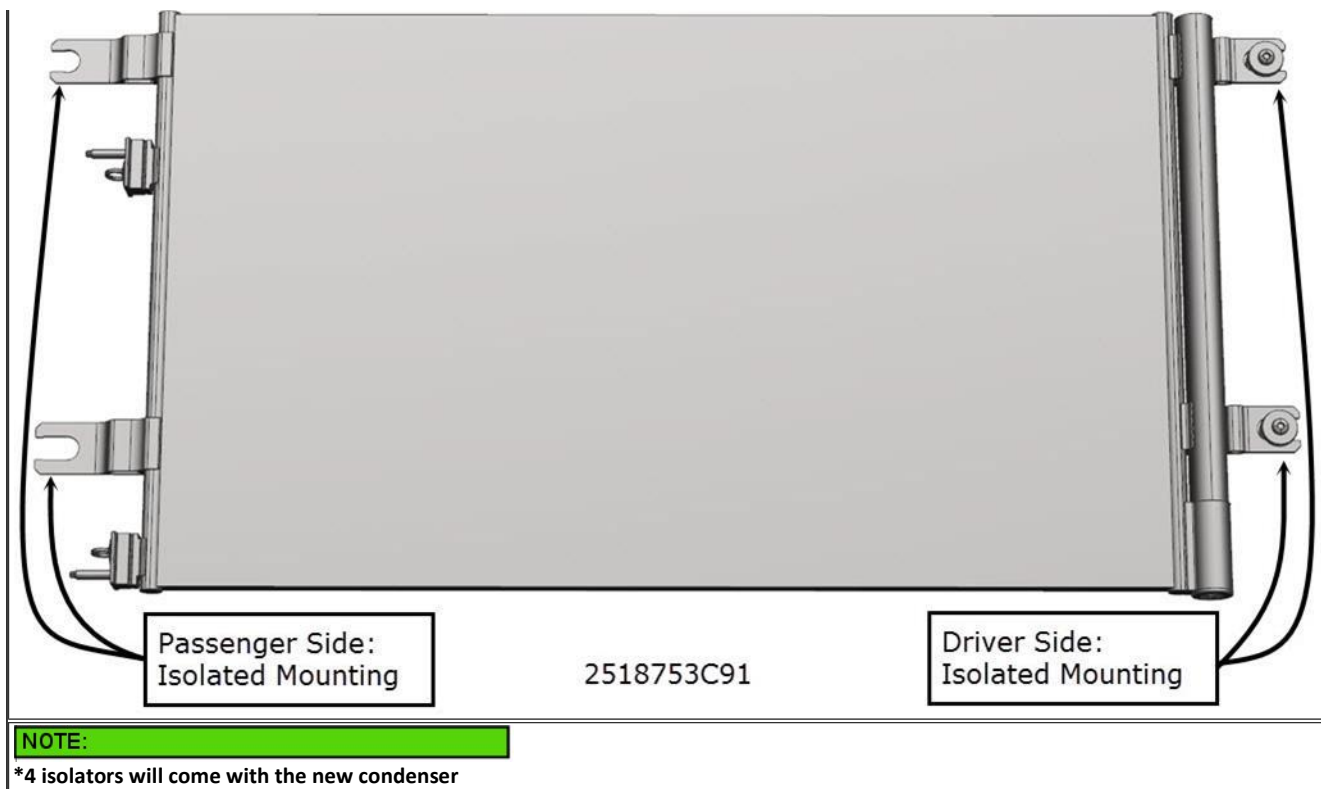
Condenser P/N 2516098C91 has been replaced with P/N 2518753C91, see images below:

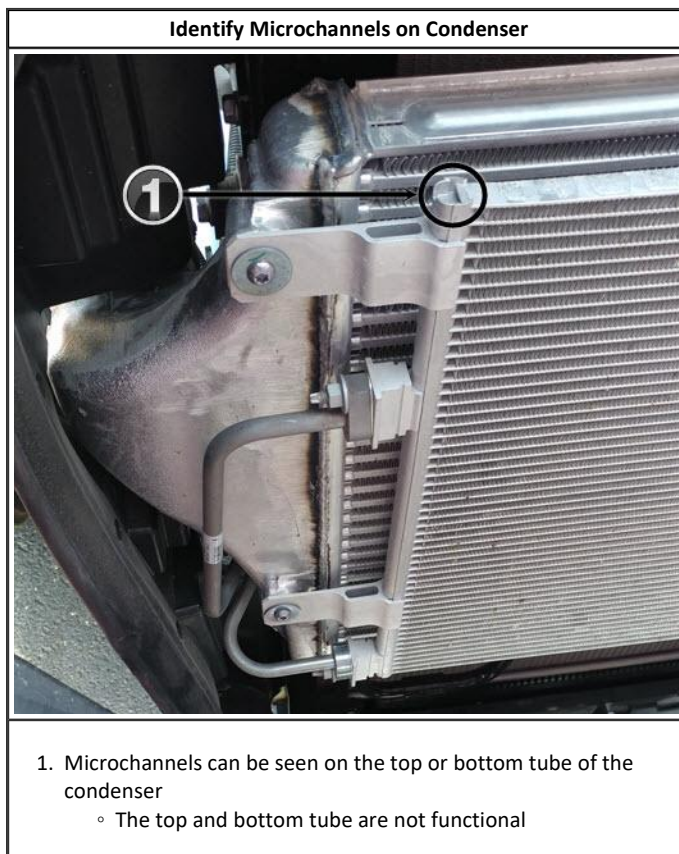
NOTE:
The New Condenser can also be identified by the number of microchannels in the tubes

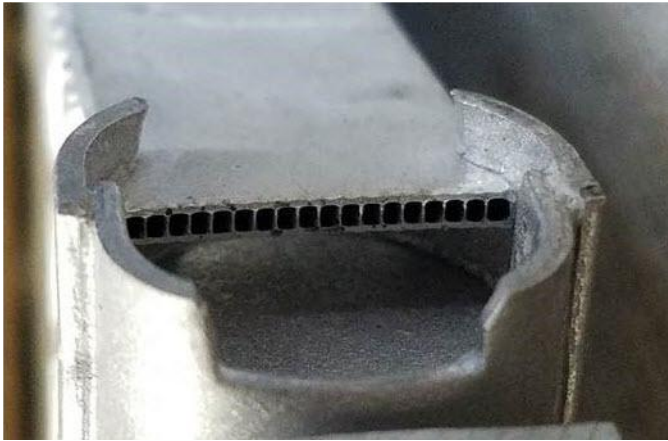
Original Condenser - 18 Microchannels

- A small number of production vehicles had 4 isolators with the 18 Microchannel design (Built between 10/17/2017 and 11/08/2017)
- 4 Isolators with 18 Microchannels was never available as a service part

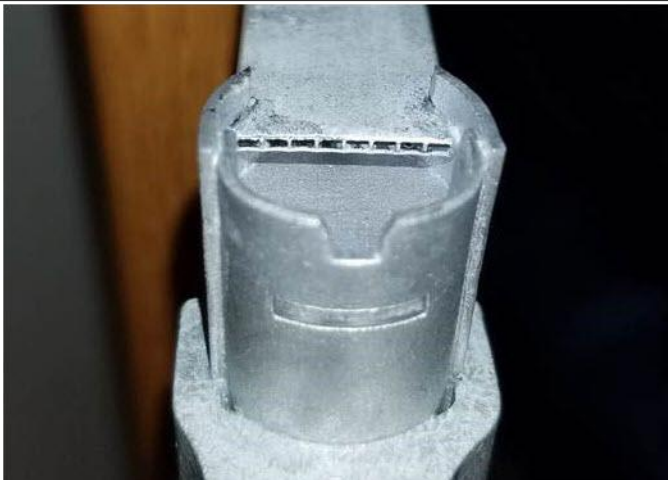
New Condenser 2518753C91 - 8 Microchannels

The New Condenser 2518753C91 is the only available service part
