Campaign Code:
L73X-A.07.18

Campaign Name:
Idler roller replacement

Model:
Aventador

Model Year:
MY12 - MY16

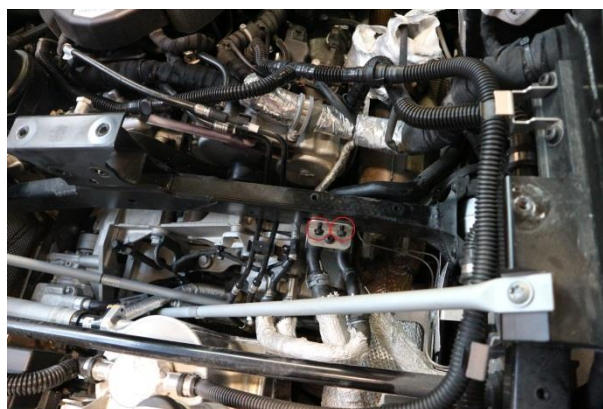
- 1. Remove the two screws.

Tighten the screws.

Tightening torque: 10 Nm (7.38 lbf ft).

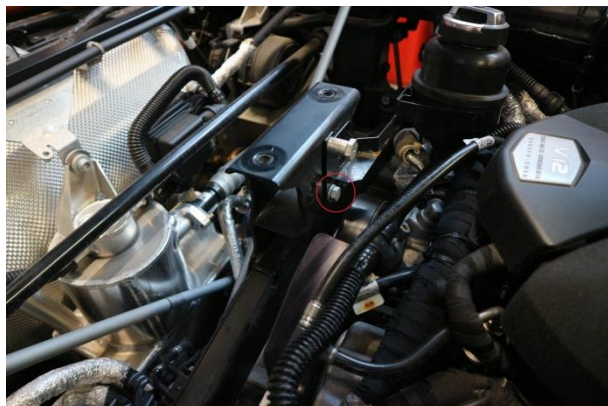
2. Remove the lower screw.

Tighten the screws.

Tightening torque: **8 Nm (5.9 lbf ft)**.

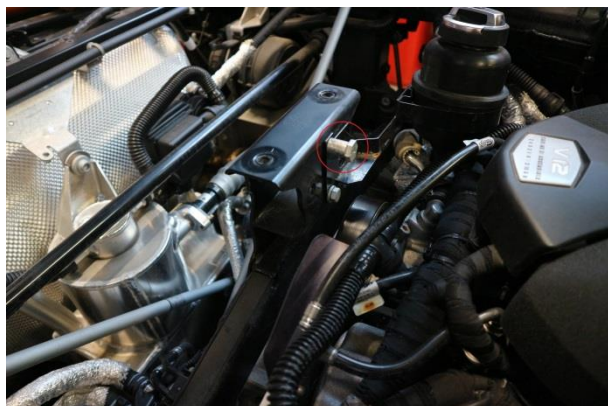
3. Remove the upper screw.

Tighten the screws.

Tightening torque: **20 Nm (14.75 lbf ft)**.

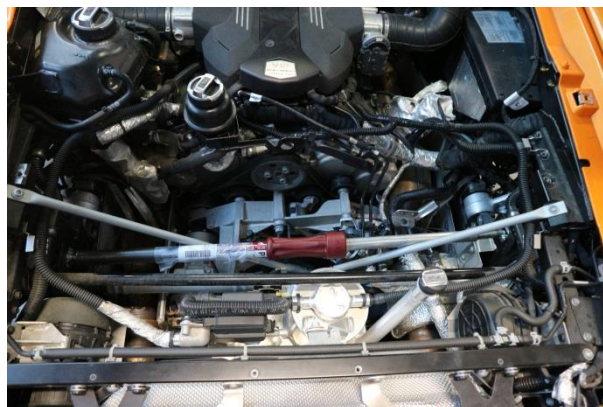
5. Position the telescopic prop (code 64153000112) as shown in the photo. Screw it down so as to allow the rear sub-frame to be freed.

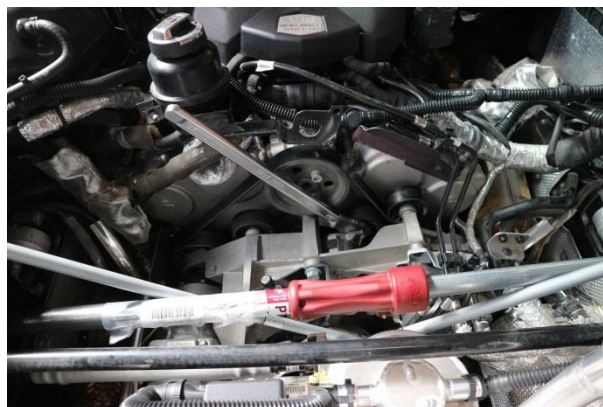
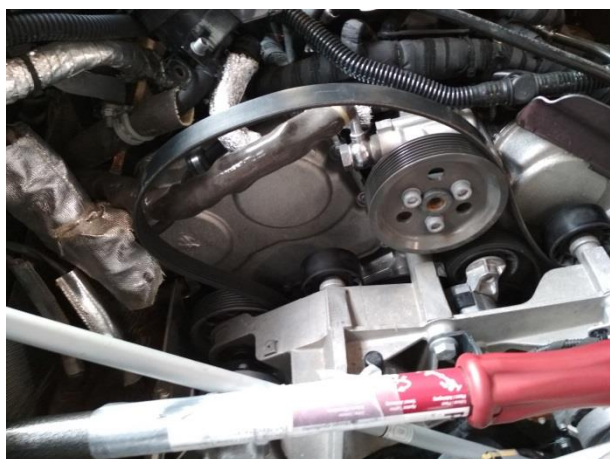
7. With the assistance of tool 61895067, release the pressure in the belt tensioner and free the auxiliary belt from the idler roller concerned.

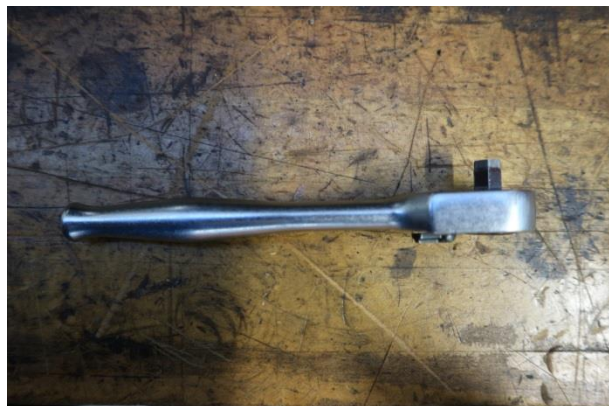
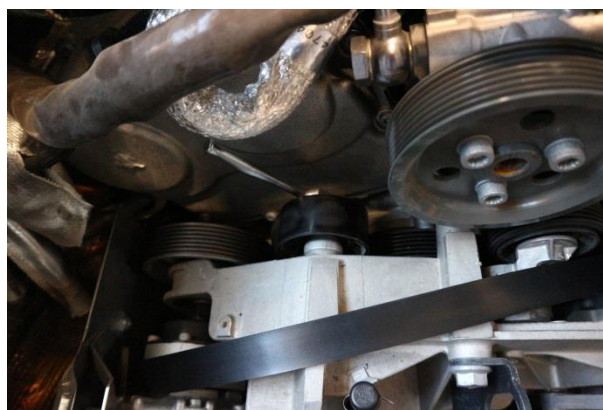
8. Fasten the size 6 insert (supplied with the kit code 61253001395) to the retaining screw of the idler roller in question, and unscrew it using a flat-head ratchet.

Do not unscrew the screw completely in order to prevent the insert from becoming trapped. Once the screw is free to move, complete the operation manually.

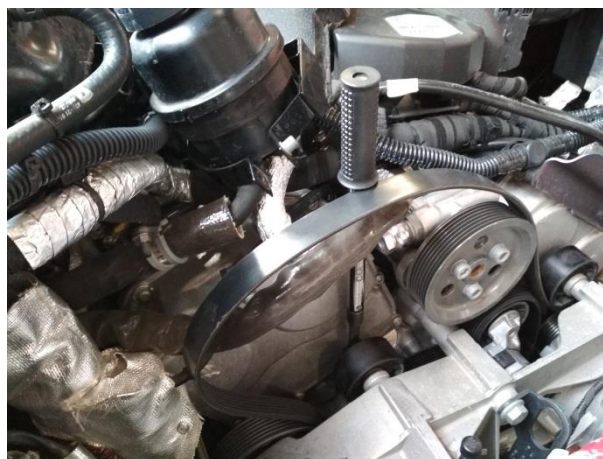
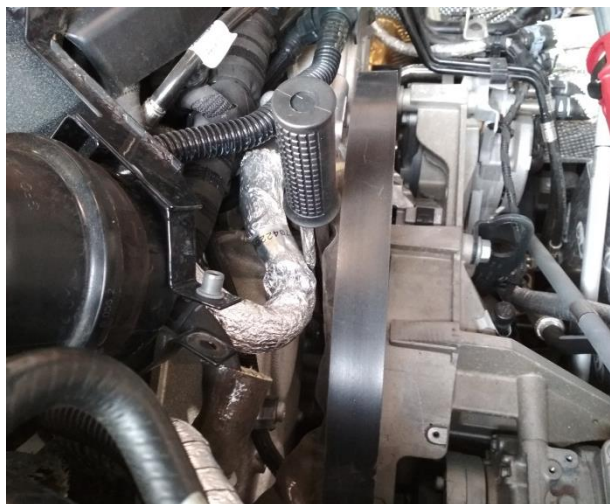
9. Free the idler roller and replace it with the new one supplied.

Apply medium-strength threadlocker.

Tighten the screw.

Tightening torque: **28 Nm (20.65 lbf ft)**.

Use the wrench supplied (code 61253001395) to tighten the screw of the idler roller to the correct torque.

The wrench is preset to 28 Nm.
