Campaign code.
L73X-A.14.18

Campaign description.
Engine SW Update

To: Official After Sales Network
Subject: Engine SW Update
Date: 21 December 2018
Pages: 8

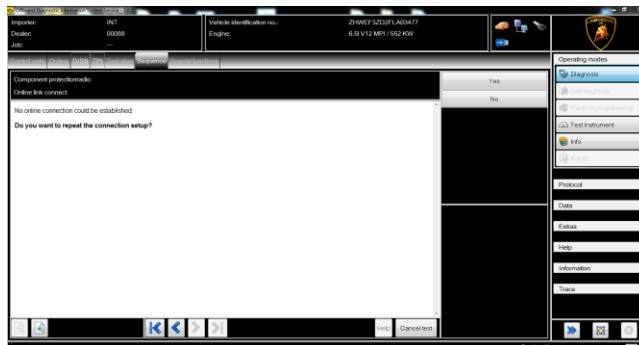
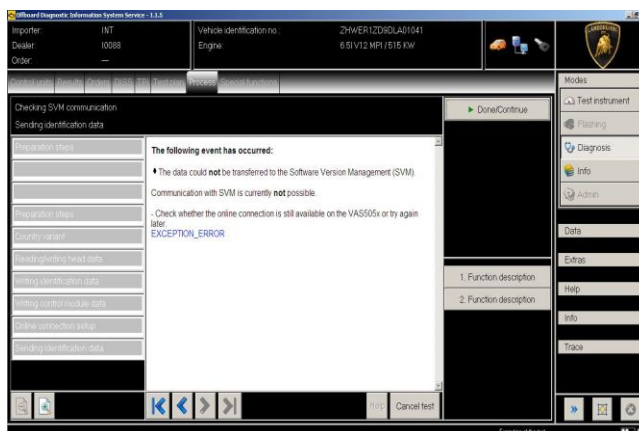
- C. If one of the connection error screens is shown as in the pictures below:
 - It is not possible to establish a connection with the central server. Please check carefully that the diagnosis laptop is properly connected to

the internet network and retry clicking “Yes” or “Done/Continue”.

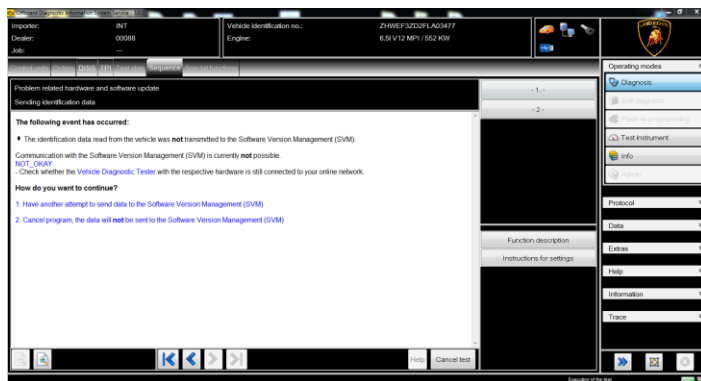
- D. If the loss of connection happens during the target/actual comparison during SVM procedure:
 - It is not possible to connect to central server, check the working connection of internet and retry by clicking “1”.

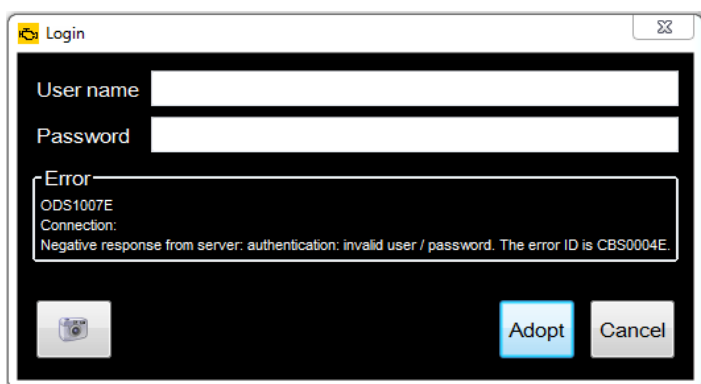
E. If the incorrect identification message is shown as in the picture below (error code: ODS1007E):

- Check that your Geko account is valid;
- Check that the label “Geko” is written on the token that you are using for the authentication;
- Check if the Password inserted is correct;
- Click on Cancel and perform the application test (see document “ODIS_Checking_ConnectionServer_SVM_2.0” (*)).

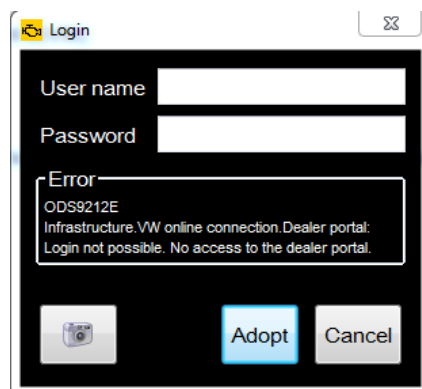
F. If the infrastructure error message is shown as in the picture below (error code: ODS9212E):

- Check that your Geko account is valid;
- Check that the label “Geko” is written on the token that you are using for the authentication;
- Check if in ODIS settings you have “Internet” instead of “CPN” (see document “ODIS_Initial_Setup_2.0” (*));
- Click on Cancel and perform the application test (see document “ODIS_Checking_ConnectionServer_SVM_2.0” (*)).
