Technical Journal

Replacement of ERAD components

REF NO: TJ 33358.3.0	ISSUING DEPARTMENT: Technical Service		ARKET: s and Canada
3 US 7	PARTNER: '510 Volvo Car USA	ISSUE DATE: 2018-05-18	STATUS DATE: 2018-05-21
FUNC GROUP: FUNC DESC: 4600 Rear axle, drive shaft		Page ⁻	1 of 23

TJ Instruction VCC-509127-1

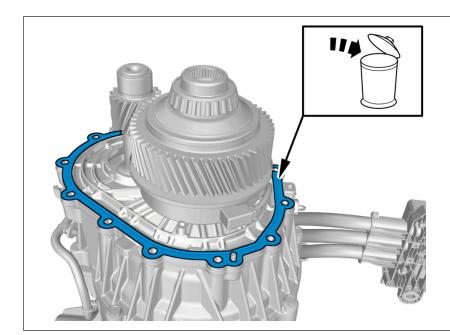
Old sealing.

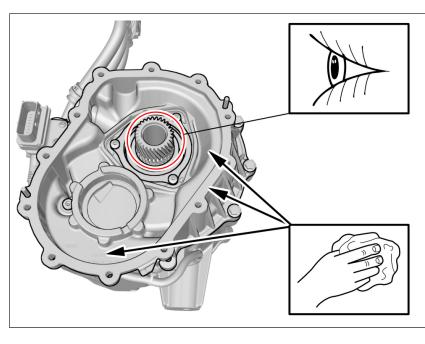
Note! Check the component. if any damage is shown, the whole complete ERAD is to be exchanged.

Note! Make sure that the component is clean and free of foreign material.
