## IMPORTANT TECHNICAL SERVICE BULLETIN : 1ZP-K8A2M-11

Potential for Sub-Optimal Grounding through Tow Vehicle Connection

2014 - 2015 Oliver Legacy Elite and Elite II models.

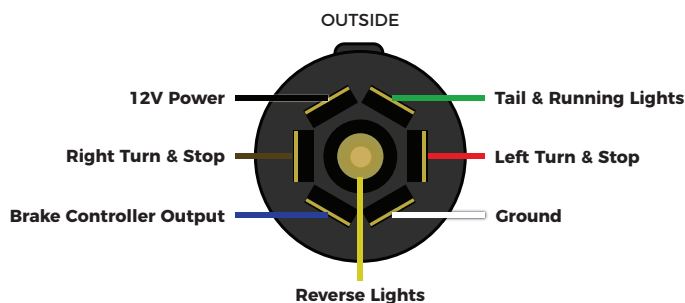
1. Using a multimeter set to Ohms to test for continuity, connect the red lead to the 7-pin ground connection. Connect the black lead to the frame directly behind the bulldog coupler.

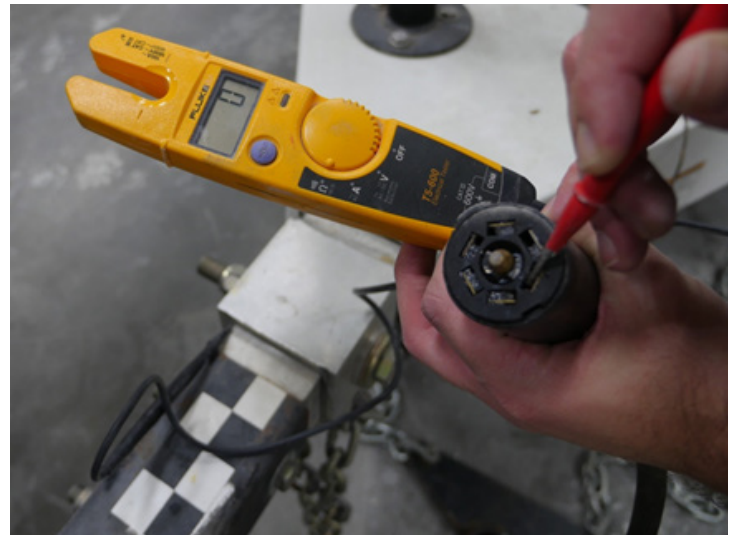
2. The multimeter should display 0 and beep or light up based on the type of multimeter, showing a complete path and proper bonded ground with the travel trailer frame.

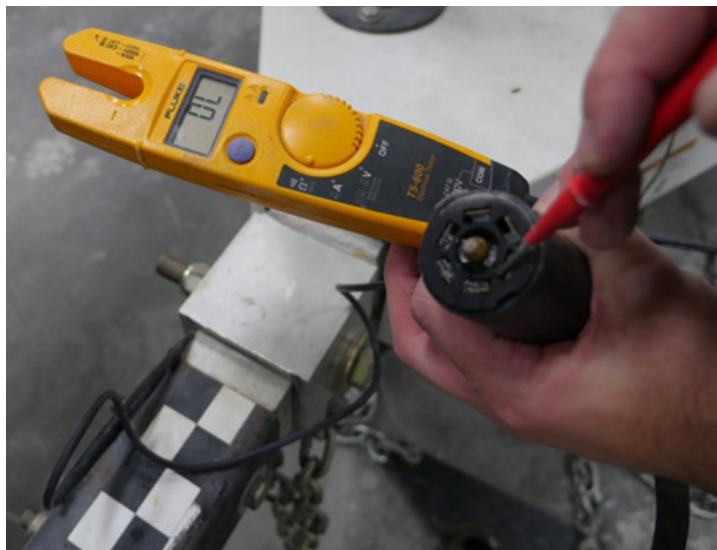
3. If the multimeter displays a 0 and beeps or lights it means the frame is properly bonded with the 7-pin ground wire, no further action is required. Please fill out the inspection reply card and mail to the address below using the postage provided return envelope.
4. If the multimeter DOES NOT beep and displays (OL) it means the circuit is open. In this case the ground is only being provided by the connection between the trailer hitch and ball. This is an approved method of grounding however when an optional anti sway device is installed this ground could be less than optimal and could lead to degraded brake operation. To ensure optimal connectivity please proceed to the corrective action steps below for bonding the trailer frame to 7-pin ground.

3. Locate the 7-pin (White) ground wire located inside the trailer under the rear dinette seat access panel.
4. After locating the white ground wire cut the wire in two and use a 3-Port connector to reconnect the two wires.

5. Using the additional port in the 3-Port connector run an additional white 12ga wire from the port over to the ground bar.
6. Using the multimeter, test the ground by performing the test procedure outlined above.
