POLARIS[®] TECHNICAL SERVICE BULLETIN

Bulletin Number: L-17-02-A

SUBJECT: 2017 GEM EPS BOLT INSPECTION

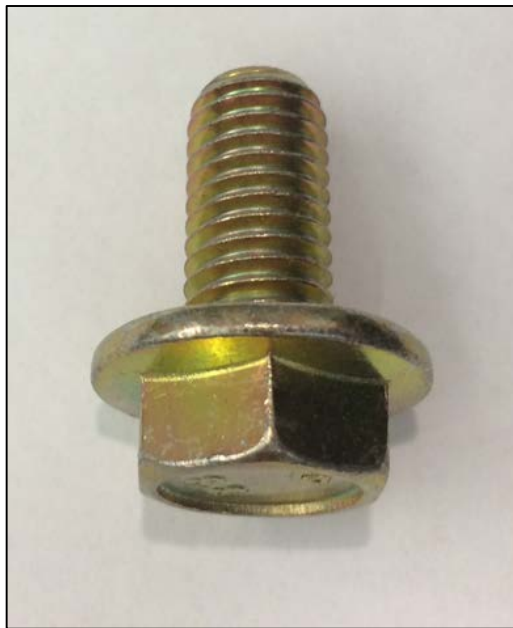
Polaris has found that a limited number of EPS-equipped vehicles were manufactured with bolts that have the incorrect thread pitch. These bolts mount the EPS module to its mounting bracket. These incorrect bolts damage the EPS unit as well as the bolts themselves. Any unit with incorrect bolts will require replacement of the bolts and the EPS unit. These bolts can be identified by their color; the correct bolts are an olive drab finish while the incorrect bolt is a yellow chromate finish.

**INCORRECT FASTENER
(Yellow Chromate Finish)**

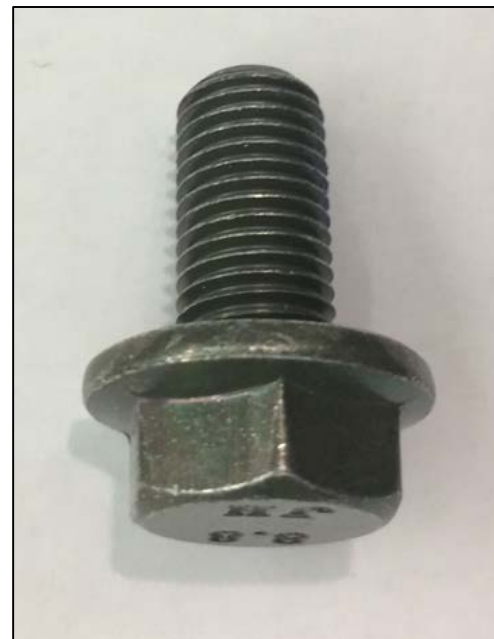
**CORRECT FASTENER
(Olive Drab Finish)**

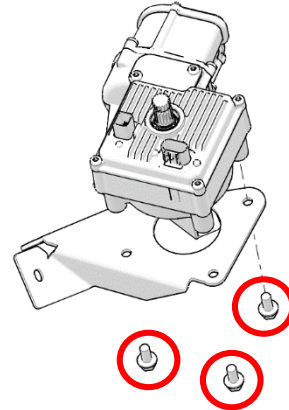
Figure 1

The bolts in question are circled, which can be viewed in Figure 1.

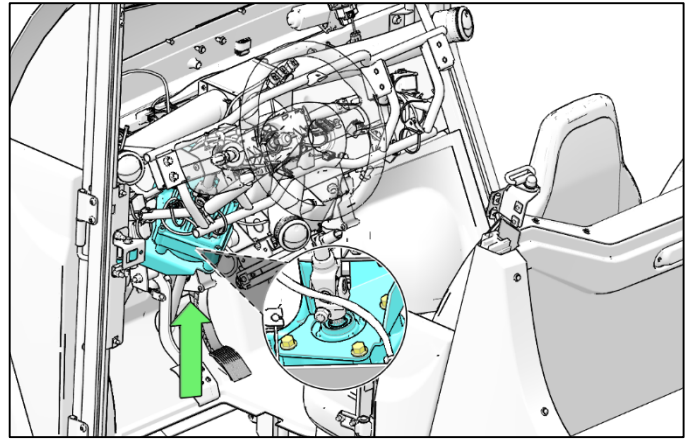
10. Inspect EPS bolt color while being underneath EPS unit and looking upward.

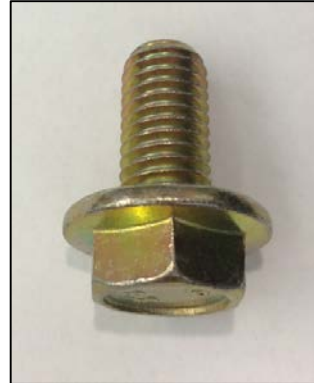
INCORRECT
(Yellow Chromate Finish)

12. If the EPS fasteners have a yellow chromate finish proceed with step 13.

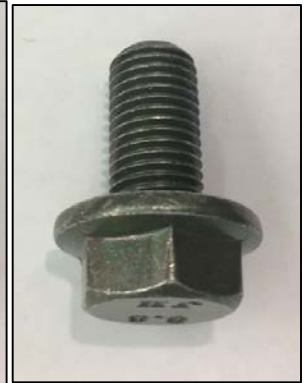
Correct
(Olive Drab Finish)

11. If the fasteners are an olive drab finish then no repair is necessary, reinstall dash components by reversing the order of steps 1-9. Install the bulletin completion decal on the frame, next to the Digital Wrench connector. File bulletin L-17-02-A.
