TEAM TIP

Communication #: L-18-04-02

Model Year(s): 2016-2018

MY16-18 GEM Cab Heater and State of Charge

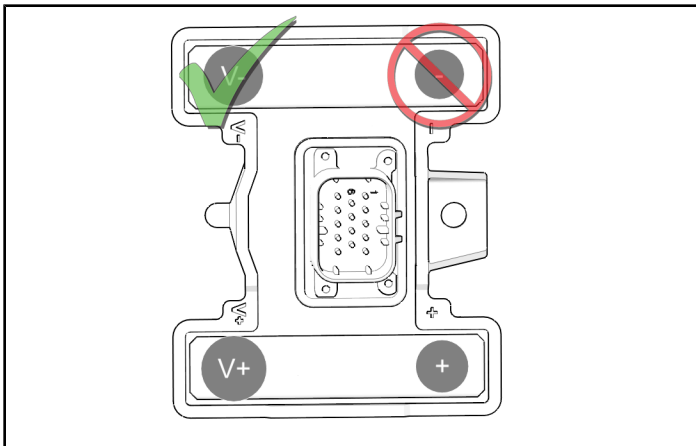
9. Inspect the BMC for a cable labeled "MC Ground". If it is connected to the BMC "-" terminal, remove the cable and install cable onto the BMC "V-" terminal.

The only cable that should be on the BMC "-" terminal is the 0-gauge negative cable from the battery pack. All other ground/negative cables should be on the BMC "V-" terminal.

BMC Terminal Bolts:
8 ft-lbs (11 Nm)
