Vehicles affected: P12: P1

Location: Powertrain Systems – Cooling System

Concern: Hybrid System Fault warning message on the instrument cluster

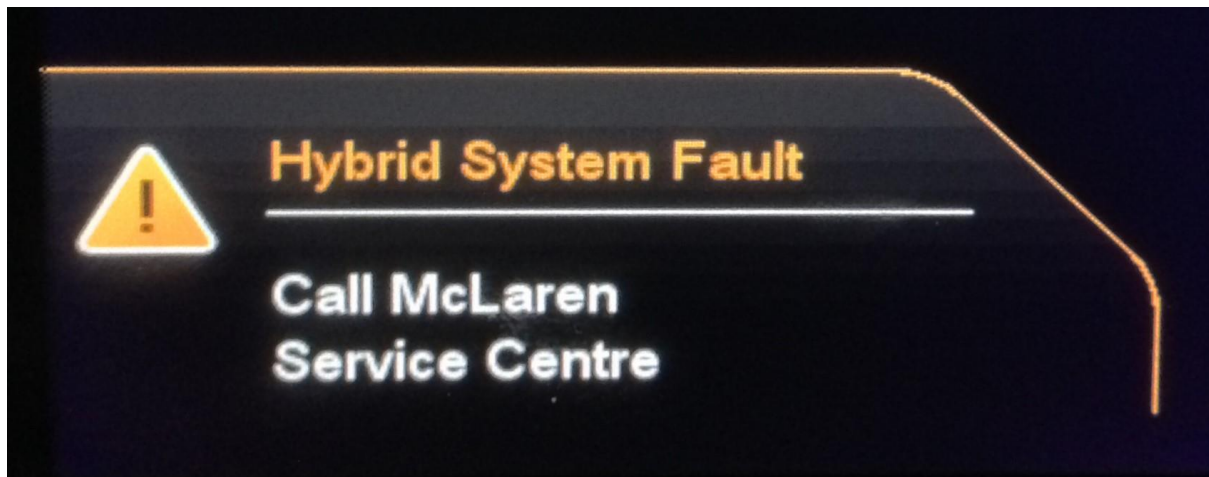
The warning message “Hybrid System Fault” (screenshot below) is **not** related to the vehicle’s Hybrid System when is **not** followed by “12V Battery Discharging” and Engine MIL light.

This warning message relates to the coolant system of the vehicle and does not generate a DTC.

- Check the engine coolant level.
- With the use of the coolant displacement tool kit, check the coolant displacement. Refer to SIS instructions BA-RM-04L001-00-001 - Drain/fill fluid - cooling system - Step 23.

If the displacement is outside the limit, proceed with the full vacuum bleed of the coolant system as per the SIS instructions.

- Once the coolant displacement is within the limits, test drive the vehicle to confirm the warning message is not returned.
