Replacing Fuel Filler or Charging Door Flap

Model	Model Year	Model Type	VIN Range	Vehicle-Specific Equipment
Panamera	2018	971	N/A	N/A

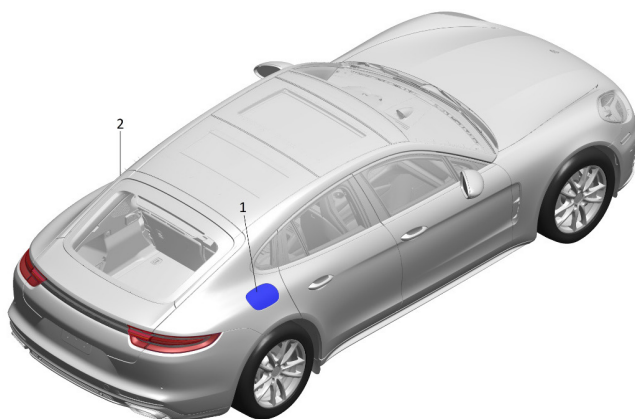
Installation Position

The fuel filler door flap, or the charging door flap is difficult to open or close.

The tolerance for the flap against the body is too tight.

- 1. Filler Flap
- 2. Charging Door Flap

Replace the fuel filler door flap or charging door flap. A revised part is now available at our PDC.

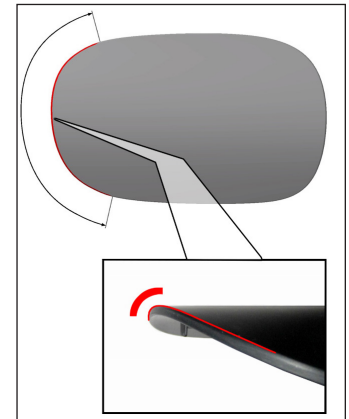
Due to the rework of the original parts by the supplier, a visible and perceptible edge may be present on the upper side of the flaps. If this is the case, smooth out the red marked edge with suitable sandpaper.

1. Painting filler or charging flap.

Information regarding the painting procedure (preparation, prime coat, base coat finish, & clear coat) see – Paint Manual – Painting procedure of plastic components
