Penske (DPR) Feedback Response – Bolt at the upper steering shaft where it meets the column

| <b>Problem Description:</b> <ul style="list-style-type: none"><li>Loose pinch bolts in steering column</li></ul> | | <b>First Reported Date:</b> | May, 11 <sup>th</sup> , 2018 |
| | | <b>Customer:</b> | Penske |

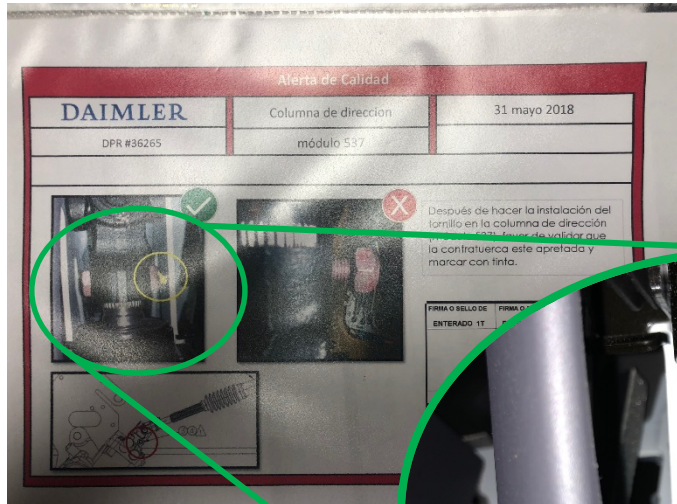
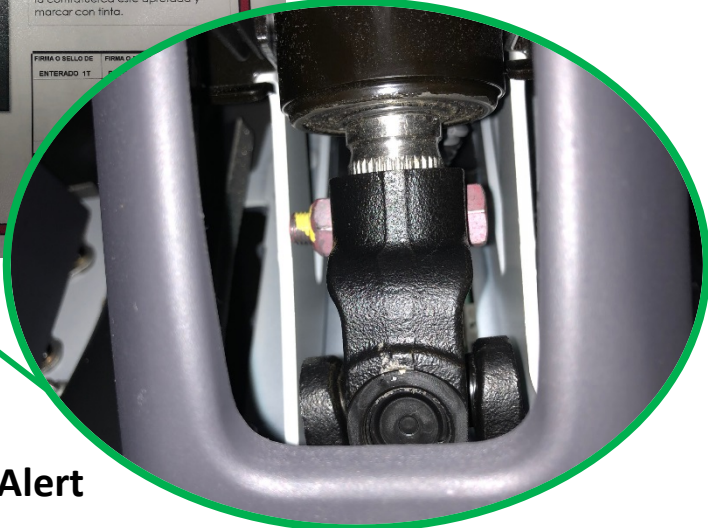
| <b>Possible Causes:</b> <ul style="list-style-type: none"><li>The documented procedure was not followed.</li><li>Tool in the process with torque out of specification</li></ul> | | <b>Claim Rate:</b> | 0.1667 |
| | | <div><p><b>Quality Alert</b></p><p>DAIMLER</p><p>Alerta de Calidad</p><p>Columna de dirección</p><p>31 mayo 2018</p><p>DPR #36265</p><p>módulo 537</p><p>Después de hacer la instalación del tornillo en la columna de dirección, se debe verificar que la contratuera este apretada y marcar con tinta.</p><p>FIRMA O SELLO DE ENTREGADO IT</p></div> <div><p><b>Quality Alert</b></p></div> | |

| <b>Containment Actions:</b> <ul style="list-style-type: none"><li>Quality alert issued in the station</li><li>Add point to inspection checklist on quality gate and put a green mark</li><li>Campaign in offline (30 trucks)</li></ul> | | | |
| <b>Corrective Actions:</b> <ul style="list-style-type: none"><li>Standard Work Instruction and Job Element Sheet is being updated to improve installation method.</li><li>A new tool (DC Tool) is in process to be implemented (June 30<sup>th</sup>)</li></ul> | | | |
