Daimler Trucks

North America LLC **Customer Advisory Letter**

**Subject :** Evolution APU No Regen

**Models Affected:** are New Cascadia built 2018 with ThermoKing Evolution APU.

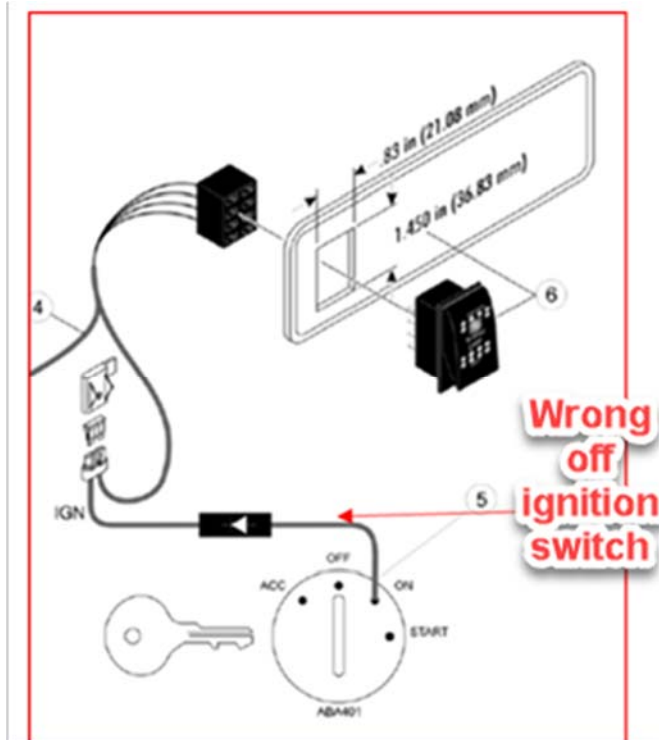
There may be reports of the factory installed APU not being able to perform a regen. Instructions from TK recommended the ignition power source be at the ignition switch. On the Cascadias', both New and Old designed models, the ignition switch is a signal and does not have 12 volts at any of the terminals. Accessory power must come from the recommended ignition source, Splice Packs. Splice Packs are the source where all accessories added in the cab should be sourced, you will find fused constant power (Fuse F35 10 AMP), fused ignition power (Fuse F44 10 AMP) and ground.

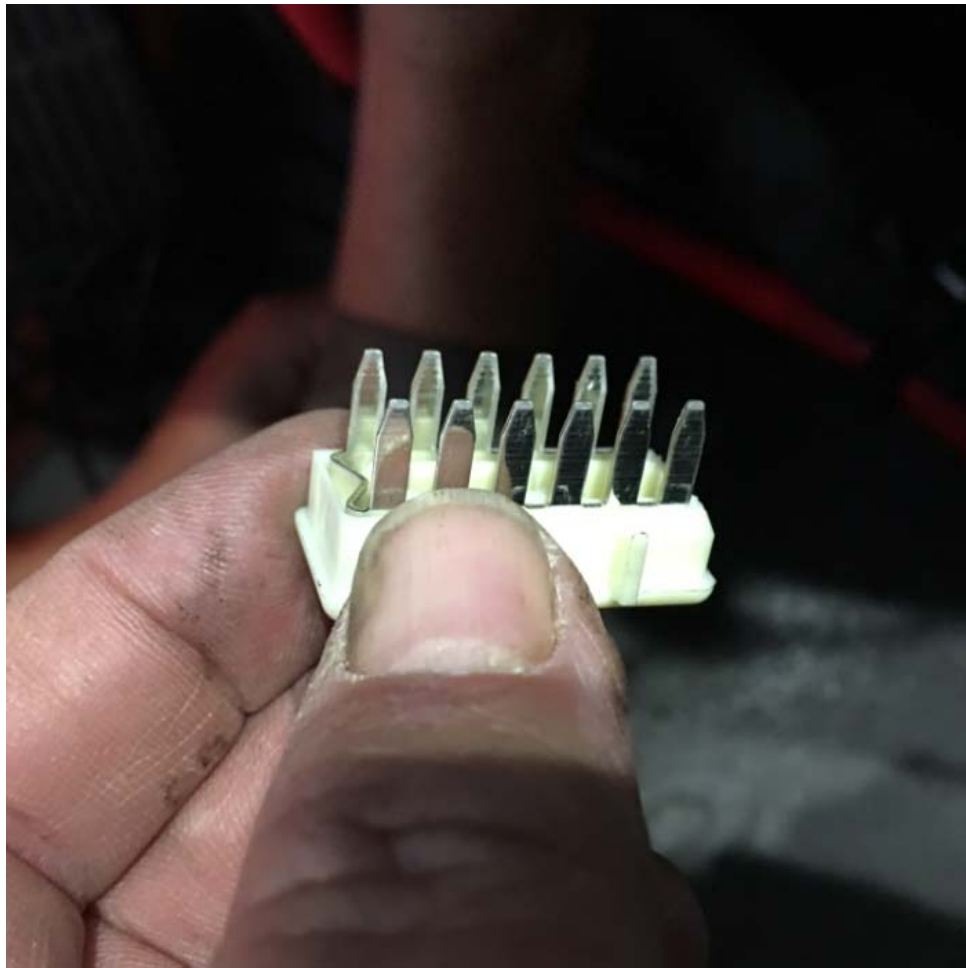
When adding a circuit, the terminals (listed above) will plug into the rear of the connector, see the white part of the connector above, that connects all circuits plugged into the connector to distribute power. Photo below shows the Splice Pack of the connector removed to see how it connects circuits.
