SI M41 01 18
Body

TICKING NOISE FROM ABOVE SUN VISOR

MINI Countryman)

Produced up to 1/2018

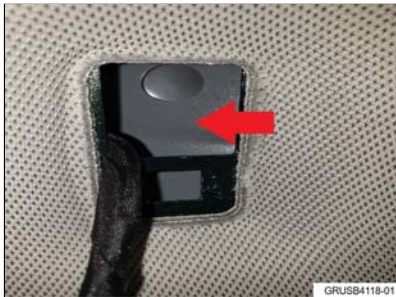
<ol style="list-style-type: none"> 3. Familiarize yourself with the proper location to reshape the sheet metal. See the photo to the left. The red arrow indicates the correct panel to reshape. <div data-bbox="597 1522 699 1623" style="display: inline-block; vertical-align: middle;"> </div> <p>Warning: Do NOT insert the tool through the hole shown to the left. The correct sheet metal panel is the one closest to the headliner.</p>

<p>4. Using a suitable tool, such as a thick plastic wedge tool, reshape the sheet metal upwards using a mallet.</p>
	<p>5. Retest the vehicle to ensure the noise is no longer present. If no noise is present after repairs, completely reassemble the vehicle.</p>
