US 64275931-01

Changed key location at PDI for K51

K51

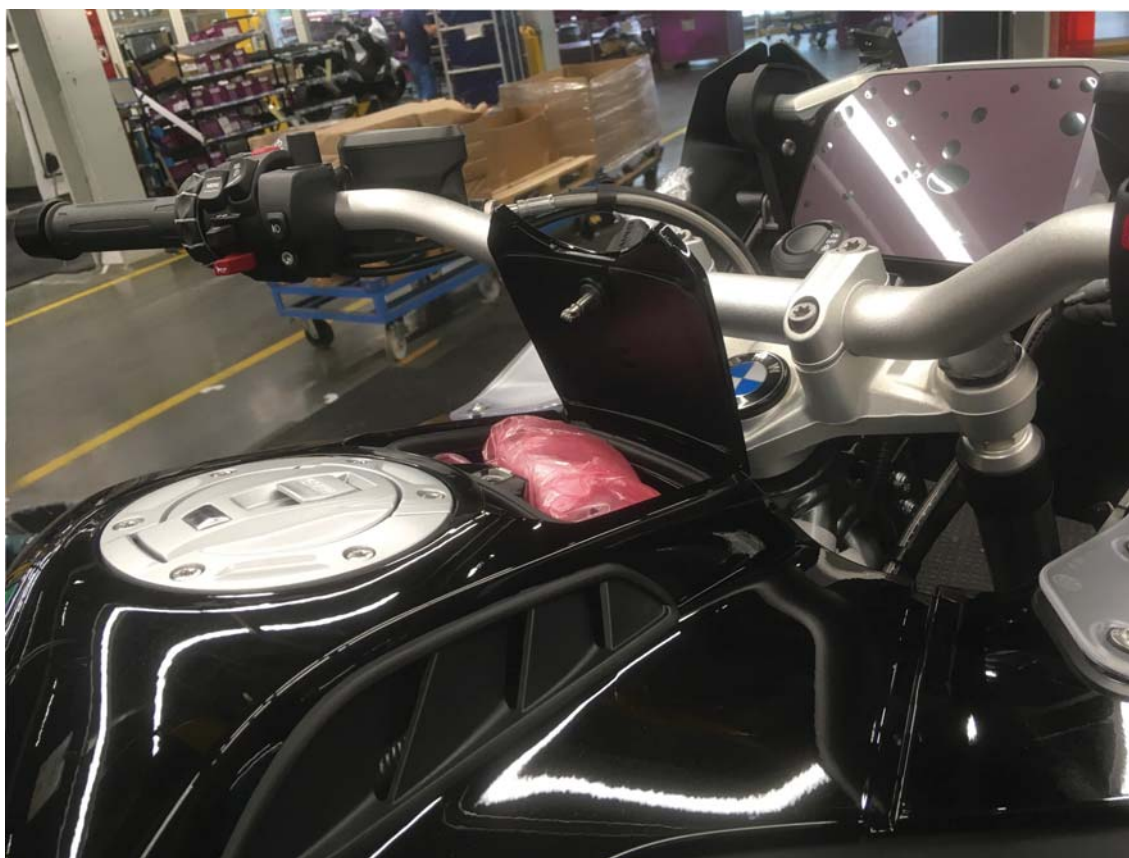
During the pre-delivery check, the ignition key is not found on the number plate carrier

There was a change in the process steps at the Berlin factory.

The ignition key will be in the storage compartment as of production date 13/06/2018 (see photo)
