11/9/2018  
CAL\_FTL 46-001

## **Subject: New Cascadia Ground Strategy**

**Models Affected: New Cascadia**

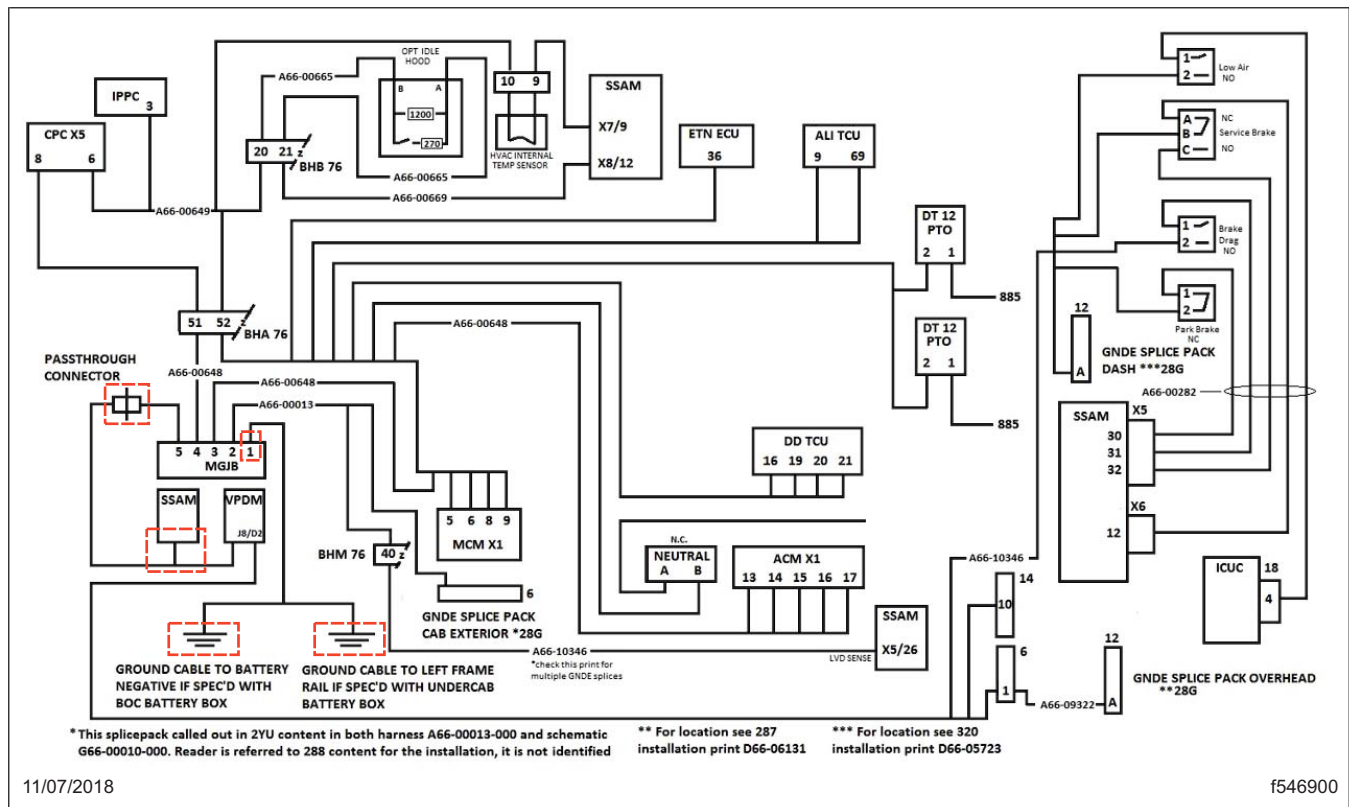
Fig. 1, GNDE Ground Summary

New Cascadia vehicles have a separated ground strategy that cannot be modified. Incorrect mapping of the ground circuits may cause backfeed, and overload an isolated portion of the grounds. This may result in damage to the clock spring, and unintended deployment of the driver-side airbag. See [Fig. 1](#) and [Fig. 2](#).

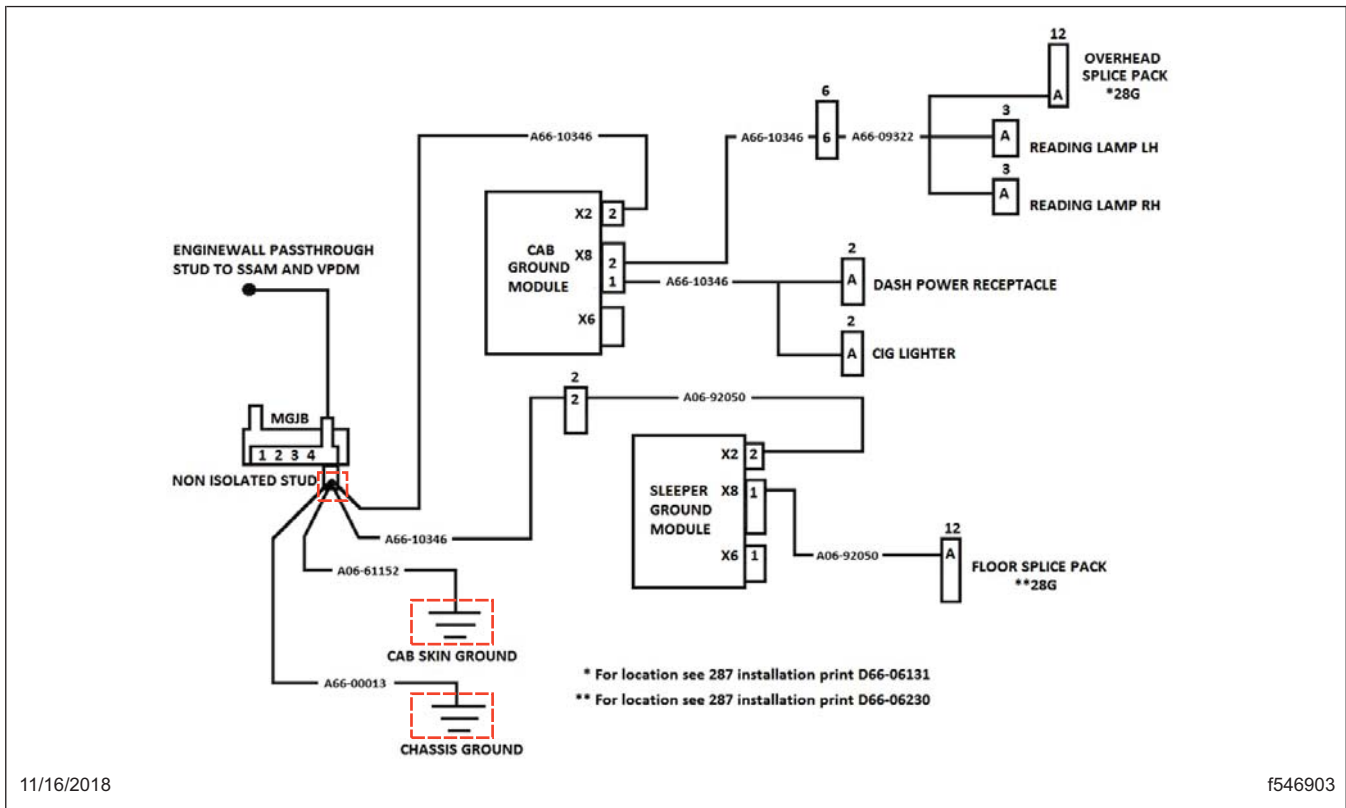
**Fig. 2, GNDP Ground Summary**

The four grounds for GNDP must remain on the non-isolated stud. These grounds must not blend with the GNDE cables located on the main ground junction block (MGJB). The GNDP grounds should have no overspray in the critical mounting points, beginning at the frame.

Use the instructions in this letter to verify that the grounds are properly routed, and that there is no overspray on the studs.

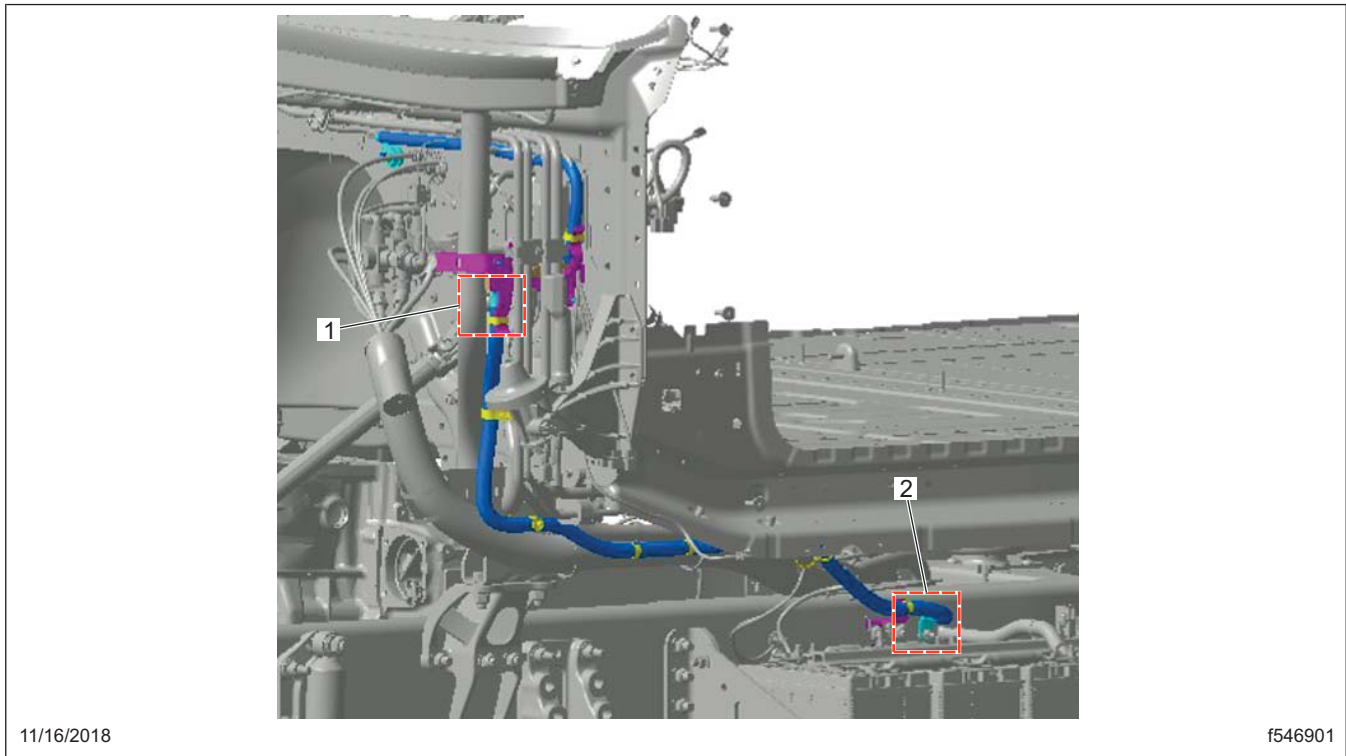
**Fig. 3, GNDE Ground Locations**

1. Park the vehicle, apply the parking brakes, and shut down the engine. Chock the tires.
2. Disconnect the batteries.
3. Remove the lower dash panels. Refer to Section 60.06, Subject 100 in the *New Cascadia Workshop Manual* for instructions.
4. Inspect the GNDP stud.
  - 4.1 Open the hood.
  - 4.2 Pull the nut off at each ground location. See [Fig. 3](#) . This ground begins at the MGJB and ends at the battery under the cab.

- 4.3 Inspect the studs for overspray on the flat surfaces, and in between the ring eyes. Use lacquer thinner as needed to clean off any excess paint.
- 4.4 Install the nuts and tighten 15 lbf-ft (21 N·m).

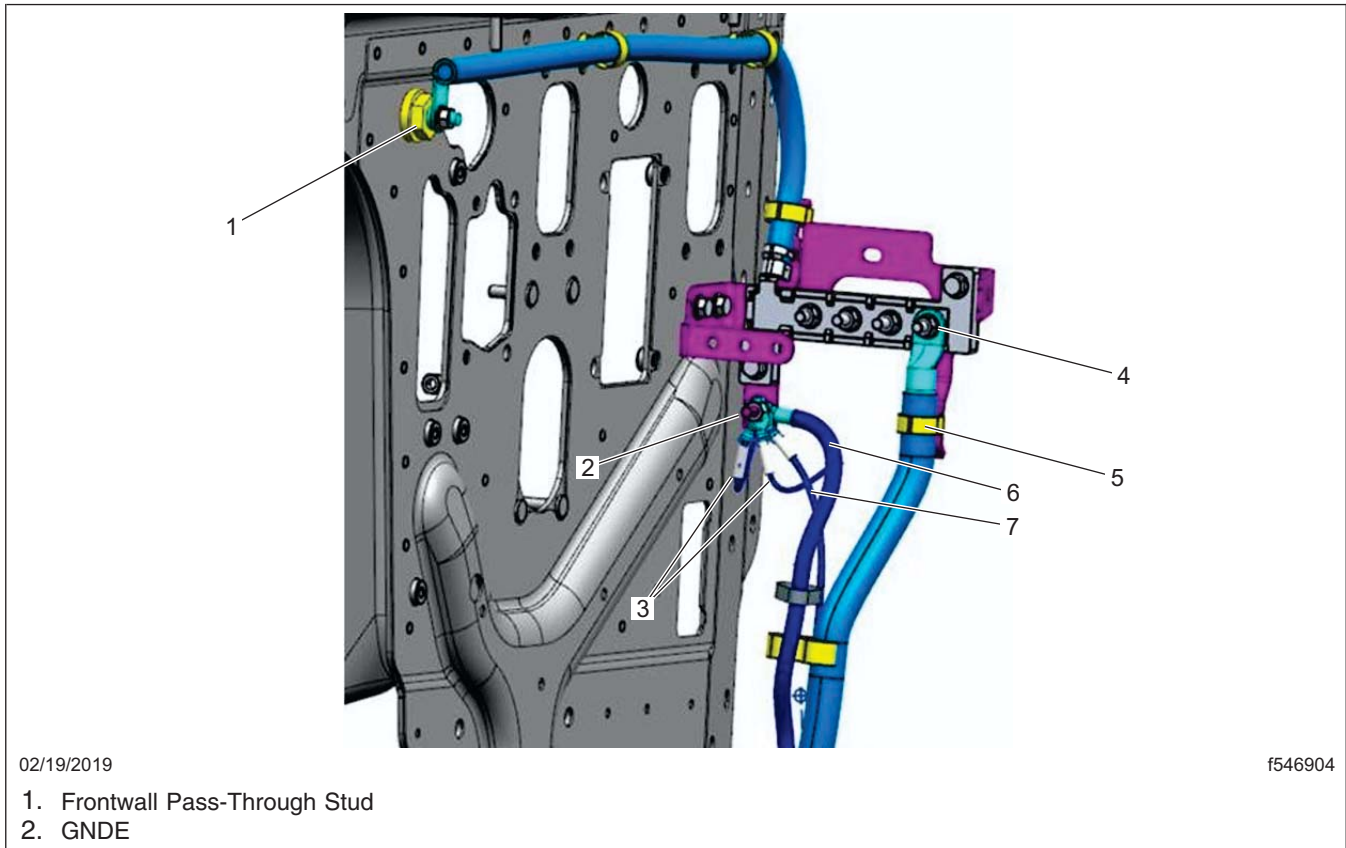
**Fig. 4, GNDP Locations on the Frontwall**

5. Inspect the GNDE stud. Trace the GNDE from the MGJB, along the cable to the passthrough stud, then inside the cab where it serves as the ground for the ASAM. This ground cable must not float due to connector failure, overspray, or loose fasteners.

- 5.1 Make sure there is a total of four circuits on the ring eyes attached to the GNDE non-isolated stud. If there are more or less than four circuits, the routing of the ground cables is incorrect.
- 5.2 Pull the nut off at each ground location. See [Fig. 4](#) and [Fig. 5](#).

- 5.3 Wipe off any overspray with laquer thinner.
- 5.4 Install the nuts and tighten 14 lbf-ft (19 N·m). Make sure that no more than three ring eyes are on each stud, and verify that all ring eyes are fanned out correctly to ensure maximum surface contact.
6. Inspect the MGJB bussbar torque specification. Torque the bussbar to 16 lbf-ft (21 N·m).
7. After validating the ground system, replace the steering wheel clock spring. Refer to Section 46.01, Subject 140 in the *New Cascadia Workshop Manual* for instructions.
8. Install the lower dash panels. Refer to Section 60.06, Subject 100 in the *New Cascadia Workshop Manual* for instructions.
9. Close the hood.
10. Connect the batteries.
