10/08/18
CAL TB 01-001

Subject: Enabling the Stay Warm Feature

Models Affected: Saf-T-Liner C2 School Buses built from April 11, 2017 through April 26, 2017.

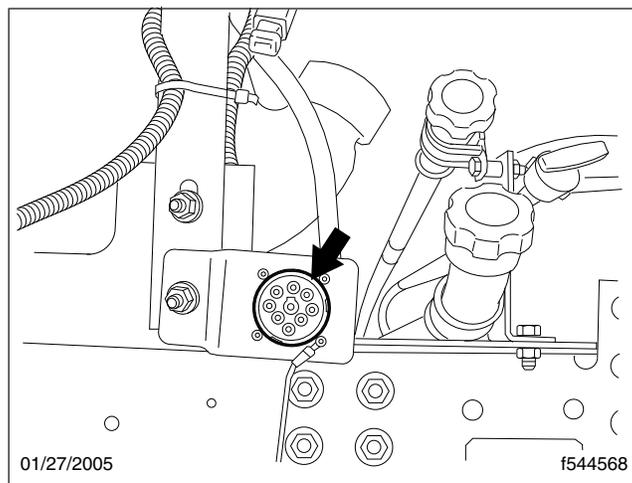
Fig. 1, Rear Diagnostic Connector (actual location may vary)

1. Park the vehicle on a level surface, shut down the engine, and set the parking brake. Chock the tires.
2. On a laptop computer, open the Cummins Insite® diagnostic program.
3. Connect the laptop connector to the diagnostic connector on the chassis. See [Fig. 1](#).
