# SS 1033522 New Cascadia With Fault Codes RDF42/524230/19 - ECU PSM data error and VRDU232/524042/19 - ECU RDF data error

This solution applies to all New Cascadia vehicles built before 1/1/2018 that have not had both the Central Gateway (CGW) and Single SAM (SSAM) modules updated to the latest software CGW 17.46 and SSAM 17.50.

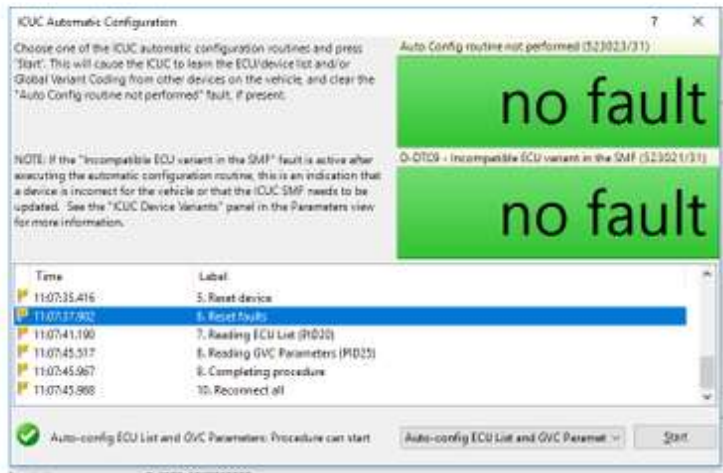
Performed ICUC Autoconfiguration and ended up with this mess

Auto Config routine not performed (523021/31)

D-DTC9 - Incompatible ECU variant in the SMF (523021/31)

I did see your last post regarding the ICU Auto Configuration, but this is a different problem from what the solution was posted for. As you could see in your screen print IPPC dropped out during the programming and never came back on line. This is a known issue and I will write a separate solution for that. Basically if you program (Flash) a module all of the other modules drop off the connection during the flash. For some reason, the IPPC does not come back on line. If this happens you should remove the 9 pin diagnostic connector from the vehicle, and then fully turn off and then turn on the ignition 2 times. This will usually allow the IPPC to reconnect. Once it reconnects then you might see that the ICU Auto Configuration will not need to be run. Also the ICU Auto Configuration code ICUC 23 SPN 523021 FMI 3— — D-DT9- Incompatible ECU Variant in the SMF code that is showing needs to be updated in the troubleshooting manual. I sent that information to the lit group back on April 18, 2018 and it appears that it is still not update. I will also write a solution for this code ICUC 23 SPN 523021 FMI 3— — D-DT9- Incompatible ECU Variant in the SMF also.

Flashed ICU 17.19.1 to same software and all codes resolved
