## SS-1033353 FCCC S2G Cab Lean

**Applicable Vehicles** - Certain 2013 thru 2015 FCCC S2G cab/chassis vehicles.

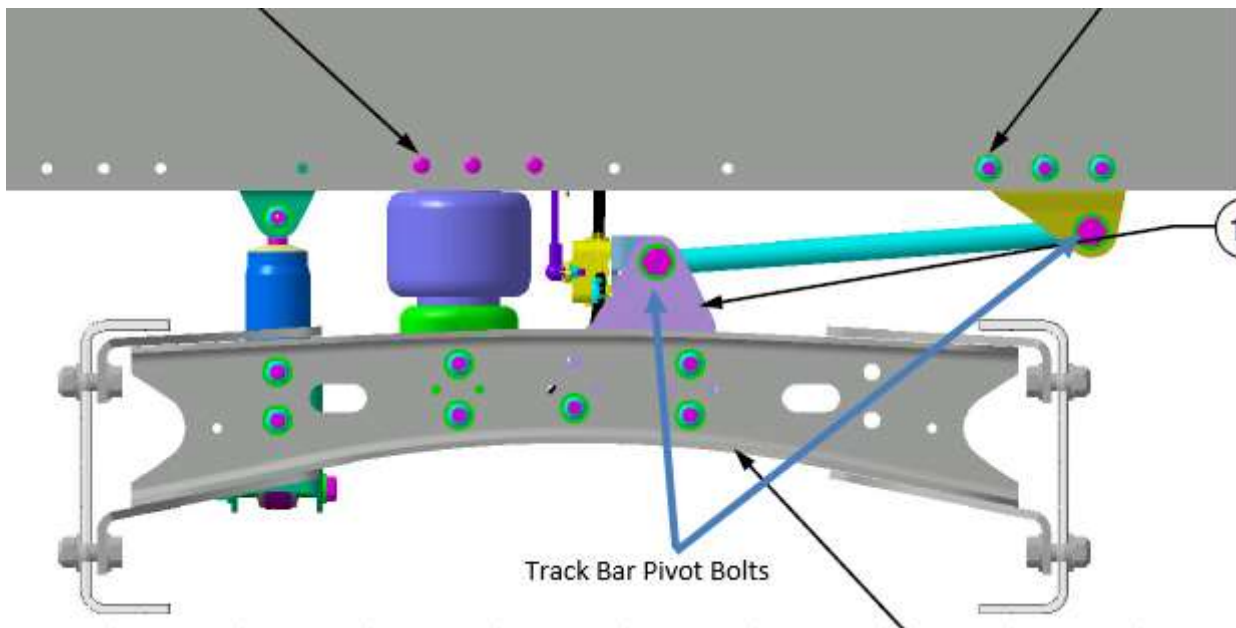
**Symptoms** - May have a cab lean or cab squeak around the track bar area

**Issue** - Certain Freightliner Custom Chassis Corporation's S2G models may have a cab lean or squeak. Use this solution to help determine if the issue is caused by the cab track bar hardware.

**Solution** - If a vehicle is exhibiting either an unexplained cab lean or cab squeak in the track bar mounting bushings, verify the pivot bolts size. The correct hardware should be 5/8" (5/8" bolt has a 15/16" hex head - 1/2" bolt will have a 3/4" hex head bolt), If found to have 1/2" hardware replace it with 5/8" : 23-11755-350 - bolt, 23-09114-000 - washer, 23-13179-110 - lock nut. Torque this hardware to 40 - 50 ftlbs. Either end of the track bar could be effected.
